ROAD MAINTENANCE MONITORING REPORT

QUARTER 1-3 FY 2018/19 (July 2018– March 2019)

Uganda Road Fund

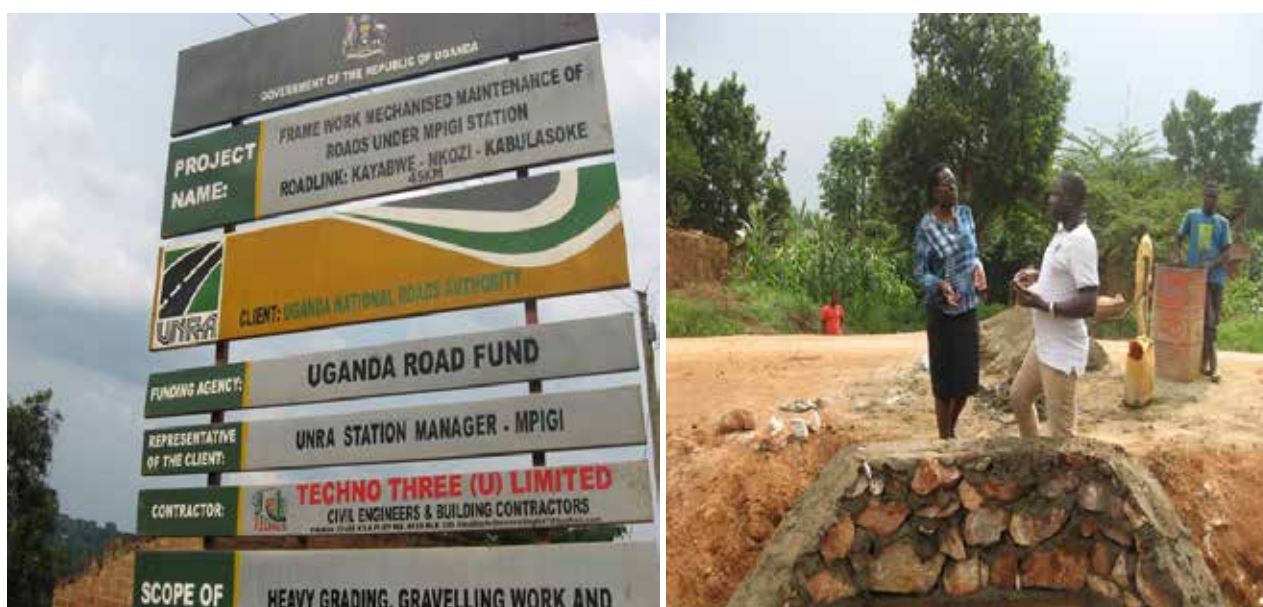
UNRA Mpigi: Kayabwe-Nkozi-Kabulasoke road (42 km) fully graded and re-regravelled under mechanised maintenance using framework contracting.

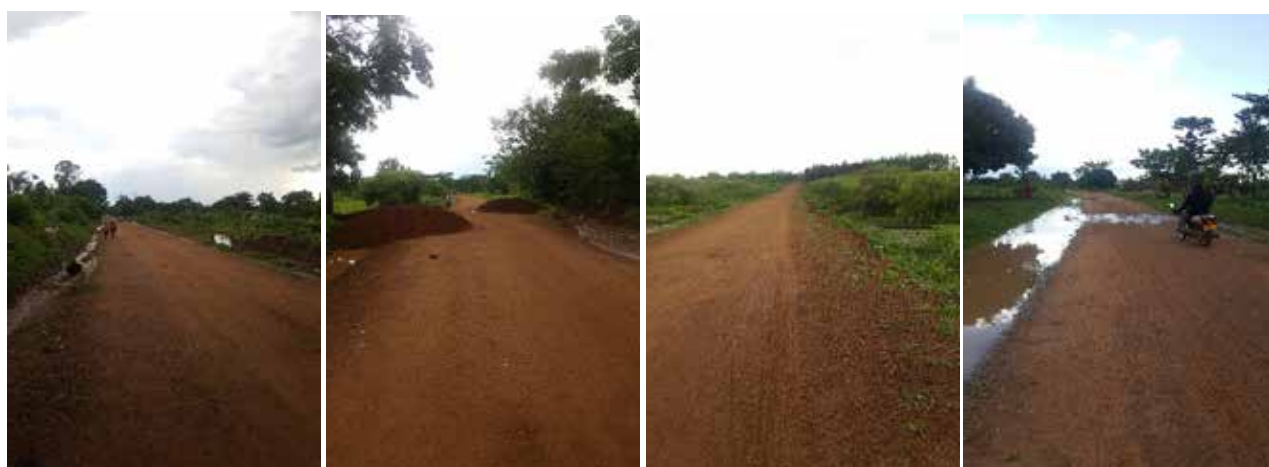
Sn	Road Name	Type of works/ Contract Details	Site Observations
1.	Rubongi – Mulanda – Buwesa – Budhumba (45Km)	<p>Routine Mechanised Maintenance using Framework contracting.</p> <p><i>Contractor: MG Eng. & Contractors Ltd</i> <i>Contract sum: UGX 1,412,410,440</i> <i>Call-off order: 3</i> <i>Commencement: 18th Dec 2018</i> <i>Completion: 17th Apr 2019</i> <i>Status: Defects Liability Period after substantial completion</i></p>	Works that had been done on the road included grading of the entire section (43.4Km), gravelling of approx. 15Km and installation of 7 lines of cross culverts and 13 lines of access culverts. Mitre drains and catch water drains had been provided in selected sections. However several of the installed culverts required more backfill along the approaches, and several existing broken culverts that required replacement were observed. Heavy scouring was observed along the side drains in the section at Km 20.0 to 20.5.

Sections of Rubongi – Mulanda - Budhumba Road (45Km)

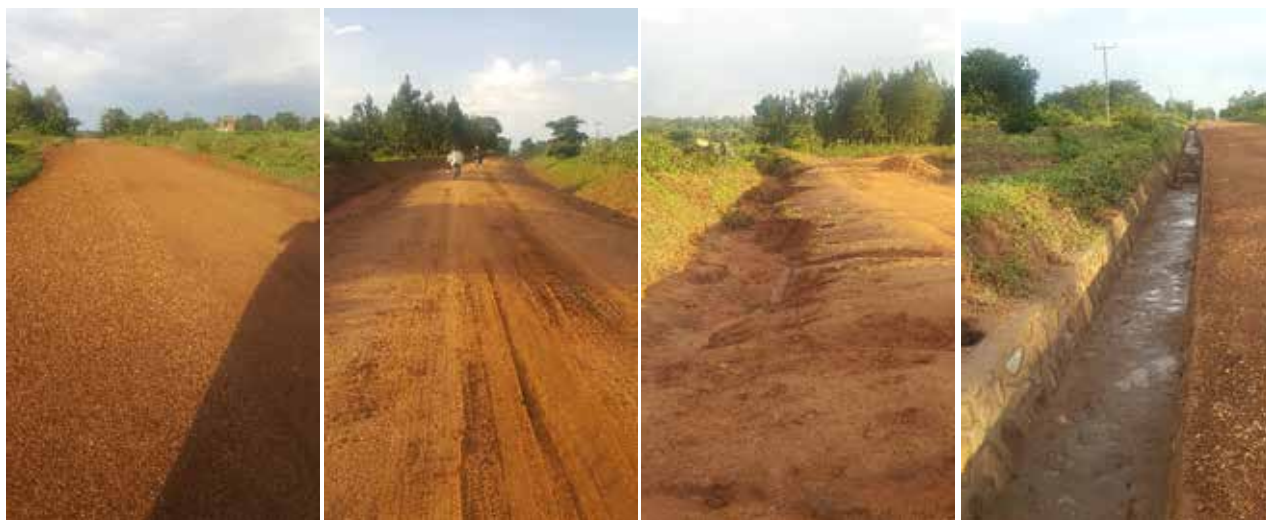
Sections of Nagongera – Merikit - Isikhoye Road (35Km)

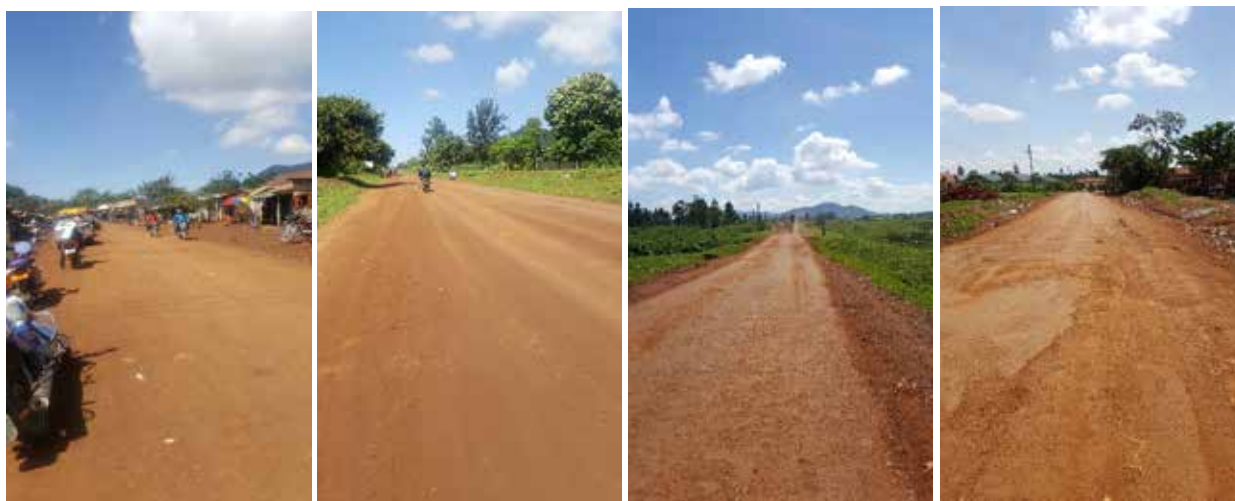
3.	Tororo – Busia (24Km)	<p>Routine Mechanised Maintenance of selected roads from group of 215Km using Framework contracting.</p> <p><i>Contractor: MML Road Constr Co. Ltd</i> <i>Contract sum: UGX 1,135,314,580</i> <i>Call-off order: 1</i> <i>Commencement: 5th June 2018</i> <i>Completion: 4th Nov 2018</i> <i>Status: Defects Liability Period after substantial completion</i></p>	<p>Works that had been done on the road included grading of the entire section (24Km), spot gravelling in selected sections and installation of 3 lines of cross culverts and 1 line of access culverts. The road had however deteriorated and therefore required re-grading. Several surface failures including potholes, cross drains and silting of side drains in some sections were observed.</p>
----	-----------------------	---	--

Sections of Tororo - Busia Road (24Km)

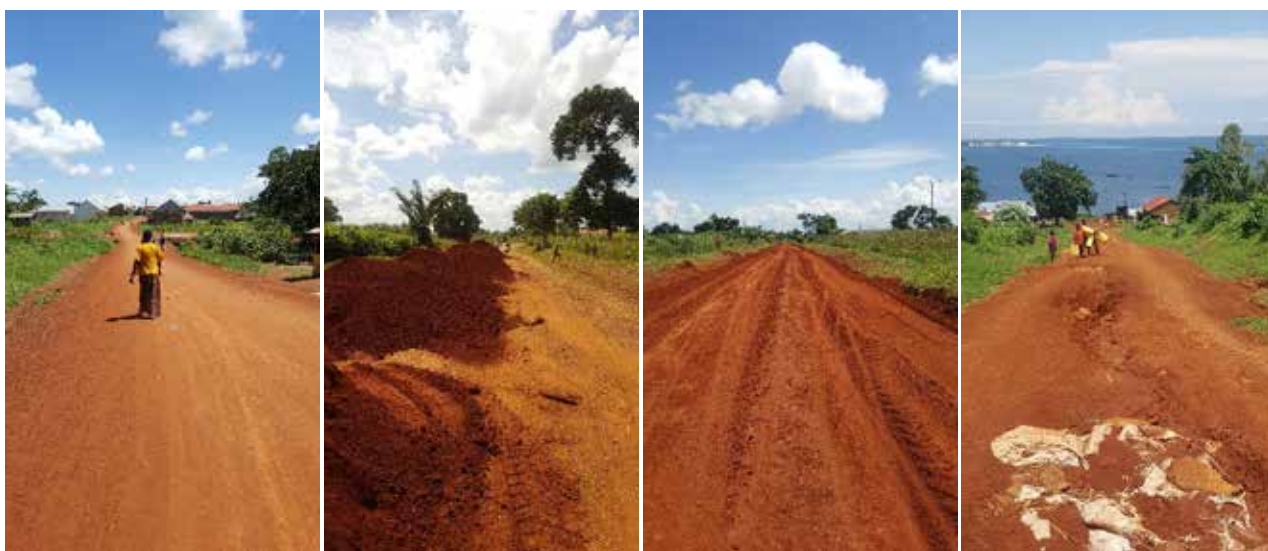
Sn	Road Name	Type of works/ Contract Details	Site Observations
4.	Namayingo – Bumeru (32Km)	<p>Routine Mechanised Maintenance of selected roads from group of 215Km using Framework contracting.</p> <p><i>Contractor: MML Road Constr. Co. Ltd</i> <i>Contract sum: UGX 1,207,009,610</i> <i>Call-off order: 2</i> <i>Commencement: 5th Feb 2019</i> <i>Completion: 4th Jul 2019</i> <i>Status: Ongoing</i></p>	<p>Works that had been done on the road included grading of the entire section (31.4Km), spot gravelling in selected sections and installation of 3 lines of cross culverts and 3 lines of access culverts. The road still had a good riding surface and gravelling in selected sections was still underway with gravel heaps observed in some sections. It was however observed that the road had not been back sloped during grading, and a culvert crossing with concrete surround had been abandoned without backfill, which was a hazard to road users. A bottleneck of galleys across the carriageway was observed at Km 29.7, along the slope to the landing site.</p>

Sections of Namayingo - Bumeru Road (32Km)

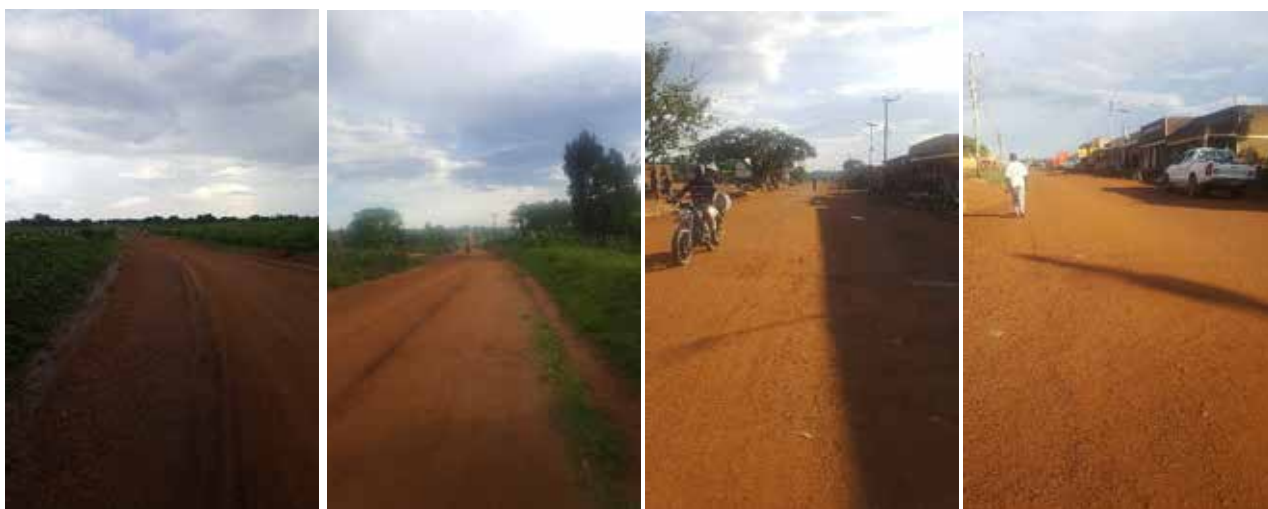
Sn	Road Name	Type of works/ Contract Details	Site Observations
1.	Budhumba – Busolwe (16.5Km)	Routine Mechanised Maintenance using force account	The road had been graded to a length of 15.7Km and still had a fair riding surface. However cross drains had already developed across the shoulders in some sections.

Sections of Budhumba – Busolwe (16.5Km)

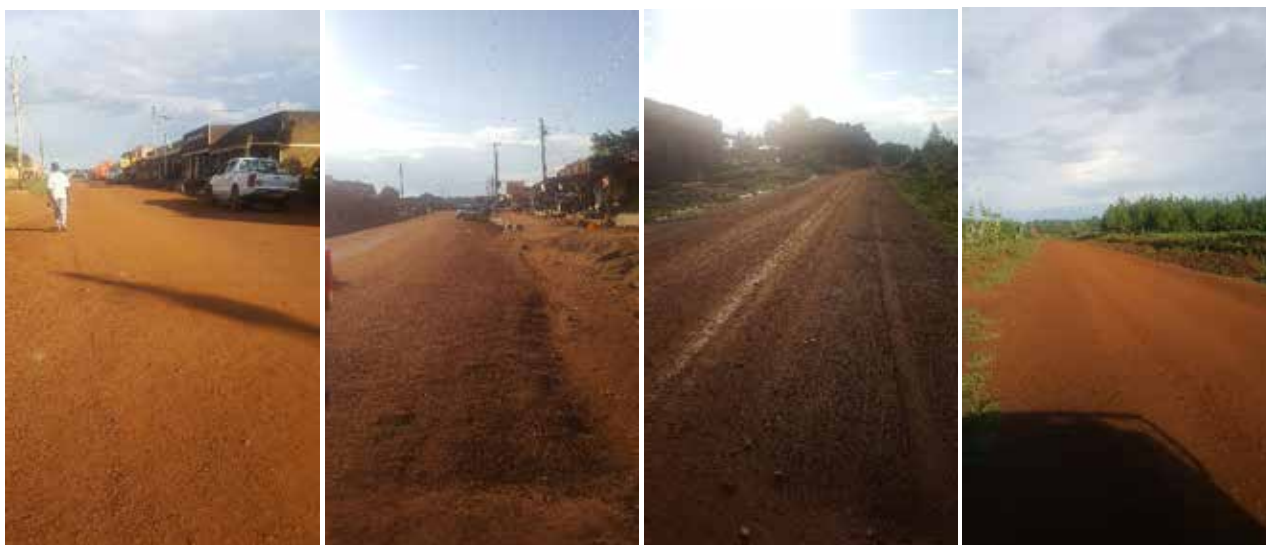
2.	Busolwe – Nagongera (14.0Km)	Routine Mechanised Maintenance using force account	The road had been graded to a length of 14.3Km and still had a fair riding surface. However cross drains and isolated potholes had already developed across the shoulders in some sections and surface water crossing at a rock outcrop at Km 6.3 was observed.
----	------------------------------	--	---

Sections of Busolwe - Nagongera Road (14Km)

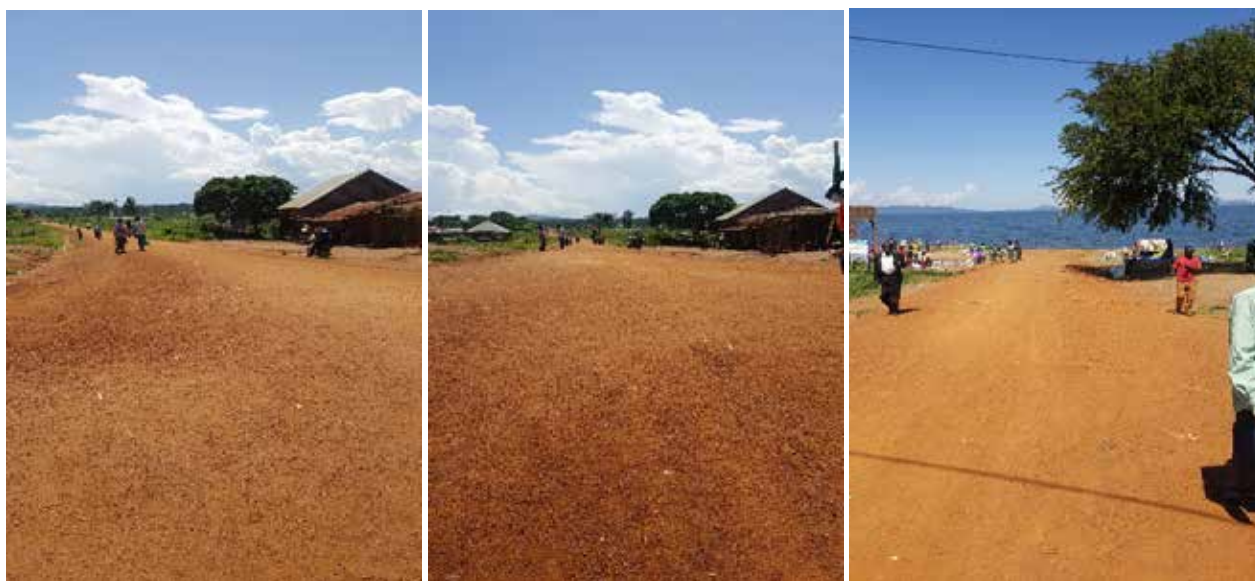
Sn	Road Name	Type of works/ Contract Details	Site Observations
3.	Namayingo – Lugala (17Km)	Routine Mechanised Maintenance using force account	The road had been graded to a length of 16.7Km and still had a fair riding surface. However cross drains had already developed across the shoulders in some sections. Routine manual maintenance works were in progress in some sections of the road.

Sections of Namayingo - Lugala Road (17Km)

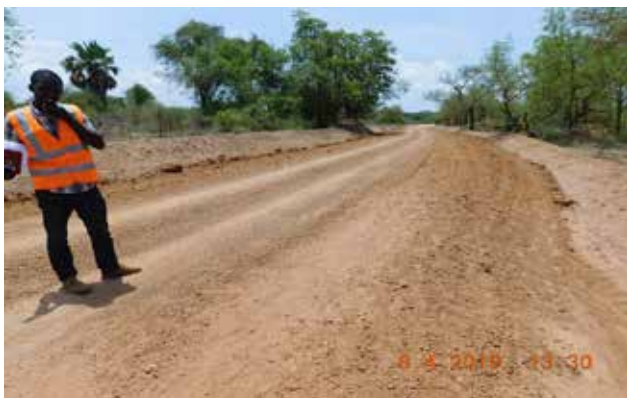
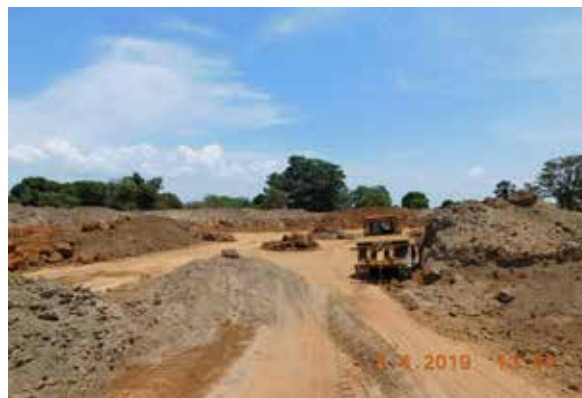
Obongi – Moyo Road (56km) underwent routine mechanised maintenance by BLD Consult (U) Ltd under Framework Contract.

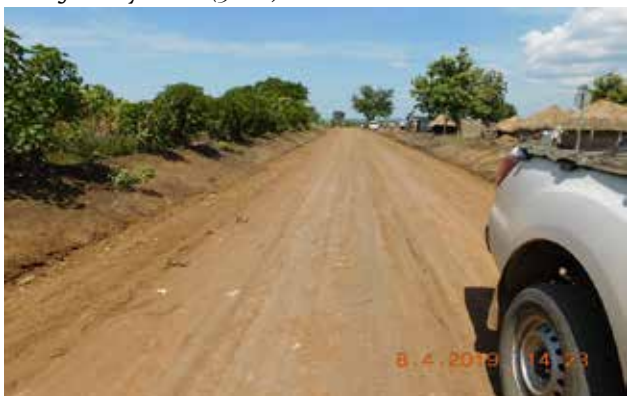
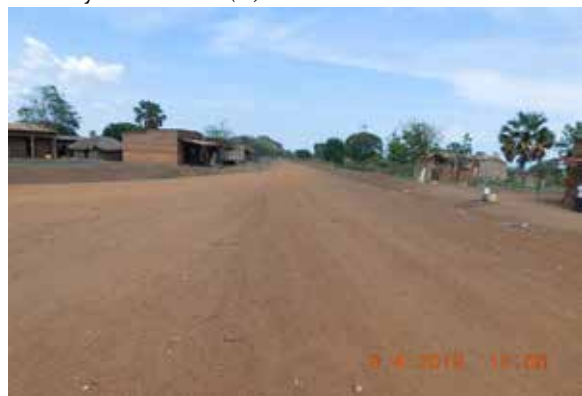
Obongi – Kulikulinga Rd was graded in Q3 using Force Account

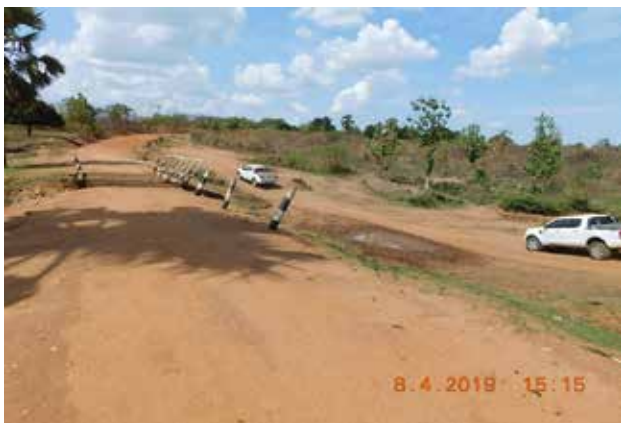
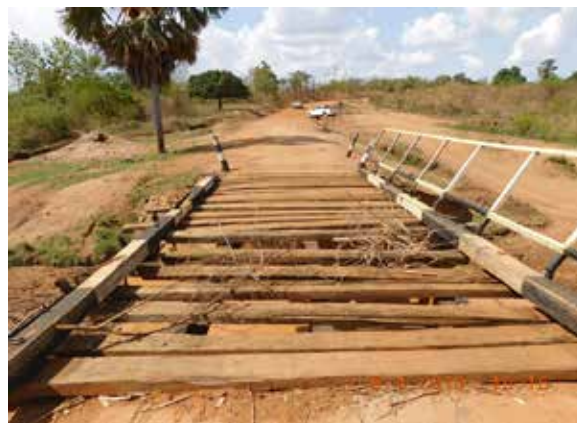
Jure – Yumbe rd received routine mechanised maintenance under Force Account in Q2. Jure bridge above is not safe for any form of traffic and is due for repair. Design and Build contract for bridge awarded to CICO.

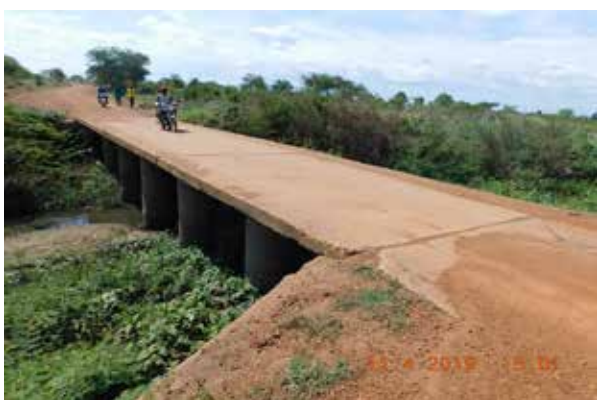
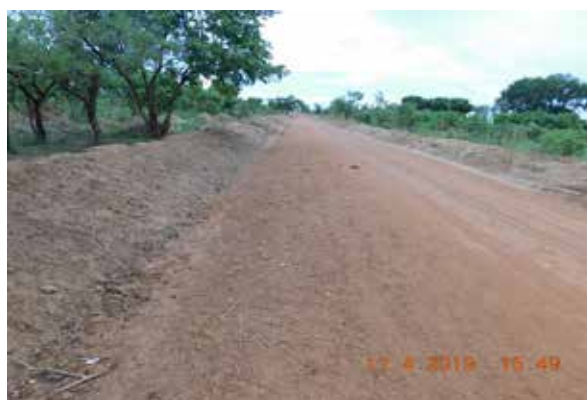
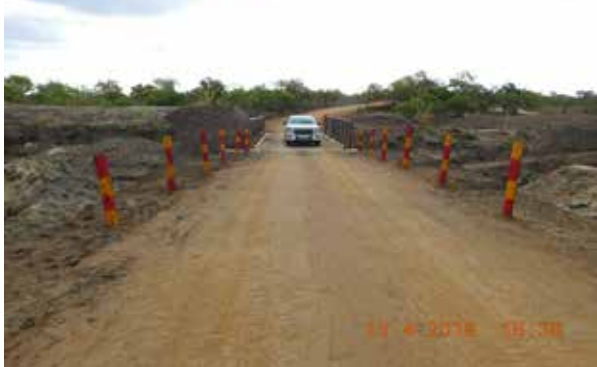
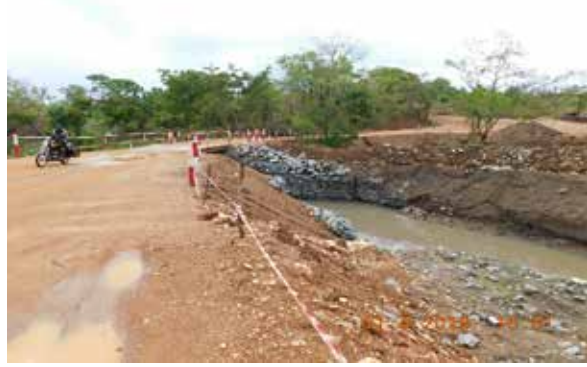
Pakele-Pabbo Rd unprotected bridge crossing at CH08+00 (top) and ongoing works at CH28+00 up to CH45+400 on

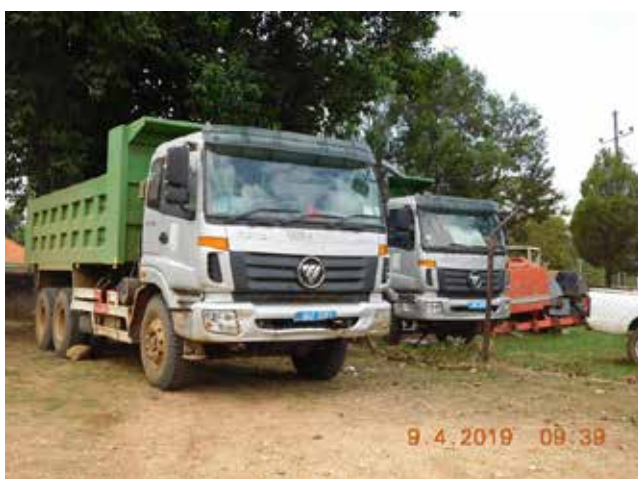
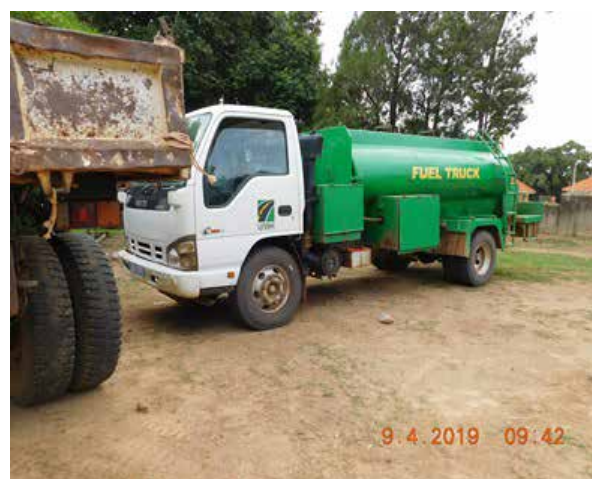
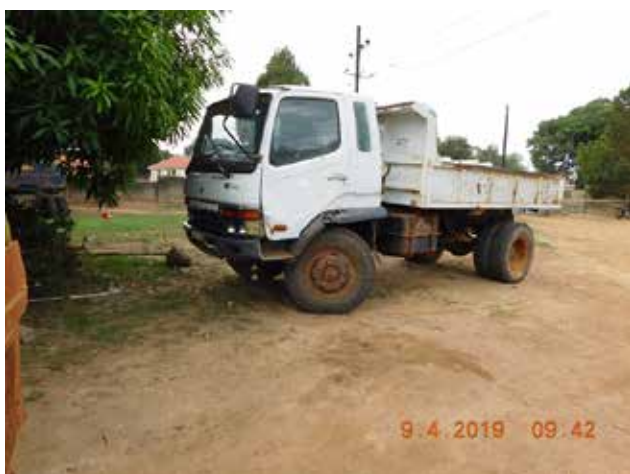
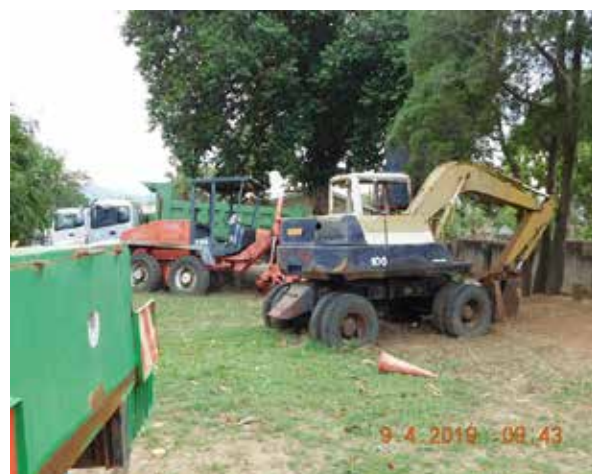
Figure 2.2: The station received some new equipment (top row) to supplement its ageing fleet (bottom)

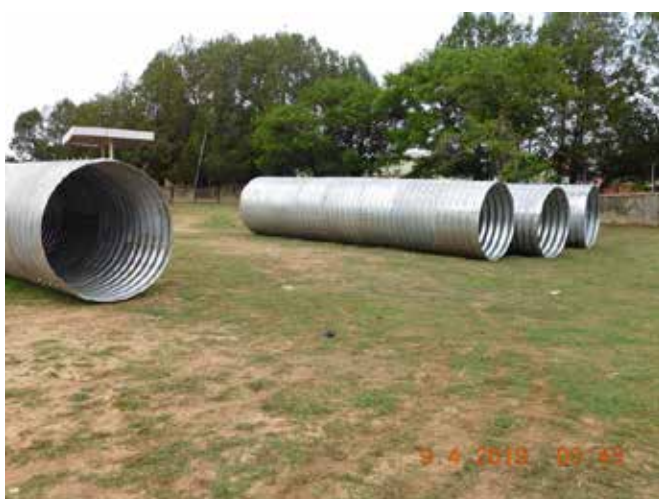
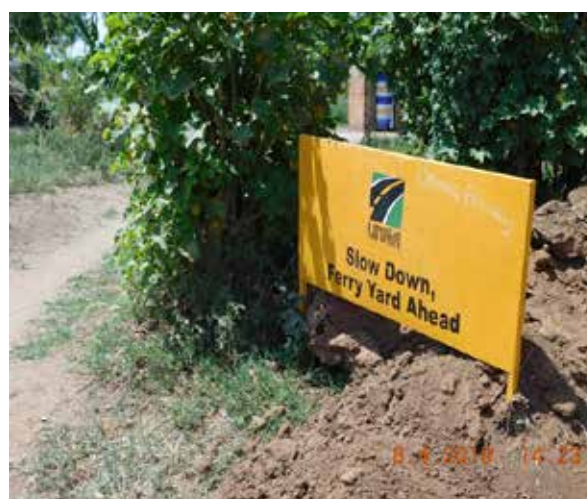
ARMCO culverts at the Station and one of the procured warning sign after installation on the approach to Obongi ferry landing

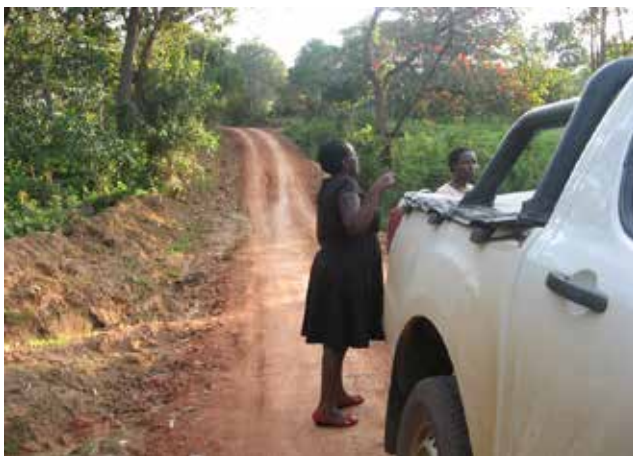
Ibanda MC: Culvert installation and spot gravelling done on a 200 m section of Rwobizizi-Kyegwisa road (19.5 km) using emergency funds.

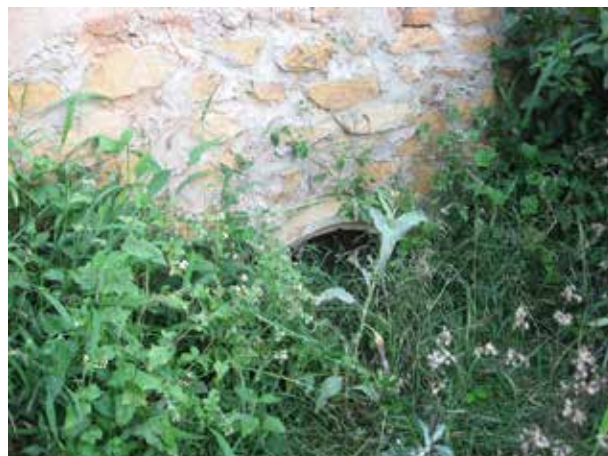
Ibanda MC: Culvert ends covered with overgrown vegetation on Rwobizizi-Kyegwisa road (19.5 km) due to lack of RMM.

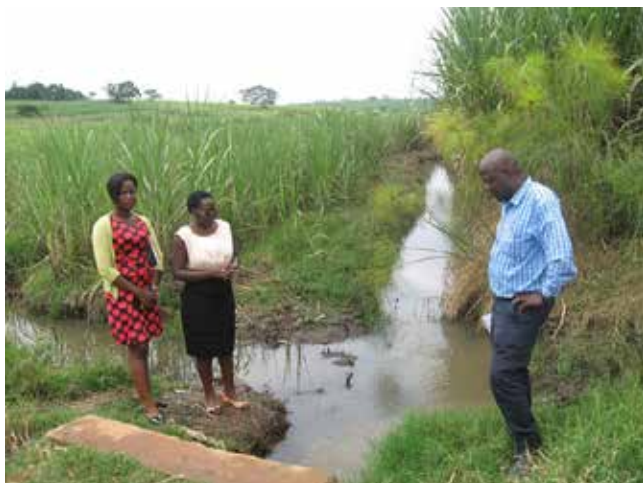
Kayunga district: River training done on Kisoga-Kikwanya-Nalwewungula road (15 km) under routine mechanised maintenance.

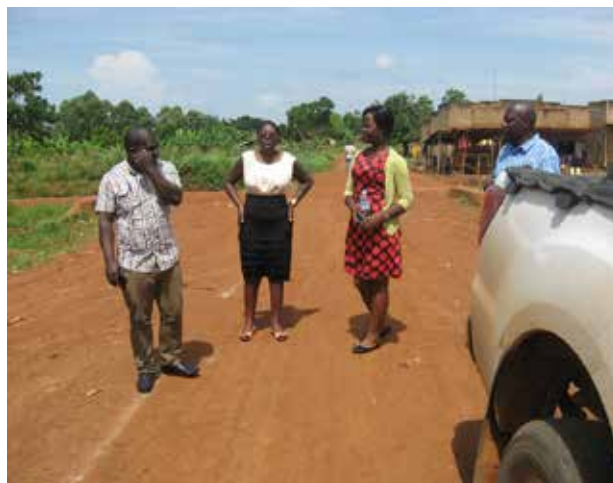
Kayunga district: A spot gravelled section on Bubajjwe-Bukujju-Kanya road (11 km) done under routine mechanised maintenance.

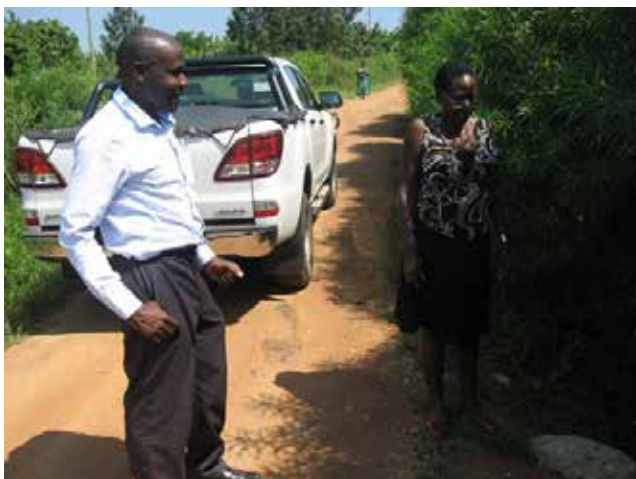
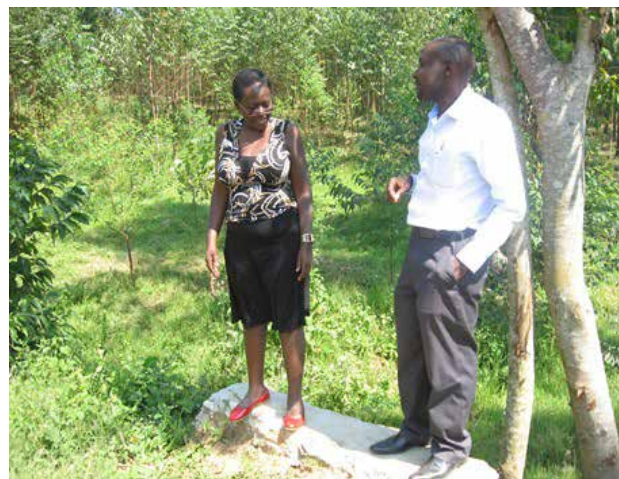
Sheema MC: Grading and culvert installation done on Rugongi-Kyabandara road (1.9 km) using emergency funds

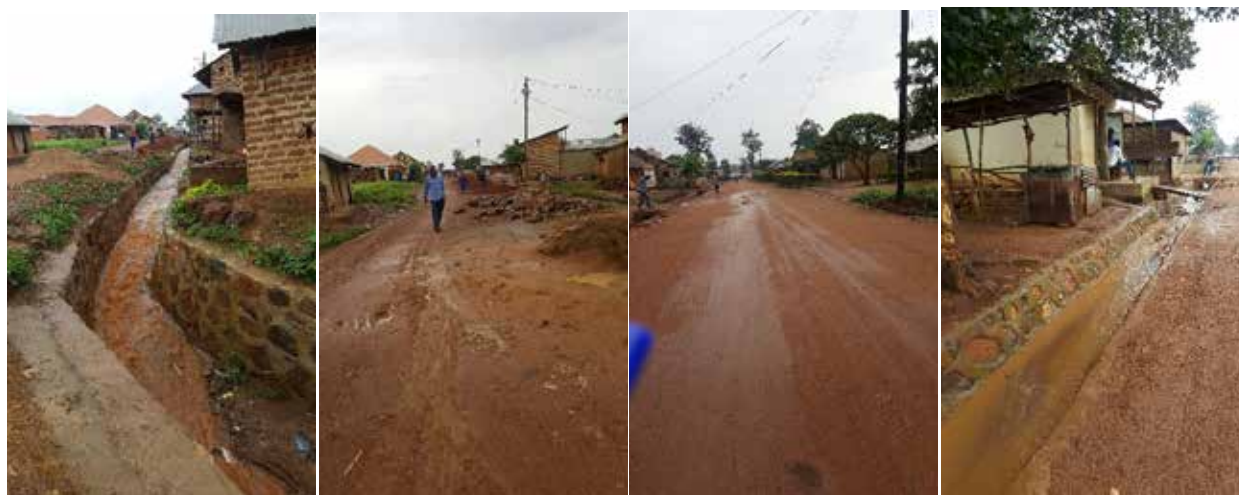
2.	Mosque road, which was not in the work plan	The road had been graded to formation but without compaction.
3.	Elizabeth Road (0.65Km) planned for routine mechanised maintenance	The road had been graded to formation and 2 lines of cross culverts and 4 lines of access culverts installed. Stone lining on one side of the road had been done to a length of 400m. Spot gravelling was still underway in selected sections of the road with gravel damped on the road. Vehicle measurement of road length was 0.55Km.

Busia MC: Sections of Elizabeth Road

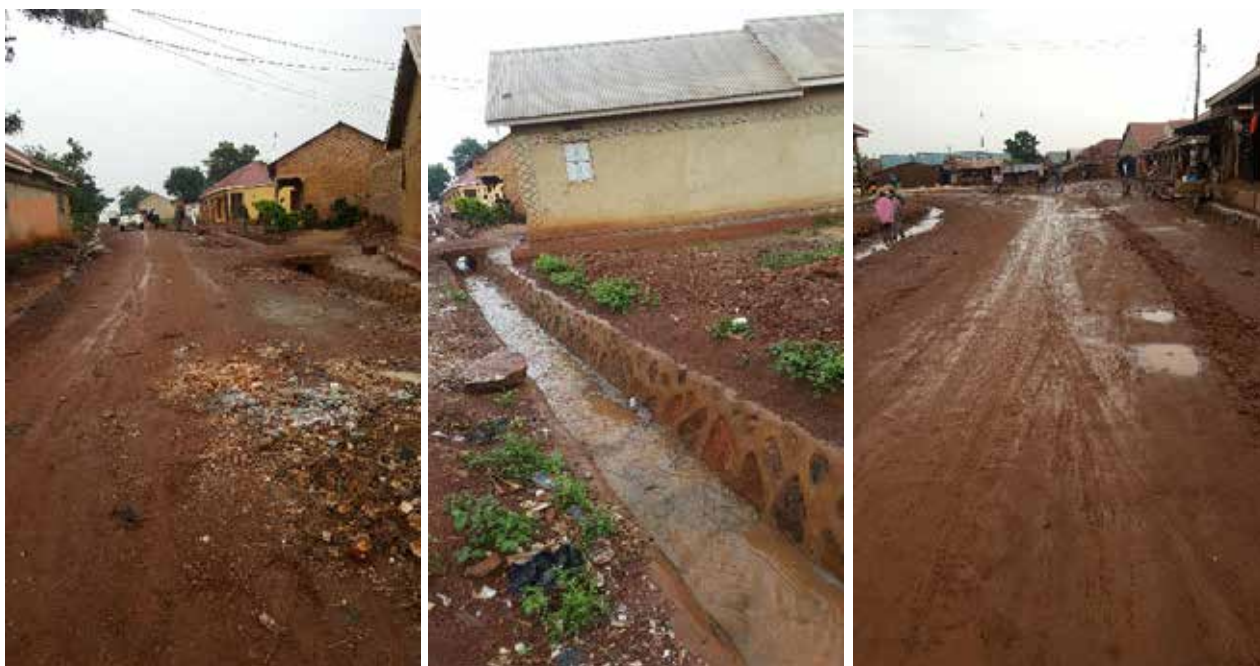
Busia MC: Sections of Rajab Benesa road

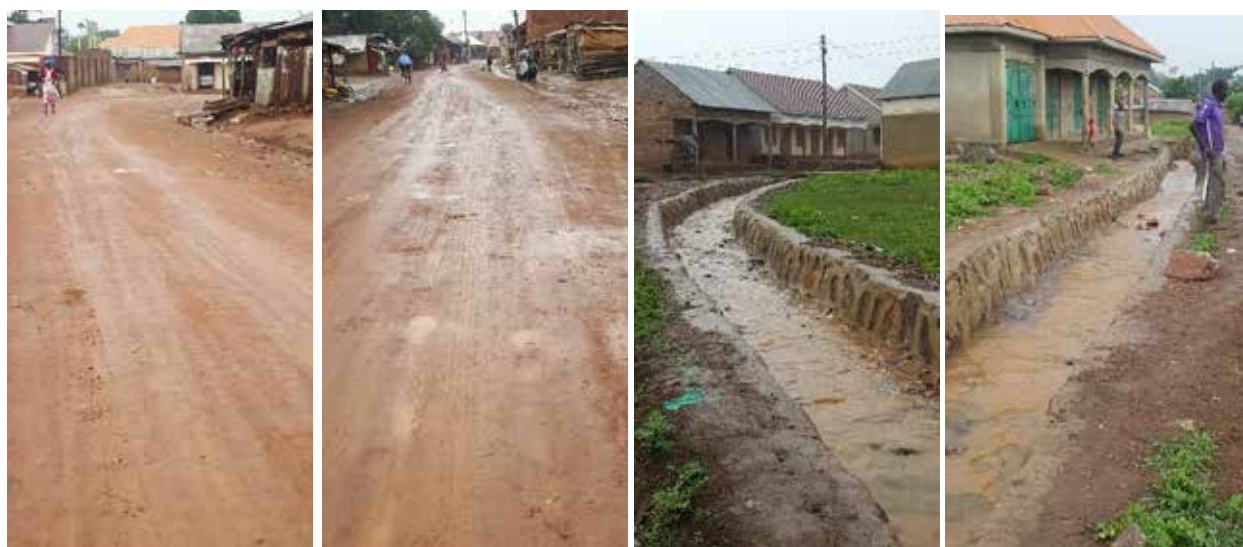
5.	Mugungu Road (0.4Km), planned for routine mechanised maintenance	The road had been graded to formation and spot gravelled in selected sections but without compaction. 3 lines of cross culverts had been installed. Stone lining on one side of the road had been done to a length of 300m. Vehicle measurement of road length was 0.4Km.
----	--	---

Busia MC: Sections of Mugungu road

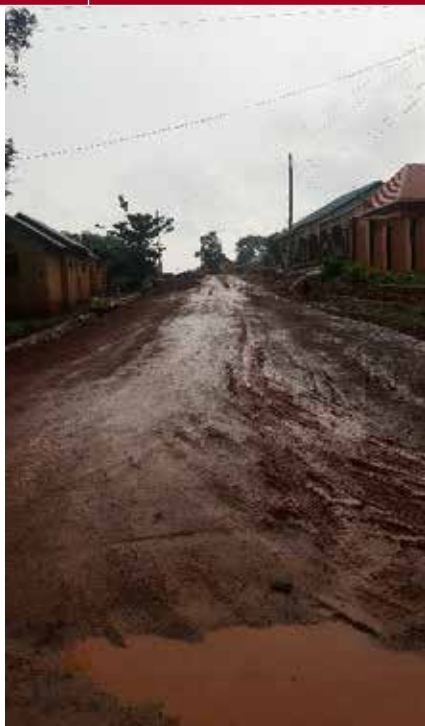
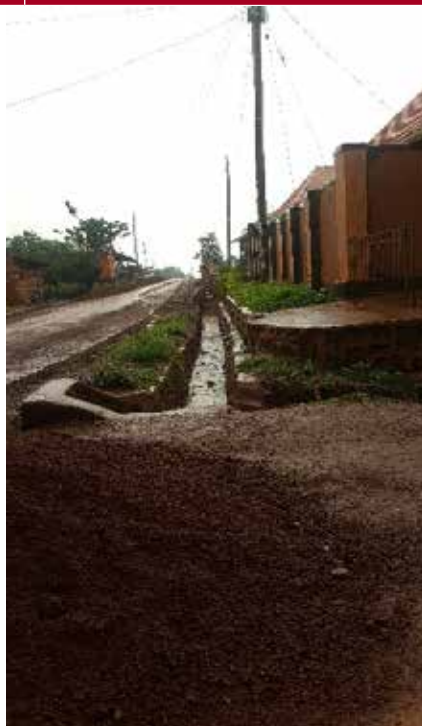
Busia MC: Sections of Siwundu road

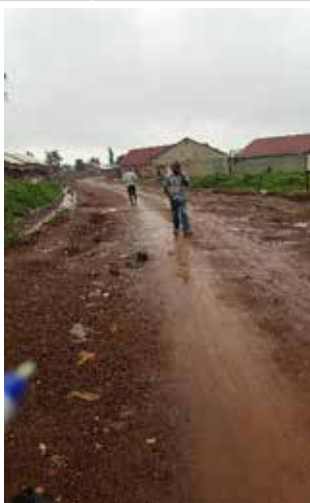
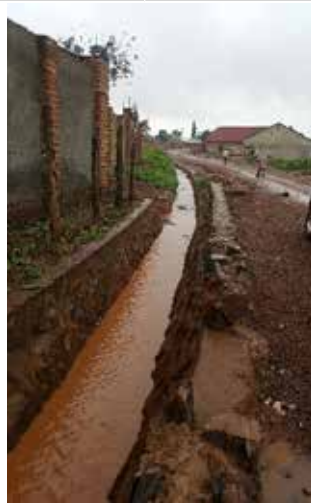
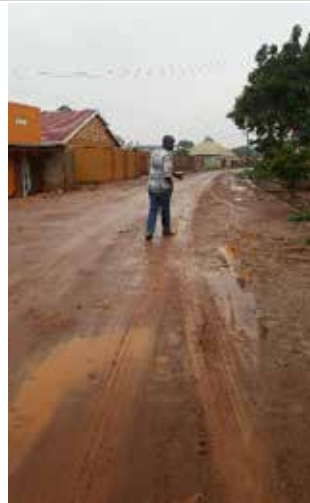
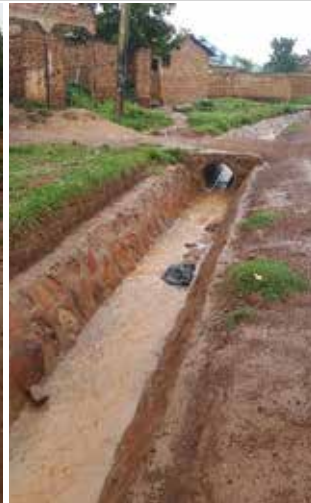
Busia MC: Sections of Mugeni road

7.	Mugeni road (0.6Km) planned for Routine Mechanised Maintenance	The road had been graded to formation and spot gravelled in selected sections. A total of 5 lines of access culverts had been installed. Stone lining in selected sections of the road had been done to a combined length of 500m. Vehicle measurement of road length was 0.5Km.
----	--	--

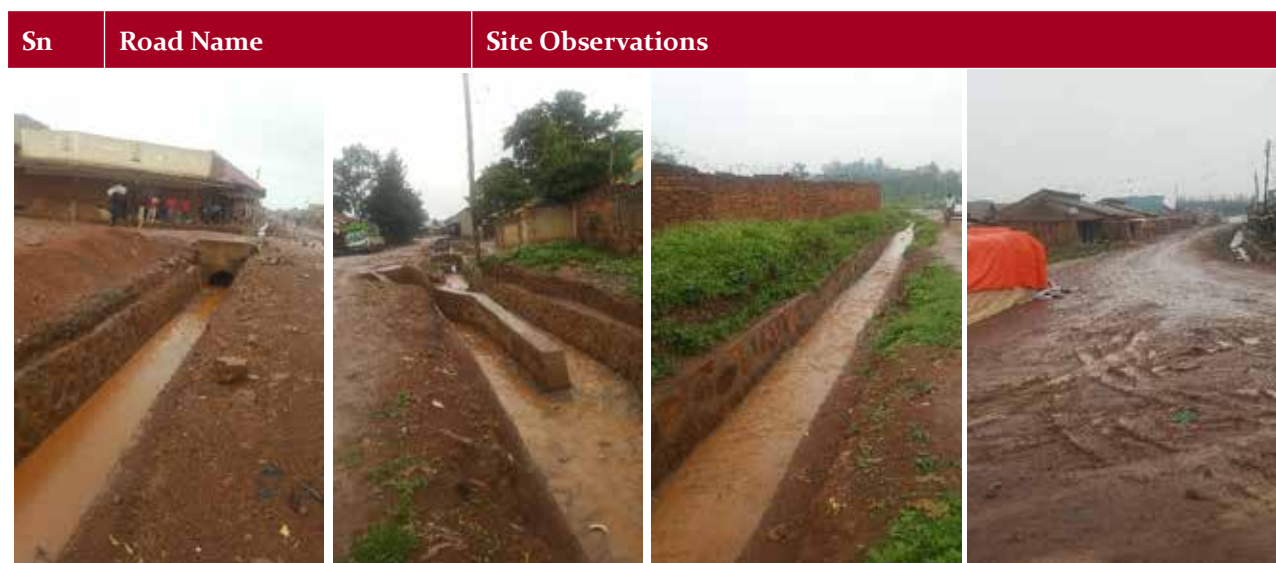
Busia MC: Sections of Jacob Aryada road
FIGURE 3.5: PHOTOGRAPHS IN BUSIA MUNICIPALITY

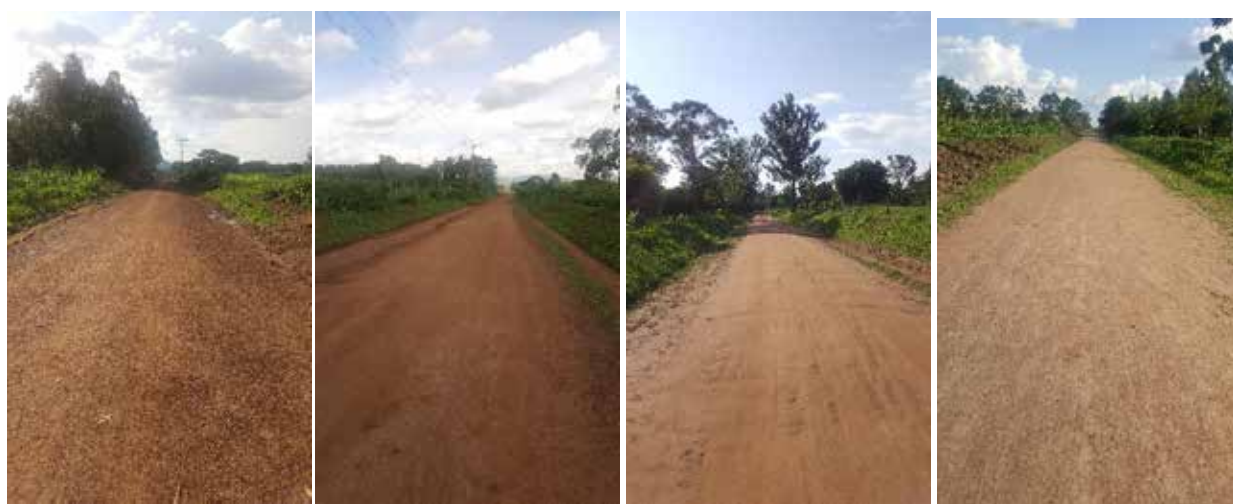
2.	TGS – Water Works (5.0Km), planned for Periodic maintenance	4.2Km of the road had been graded, 700m spot gravelled and 1 line of 900mm dia. cross culverts installed. The riding surface of the road was still generally in good condition.
----	---	---

Tororo DLG: Sections of TGS – Water Works Road

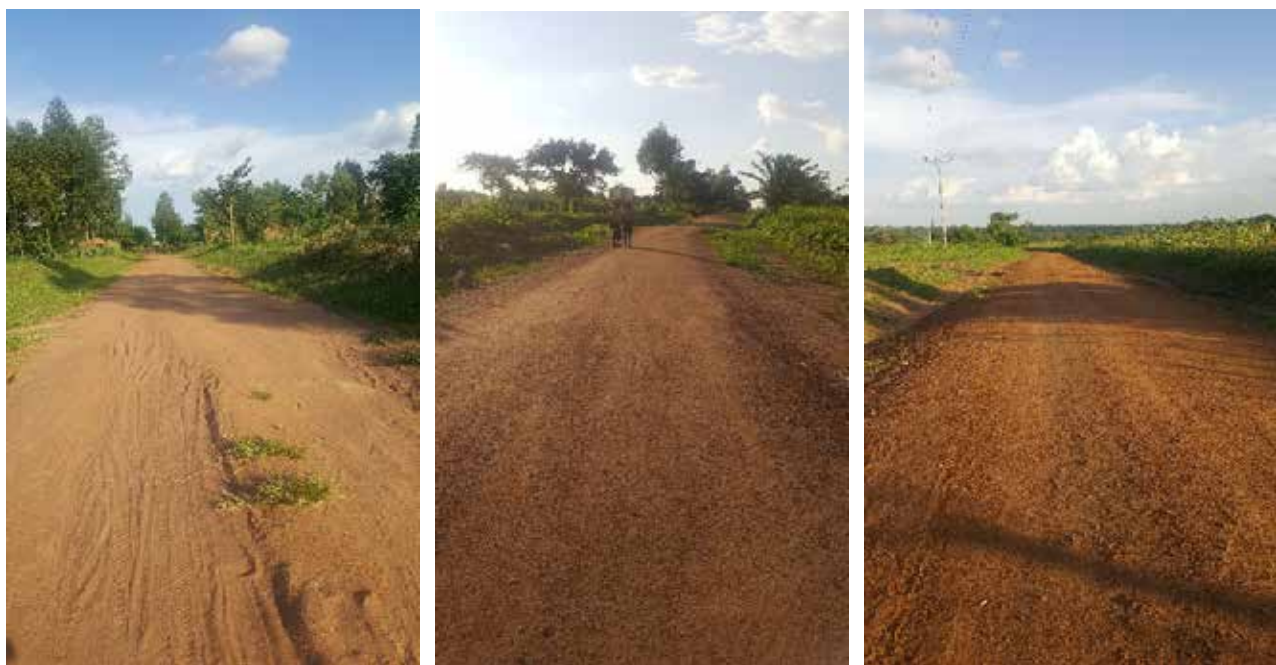
4.	Namwaya - Pajenda (7.8Km), planned for Periodic maintenance	The road had been graded and spot gravelled in selected sections. However the riding surface was still rough in some sections with several granite rock outcrops.
----	---	---

Tororo DLG: Sections of Namwaya – Pajenda Road

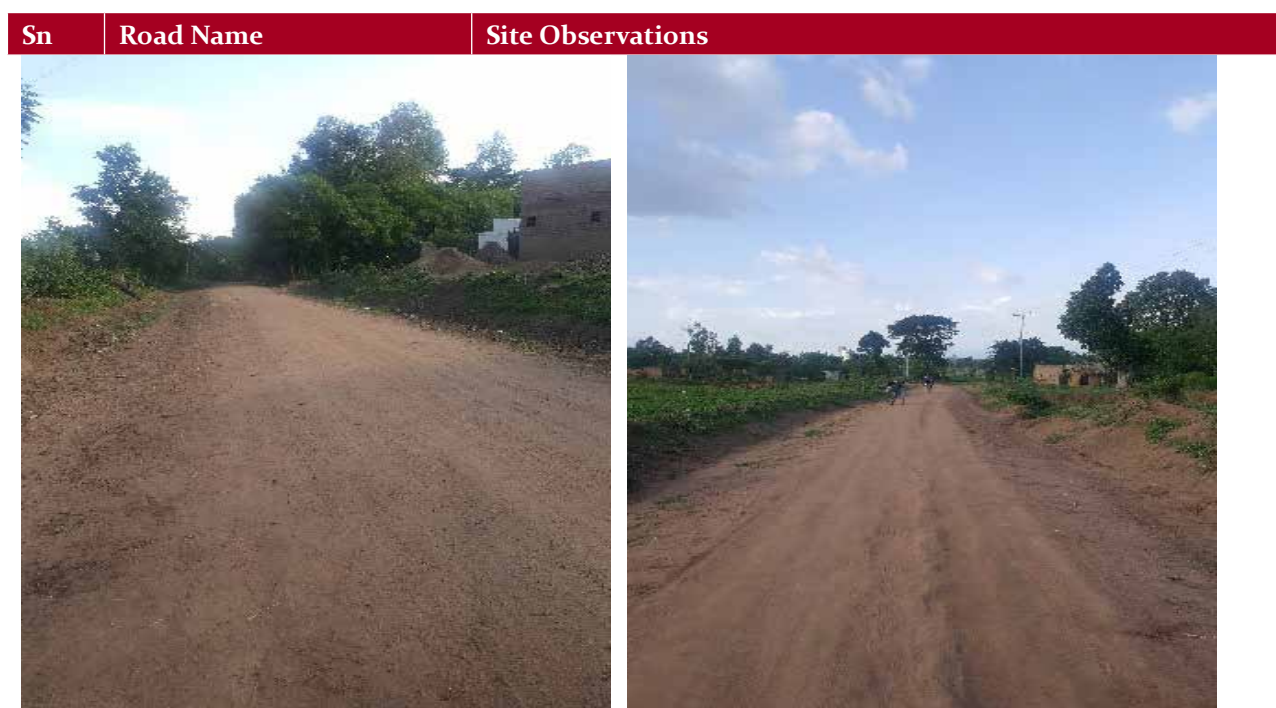
Rubongi Sub-county: Sections of Acet – Mudodo road

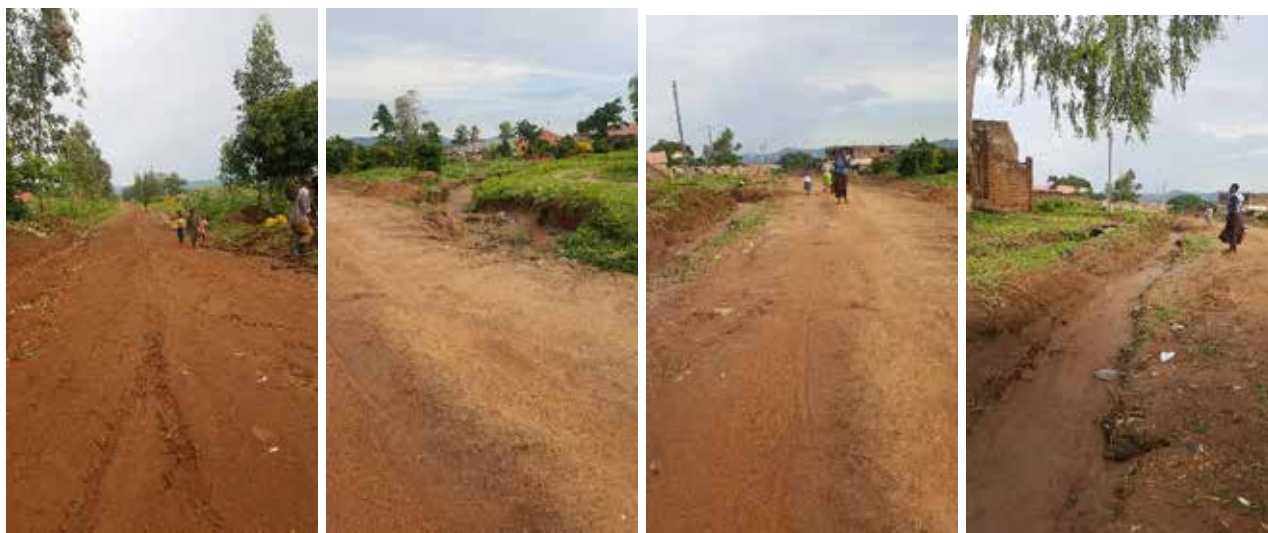
Sn	Road Name	Site Observations
1.	Ikuruk road (1.0Km) <i>planned for Routine Mechanised maintenance</i>	The road had been graded to a formation of approx. 6.0m but without compaction. Several sections however had heavy scouring in the side drains and silting in others. The riding surface was generally rough.

Malaba TC: Sections of Ikuruk road

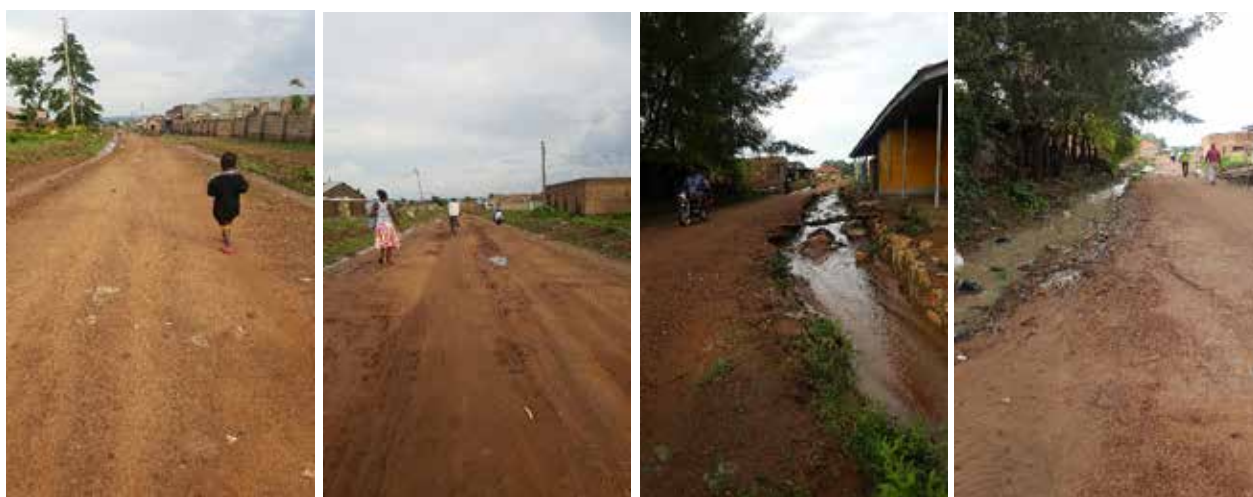
2.	Obwana road (0.3Km) <i>planned for Routine Mechanised maintenance</i>	0.5Km of the road had been graded to a formation of approx. 6.0m but without compaction. Several sections had heavy scouring/silting in the side drains. The riding surface was generally rough.
----	---	--

Malaba TC: Sections of Obwana road

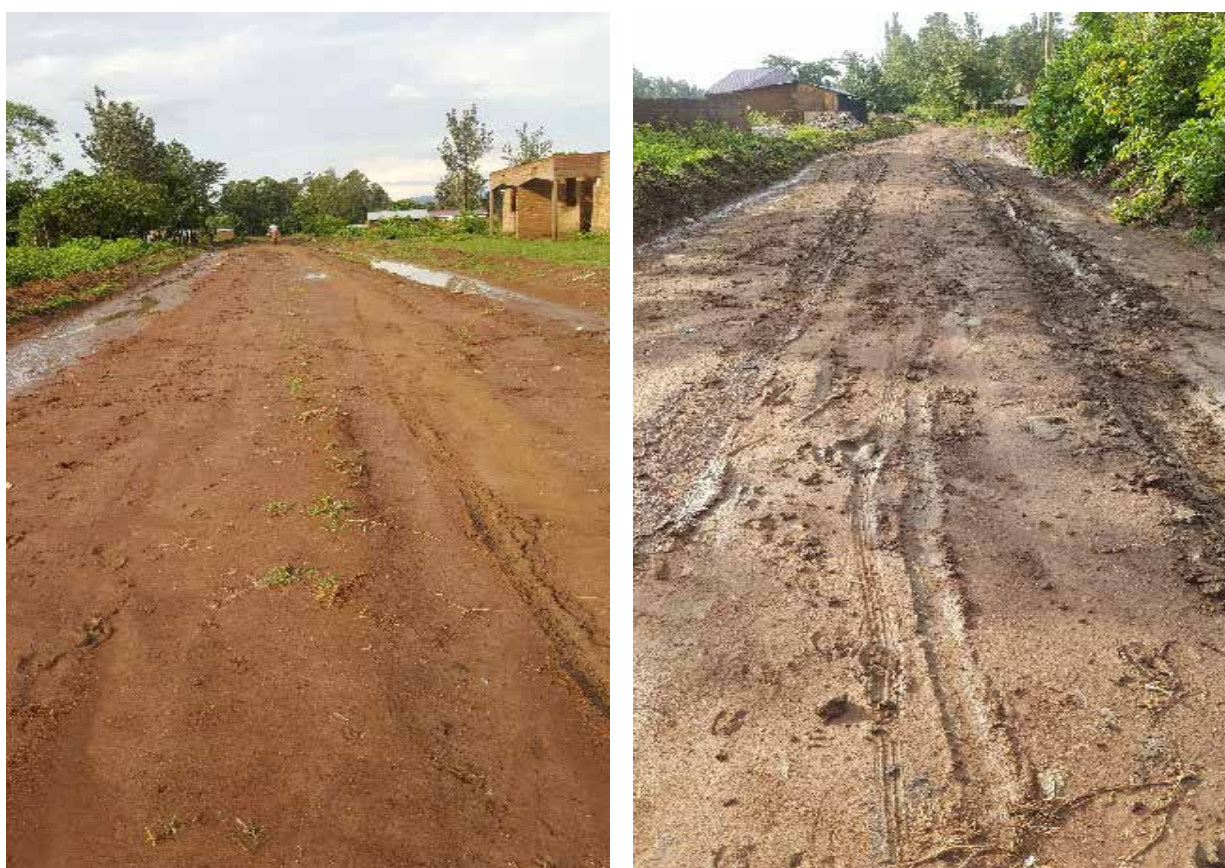
4.	Eunice Okware road (1.0Km) planned for Periodic maintenance	o.8Km of the road had been opened and graded to formation but without compaction. The riding surface was loose and heavily soaked.
----	---	--

Malaba TC: Sections of Eunice Okware road
