ROAD MAINTENANCE MONITORING REPORT

QUARTER 1-3 FY 2018/19 (July 2018– March 2019)

Uganda Road Fund

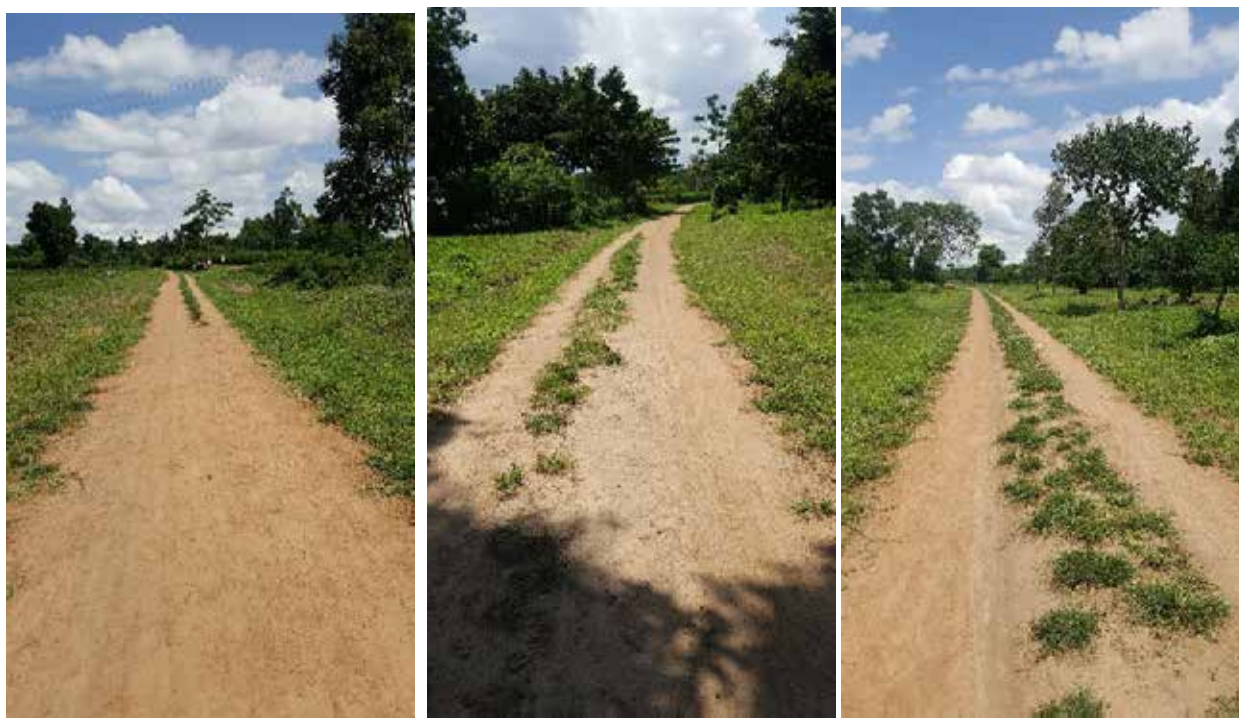
2.	Ojwi road (1.4Km) <i>planned for Periodic maintenance</i>	0.6Km of the road had been opened, widened and graded to formation but without compaction. Removal of trees and tree stamps was evident. 2 lines of 900mm dia. Culverts had been installed but without sufficient backfill. The road had predominantly insitu black cotton soils which are problematic.
----	---	---

Nagongera TC: Sections of Ojwi road

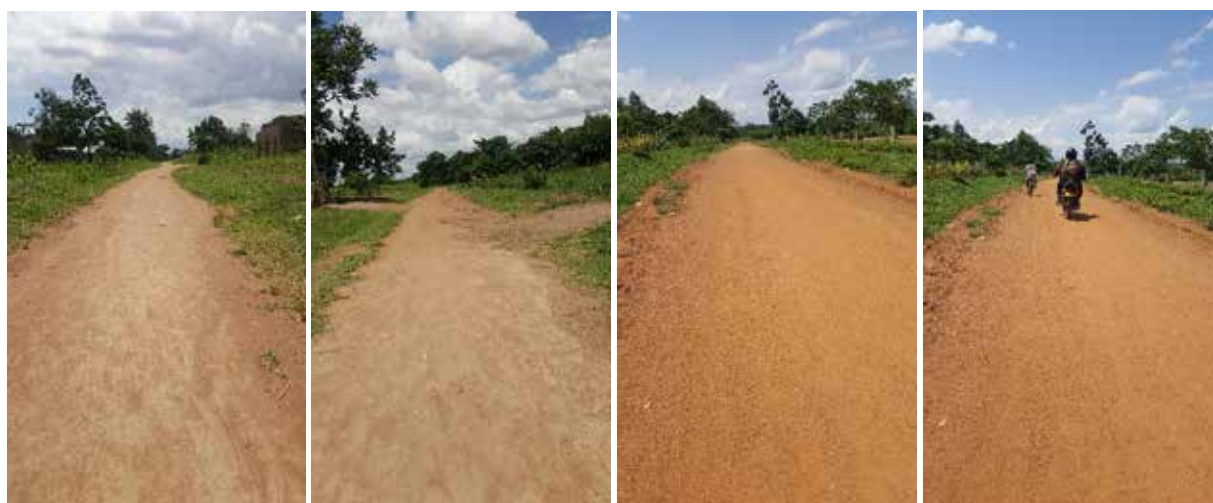
4.	Seminary road (3.0Km) <i>planned for Routine Mechanised maintenance</i>	The road had been graded but without compaction and offshoots. It was overgrown with grass across the shoulders and side drains, and had several rough sections, rock outcrops and sections damaged by rain and run off in the side drains.
----	---	---

Nagongera TC: Sections of Seminary road

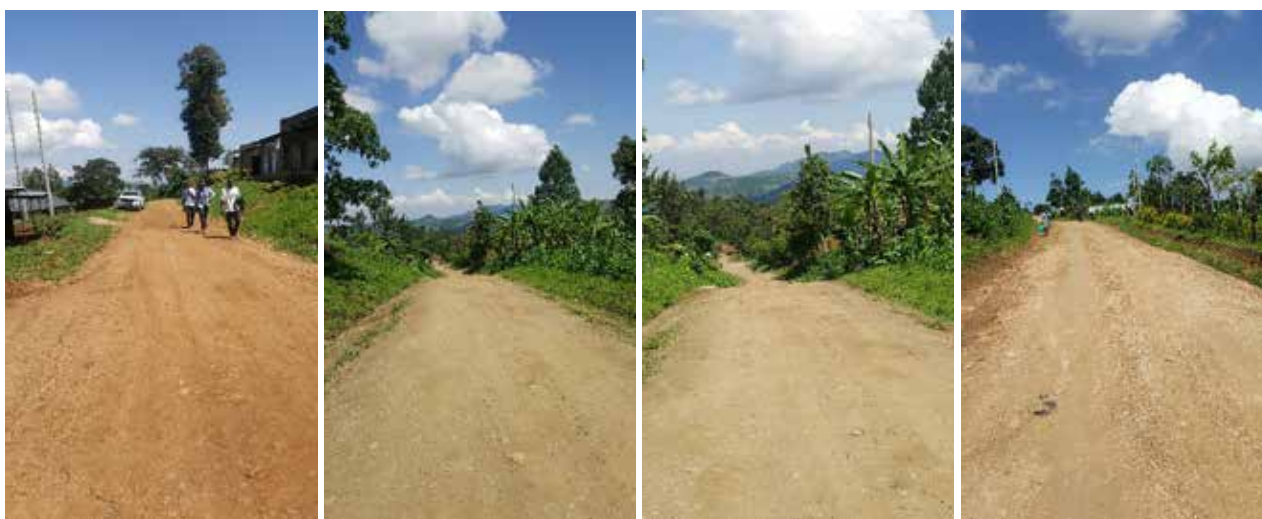
Sn	Road Name	Site Observations
1.	Mwikonge – Bupoto (4.1Km) <i>planned for Routine Mechanised maintenance</i>	<p>The road had been graded to a formation of approx. 5.0m width and spot gravelled in selected sections. Routine manual maintenance using road gangs was evident along the road and the riding surface was still generally in good shape. Vehicle Measured length of the road was 3.9Km.</p> <p>Monitoring team was informed that the gravelling was undertaken using funding from DDEG (Development Discretionary Equalisation Grant).</p>

2. Namisindwa DLG: Sections of Mwikongo – Bupoto road

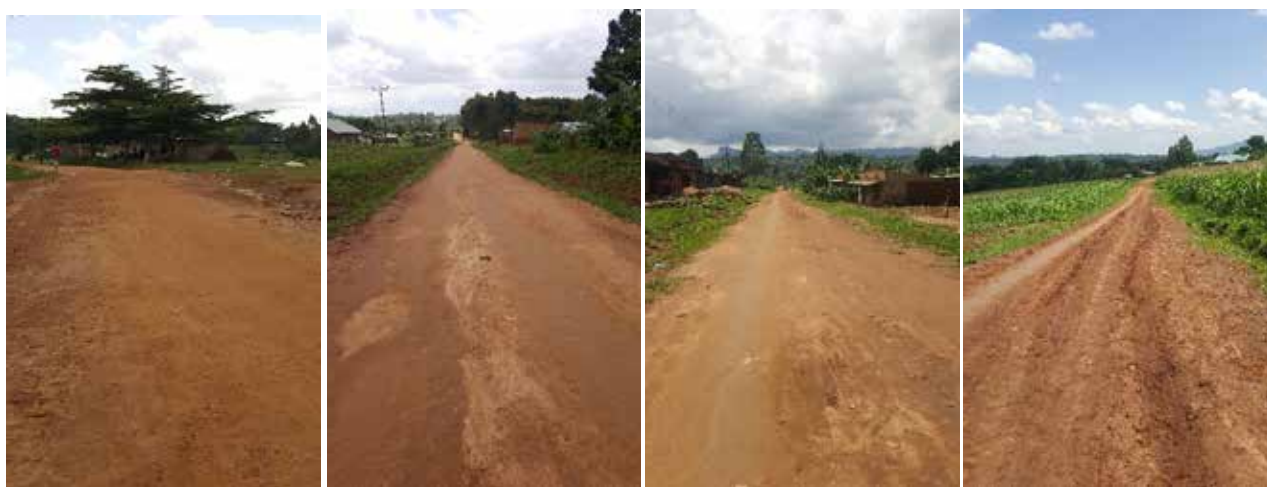
3.	Bubutu – Maghale (9.6Km) <i>planned for Routine Mechanised maintenance</i>	The road had been graded to a formation of approx. 5.0m. Several sections had however been damaged by rains while others had predominant slippery insitu soils. The road was potentially impassable in wet conditions but generally had a fair riding surface. Remedial works were underway in the sections damaged by rains. Vehicle Measured length of the road was 9.1Km.
----	---	--

Namisindwa DLG: Sections of Bubutu – Maghale road

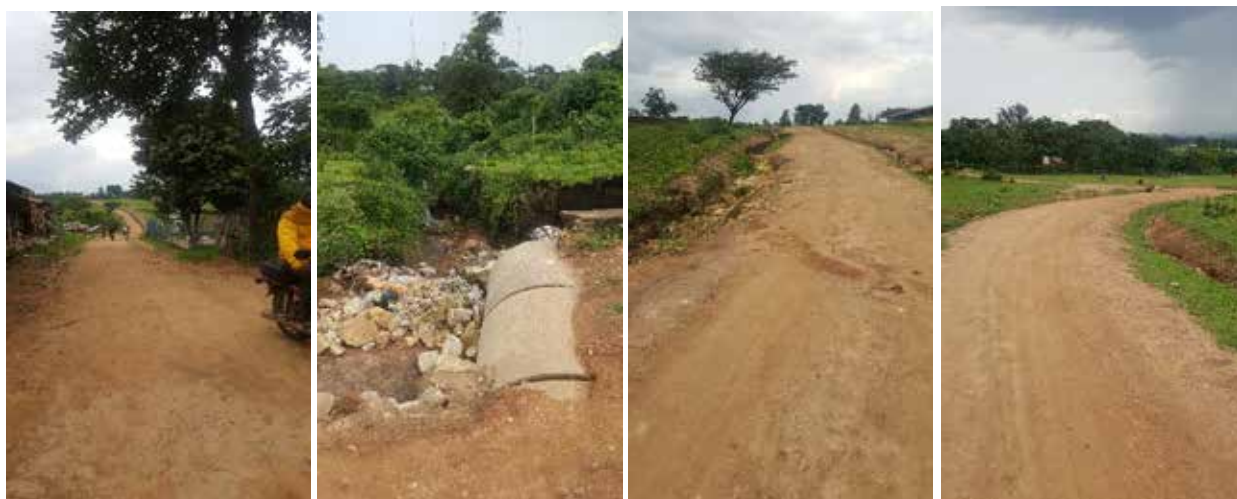
Sn	Road Name	Site Observations
1.	Lwakhakha road (1.5Km) <i>Planned for routine mechanised maintenance</i>	The road had been graded to a formation of about 5.0m width and 1 line of access culverts installed. The road had residual gravel from previous interventions. However the following defects were observed: no offshoots had been provided; outflow headwall and apron at Km 0+100 had been swept by rains; heavy scouring in the side drains in some sections; silting across the carriageway; and surface crossing of runoff in a section with rock outcrops. Vehicle measurement of road length was 1.55Km.

Lwakhakha TC: Sections of Lwakhakha road

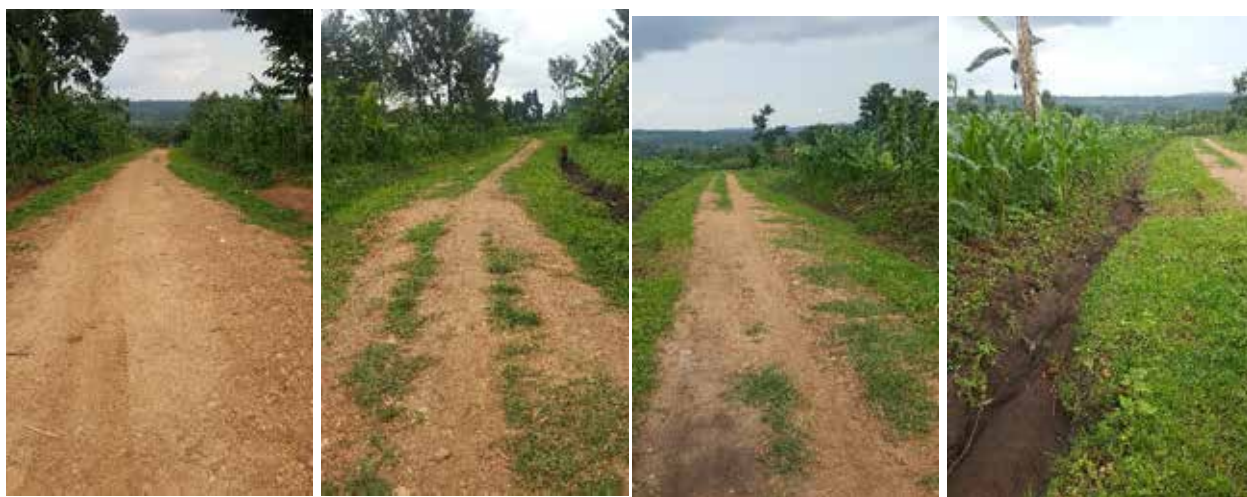
Sn	Road Name	Site Observations
2.	Wambuno road (0.5Km) <i>Planned for routine mechanised maintenance</i>	The road had been graded to formation and 1 line of cross culverts installed. The road had residual gravel from previous interventions. However the following defects were observed: no offshoots had been provided; heavy scouring in the side drains in some sections; and overgrown grass across the shoulders and side drains. Vehicle measurement of road length was 0.5Km.

Lwakhakha TC: Sections of Wambuno road

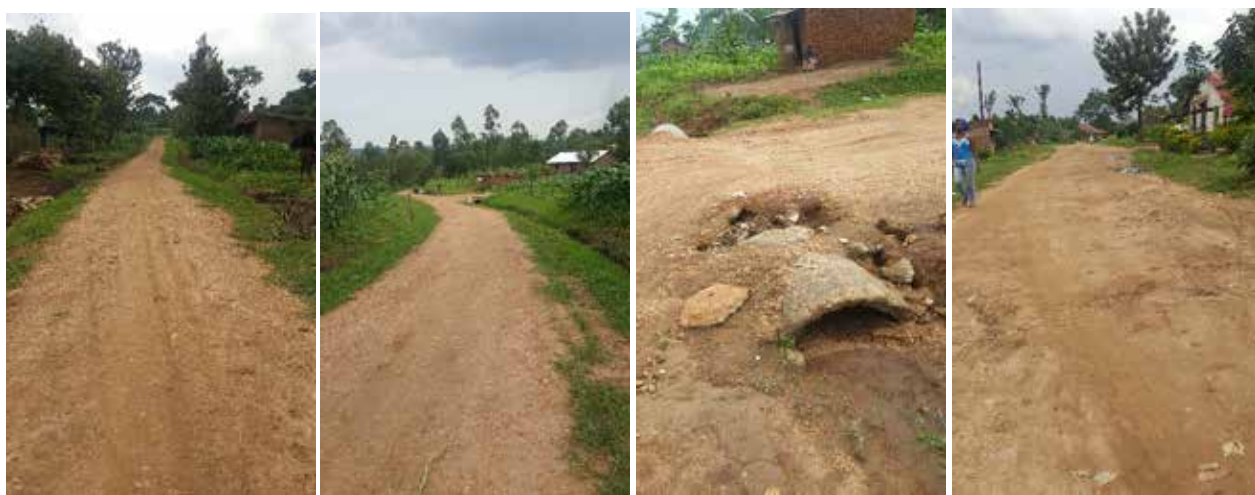
3.	Meru Ibrahim road (1.0Km) <i>Planned for routine mechanised maintenance</i>	The road had been graded to formation and still had residual gravel from previous interventions. However the following defects were observed: no offshoots had been provided; heavy scouring in the side drains in some sections; sections not provided with culverts and overgrown grass across the shoulders and side drains. Vehicle measurement of road length was 0.7Km.
----	--	---

Lwakhakha TC: Sections of Meru Ibrahim road

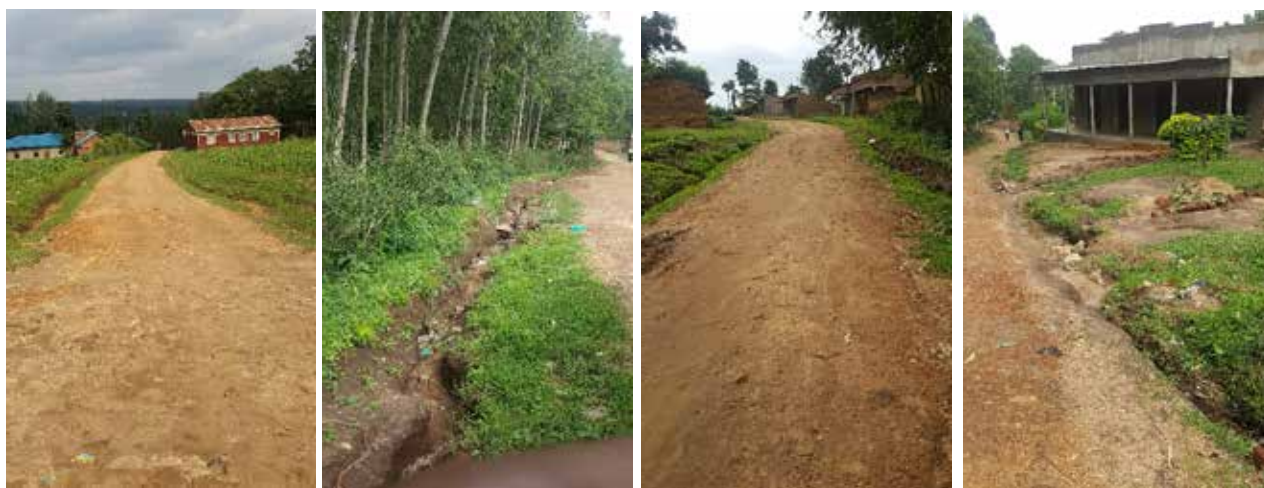
5.	Zakariah road (1.7Km) which was not in the work plan	The road had only bush cleared but gravelling and culvert installation were underway in selected sections. The road required to be graded before gravelling. Other defects observed included: no offshoots had been provided; and overgrown grass across the shoulders and side drains. Vehicle measurement of road length was 1.1Km.
----	--	---

Lwakhakha TC: Sections of Zakariah road

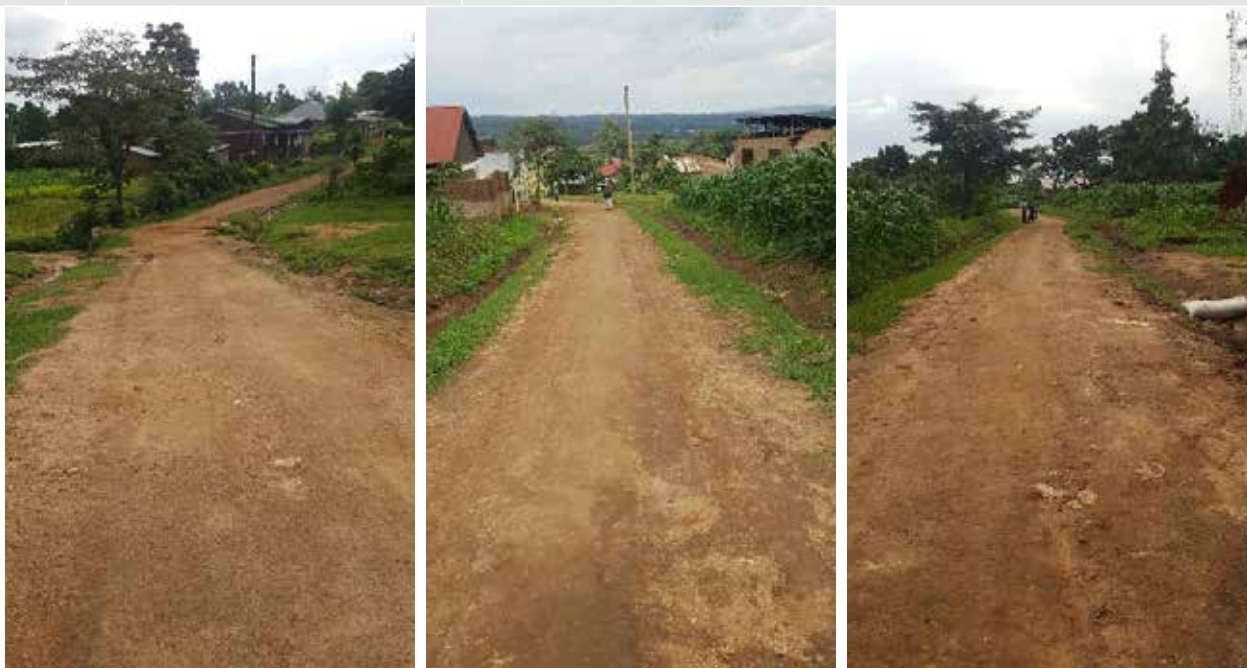
Lwakhakha TC: Sections of Bitonge road

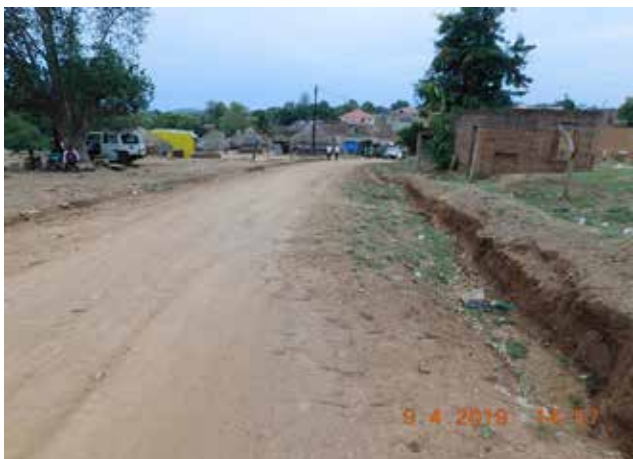
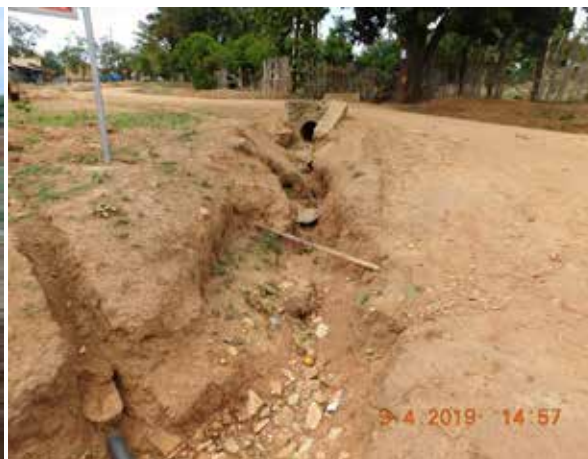
Besia road under Moyo TC was graded in Q1 but needs scour-checks for the side drains to avoid related road failures as seen above

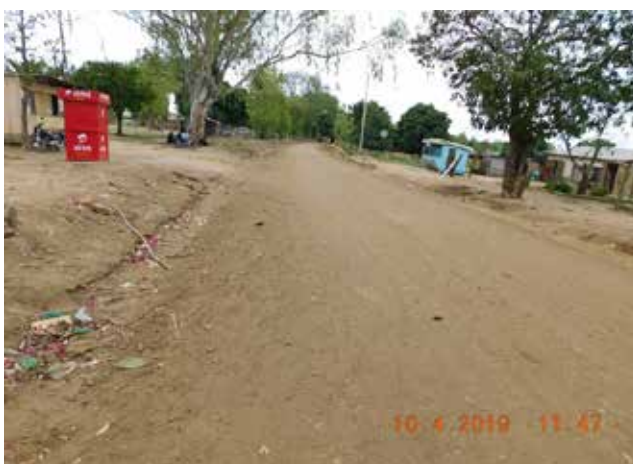
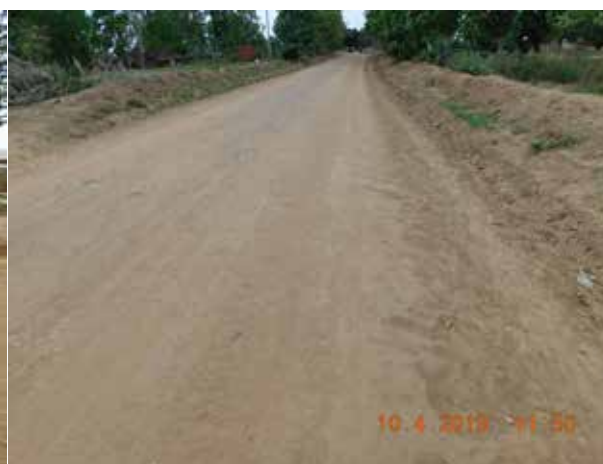
Celecelea-Lama (7.4km) district road received grading and spoy gravelling in Q1 and Q2.

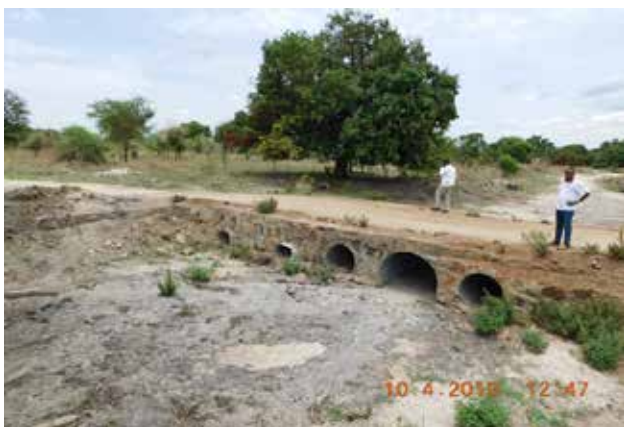
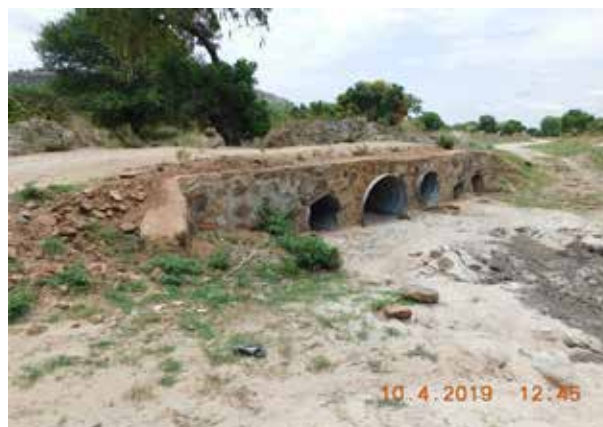
FIGURE 3.8: PHOTOGRAPHS DURING SITE VISITS IN MOYO DISTRICT

Drainage works on Laropi-Panjaala Road were done under programme adjustment in Q1 after the road was cut off due to heavy run-off from the hills. Light grading of the road was also done

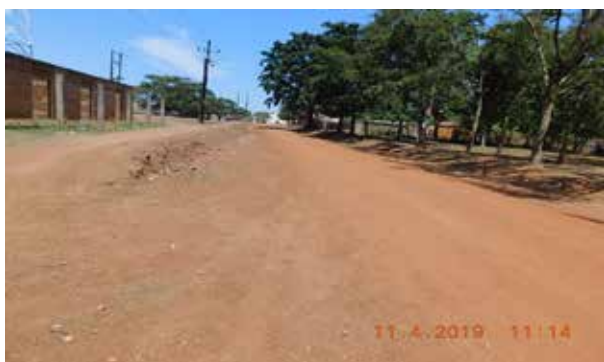
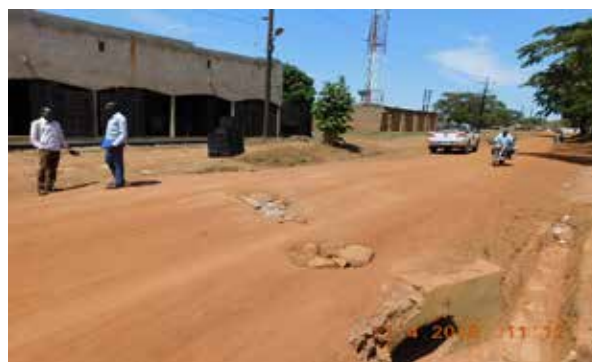
Mission Road (0.2km) received grading and gravelling in Q2 under Adjumani Town Council rd maintenance programme. One cross culvert was also installed

The road was in good condition except for the damaged culvert at the start due to heavy trucks at the adjacent beer depot

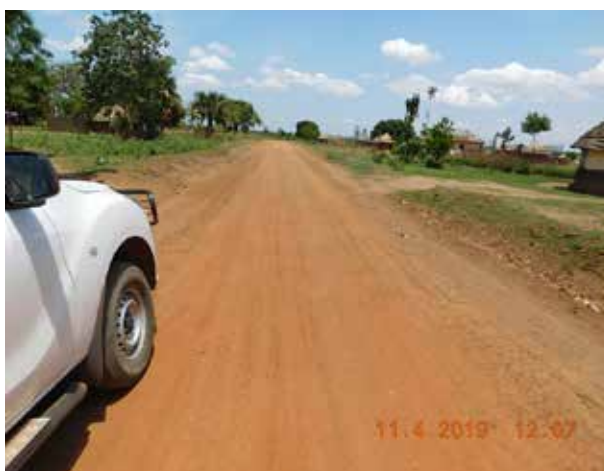
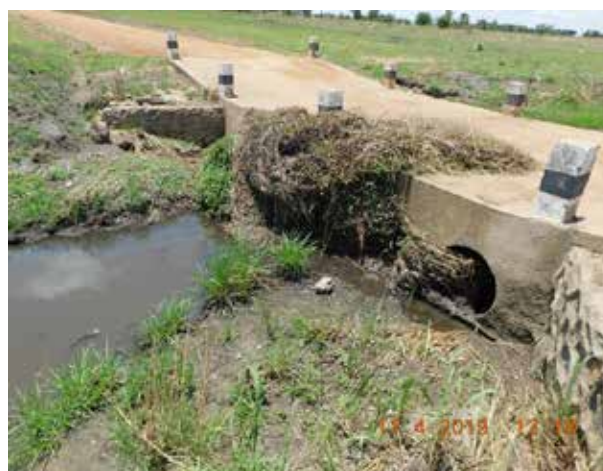
The road was in good condition but the drift locate at CHo4+750 was in need of routine manual maintenance

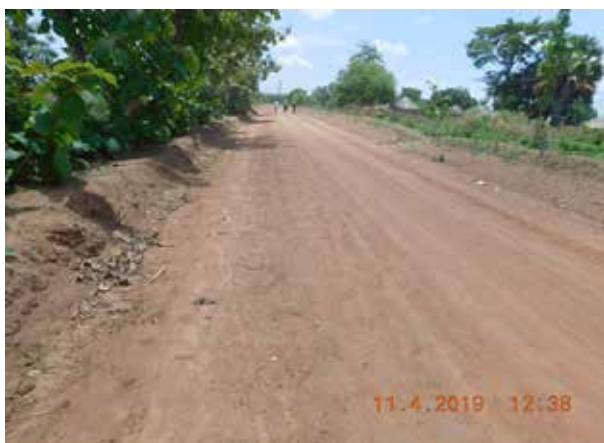
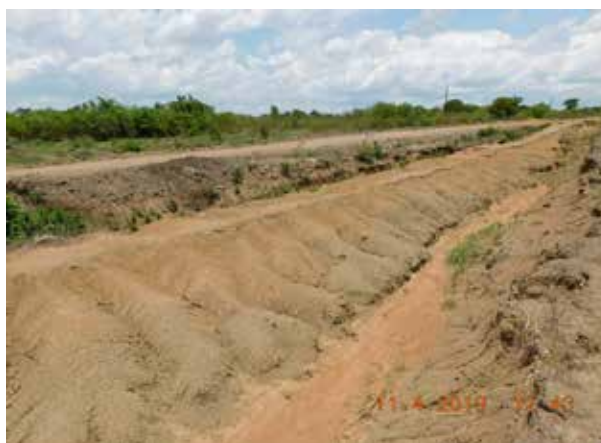
Effects of delayed maintenance are evidently visible on the right where the old road was abandoned and a new one opened up parallel to it. In areas where land is not readily available, this can be very costly.

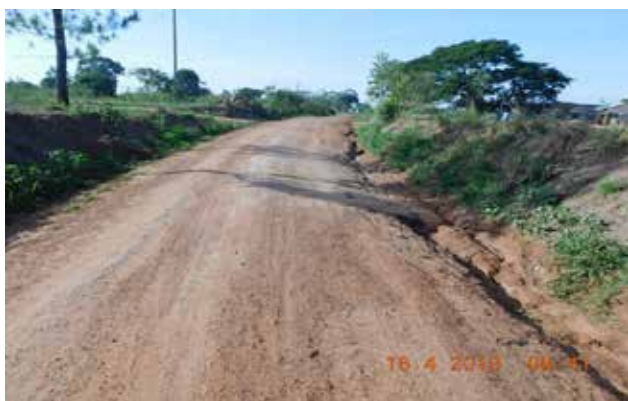
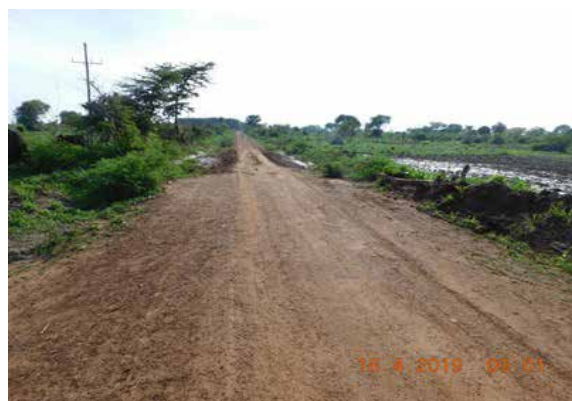
Apac – Ollepek (7km) above Left and Awila Ollepek (23km) above Right both underwent routine mechanised maintenance in Q2. Both were in good condition but sections in low lying areas were threatening to fail due to poor drainage

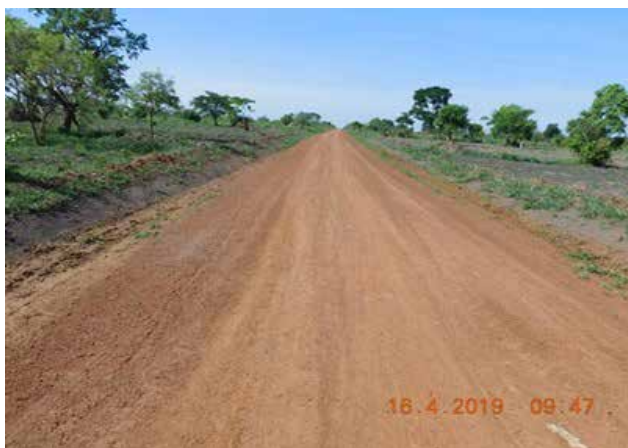
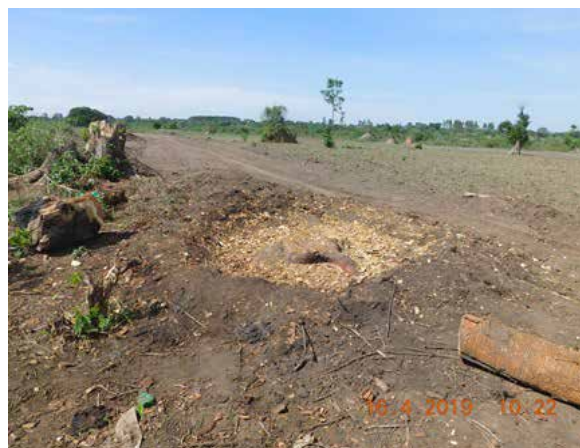
Teibu- Akuli district road (Left) and Arwotolek-Adyegi CAR under Chegere Subcounty received routine mechanised maintenance in Q2

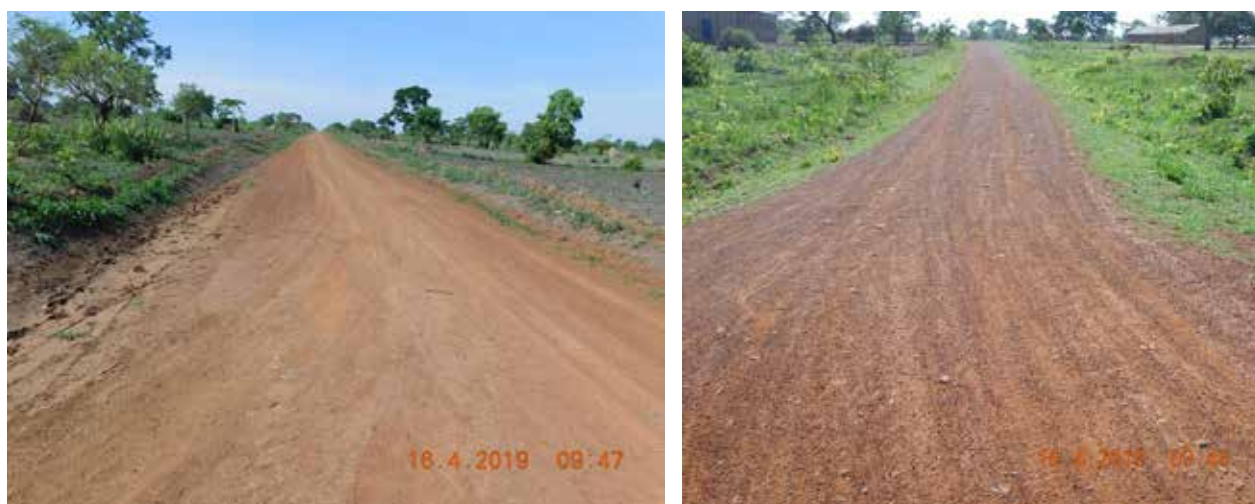
Figure 3.5: Sections of Atopi-Akuli road that received grading and gravelling under emergency funding.

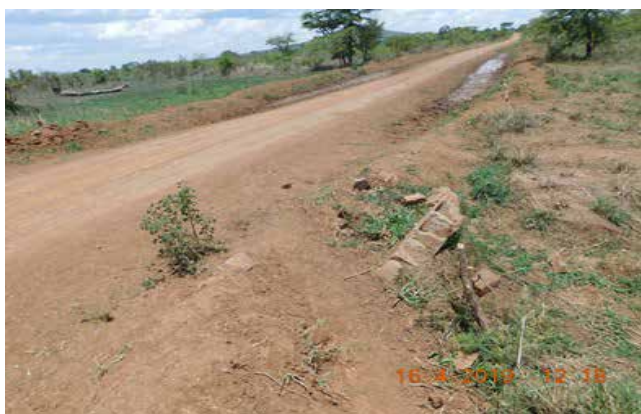
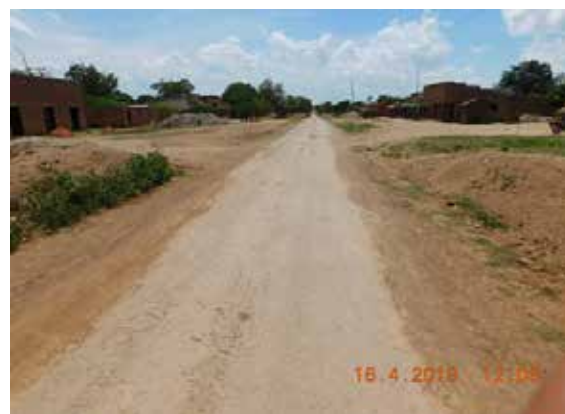
Awiri – Ayenjeri (7.1km) graded and spot graveled in H1 FY2018/19

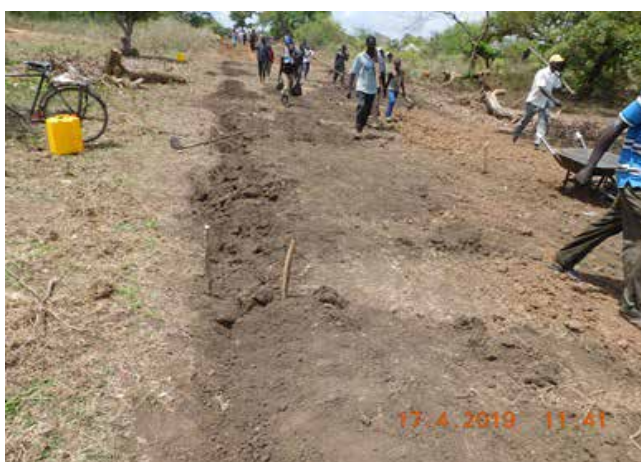
Opening of a new road connecting to Amon - Awiri road under NUSAF in Apac Municipal Council. Road gangs are usually attracted to such projects because they offer better rates compared to URF.

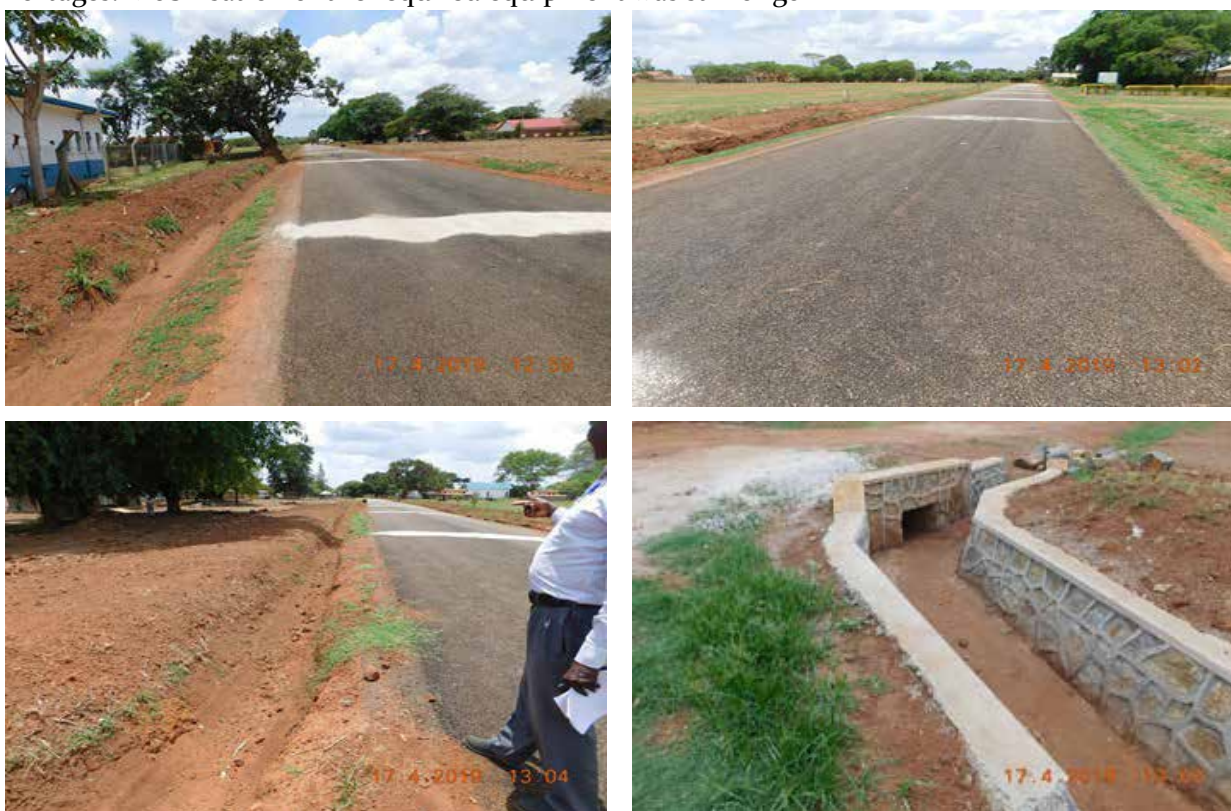
Figure: Photographs of some of the emergency road works in Apac MC in FY2018/19
