**REPORT ON THE TECHNICAL AND FINANCIAL REVIEW OF ROAD
MAINTENANCE PROJECTS IN KABALE MUNICIPAL COUNCIL FOR
THE FINANCIAL YEAR 2015-16**

3. SPECIFIC TECHNICAL REVIEW FINDINGS ON SELECTED ROADS INSPECTED

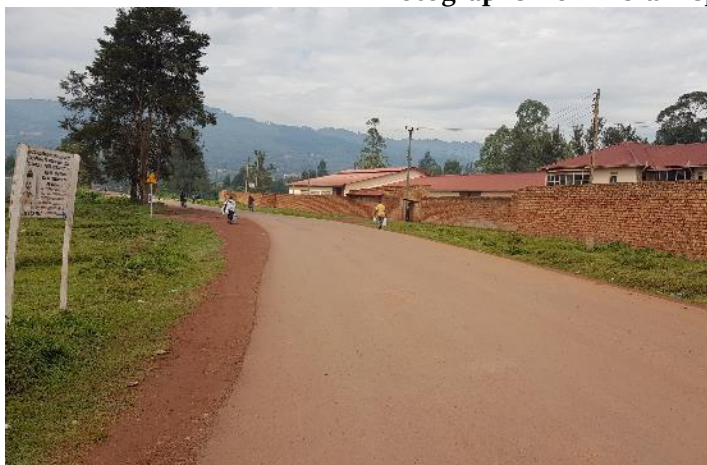
Planned amount (UGX)	237,390,000/=
Actual sum (UGX)	241,900,000/=
Variance	4,510,000/=
Start date	Not on file
Completion date	Not on file
Management type	Force Account
Supervisor	Municipal Engineer
Activity done	Resealing with Hot Mix Asphalt
Project Description and Condition	
<p>The project is a 900m paved urban road with a 7.0 m wide roadway and 5.8m carriageway. The road traverses a hilly terrain.</p> <p>The road received resealing by application of 40mm thick overlay of hot mix asphalt at an estimated cost of UGX 241.9M/=.</p> <p>At the time of the review, the road was at a good service level and motorable through the entire stretch. However, it requires urgent drainage improvement.</p>	
Review Findings	
<ul style="list-style-type: none"> Over design for wearing course leading to expensive surfacing at UGX241.9M/=. A surface dressed wearing course would've cost an estimated UGX150M/=, Lack of project information signage, and Inadequate drainage provisions.

0+000: Surface treated with HMA

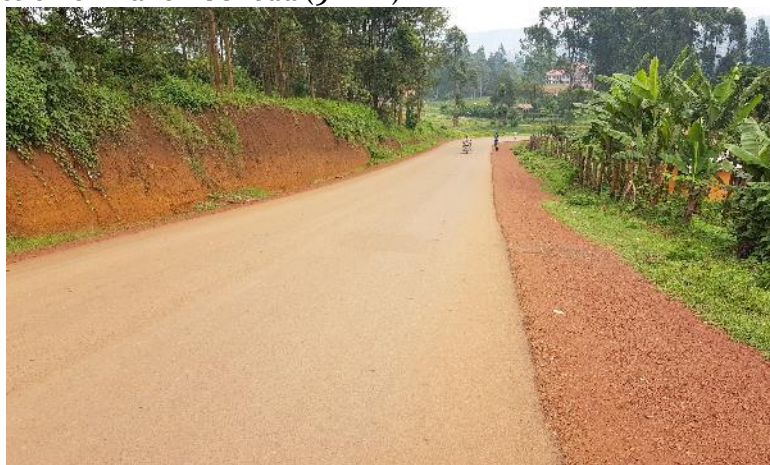
Ch. 0+800: Drainage improvement required by provision of lined drains and relief culverts

3. Poor drainage system of <i>Mukombe road</i>	Urgently install stone pitched side drains and relief culverts on <i>Mukombe Road</i>	TC	By June 2017
4. Inadequate oversight over road maintenance funding	Oversight over road maintenance funds should be increased to ensure value for money.	TC	Immediate

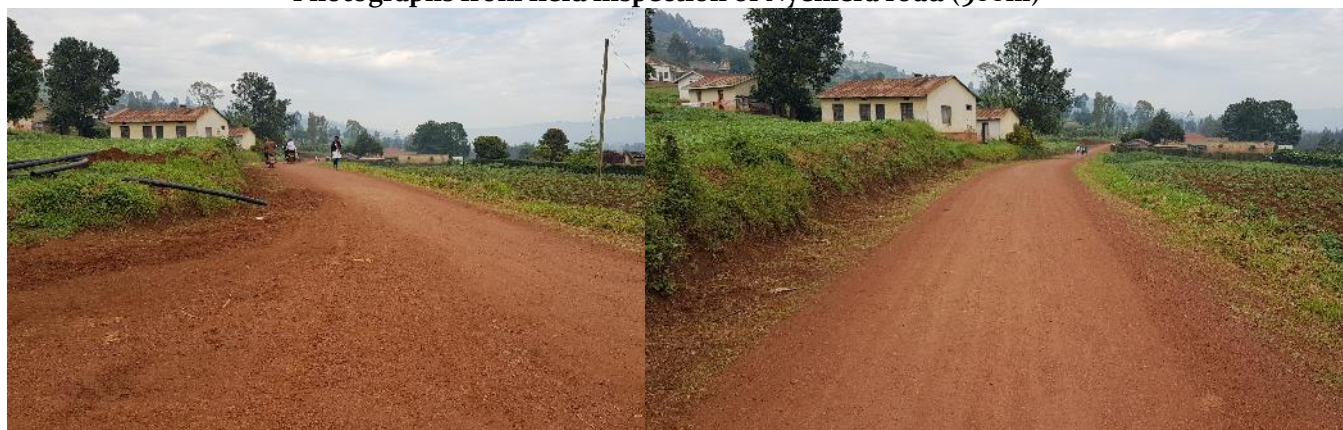
Planned amount (UGX)	33,000,000/=
Actual sum (UGX)	33,001,200/=
Variance	1,200/=
Start date	Not on file
Completion date	Not on file
Management type	Force Account
Supervisor	Municipal Engineer
Activity done	Periodic maintenance
Project Description and Condition	
<p>The project is a 900 m unpaved urban road with a 6.0 m wide roadway and 4m carriageway. The road traverses a rolling terrain.</p> <p>The road received periodic maintenance by reshaping and full regravelling (100mm thickness) with drainage improvements at an estimated cost of UGX 33M/=.</p> <p>At the time of the review, the road was at a good service level and motorable through the entire stretch.</p>	
Review Findings	
<ul style="list-style-type: none"> • Lack of project information signage, • High unit rate for periodic maintenance due to multiple overlapping items, • Lack of final account documentation, and • Narrow carriageway at 4m instead of the required 5.4m.

Ch. 0+000: Project information signage lacking

A well maintained section of the road

EVALUATION OF PROJECTS IMPLEMENTED	<p>✓ Lack of project information signage</p> <p>Clause 9 (k) of the performance agreements required Kabale MC to install appropriate signage at the beginning and end of every road on all road works under URF funding. The signage should show road name, funder, financial year, length of the road, activity being undertaken and the road management type. Kabale MC did not install any signage on all the roads that were inspected in the FY2015/16.</p> <p>✓ Deviation from engineering design standards and practices</p> <p>Section 9 (e) of the performance agreements stipulates that the designated agencies must ensure</p>	<p>This implies lack of compliance with guidelines and performance agreements.</p> <p>This implies lack of compliance with guidelines and</p>	The issue of signage has been noted. There's signage installed on all major projects currently.	<p>The agency should place signage on all major projects as a standard practice.</p> <p>The agency should follow the MoWT standards as a guide for project</p>

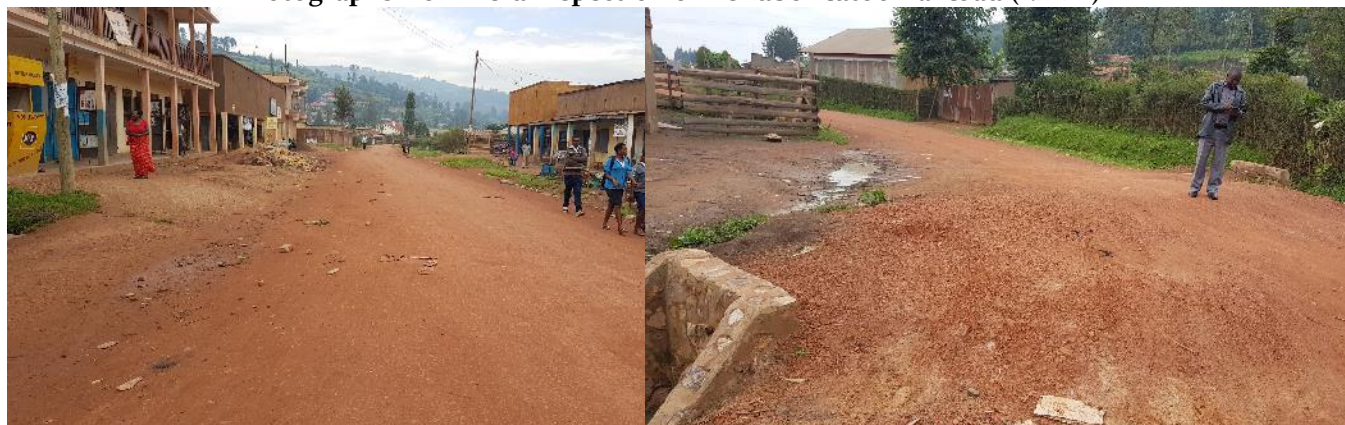
Planned amount (UGX)	49,689,000/=
Actual sum (UGX)	49,688,240/=
Variance	760/=
Start date	Not on file
Completion date	Not on file
Management type	Force Account
Supervisor	Municipal Engineer
Activity done	Periodic maintenance
Project Description and Condition	
<p>The project is a 1.2 km unpaved urban road with a 6.0 m wide roadway and 4.5m carriageway. The road traverses a rolling terrain.</p> <p>The road received periodic maintenance by reshaping and full regravelling (100mm thickness) with drainage improvements at an estimated cost of UGX 49.7M/=.</p> <p>At the time of the review, the road was at a good service level and motorable through the entire stretch.</p>	
Review Findings	
<ul style="list-style-type: none"> • Lack of project information signage, • High unit rate for periodic maintenance due to multiple overlapping items, • Lack of compaction of culvert backfill, • Lack of final account documentation, and • Narrow carriageway at 4.5m instead of the required 5.4m.

Ch. 0+000: Project information signage lacking

1+100: Poor compaction of culvert backfill material

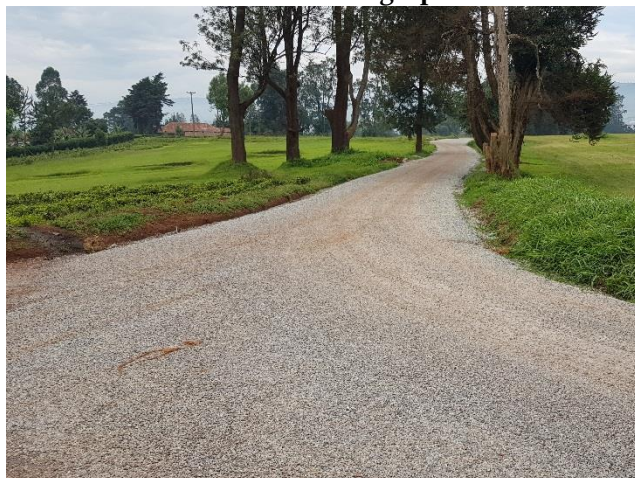
Planned amount (UGX)	178,500,000/=
Actual sum (UGX)	99,364,640/=
Variance	79,135,360/=
Start date	Not on file
Completion date	Not on file
Management type	Force Account
Supervisor	Municipal Engineer
Activity done	Resealing
Project Description and Condition	
<p>The project is a 700m paved urban road with a 6.0 m wide roadway and 4.5m carriageway. The road traverses a flat terrain.</p> <p>The road was resealed with double bituminous surface treatment at an estimated cost of UGX 99.4M/=.</p> <p>At the time of the review, the road was at a fair service level and motorable through the entire stretch.</p>	
Review Findings	
<ul style="list-style-type: none"> • Lack of project information signage, • Segregation of aggregates, • The project was not included in the accountability report, • Bituminous works were not subjected to quality control tests, • Lack of final account documentation. Culvert installations were not in the BOQ, and • Narrow carriageway at 4.5m instead of the required 5.4m minimum.

Sealed surface with loose aggregate

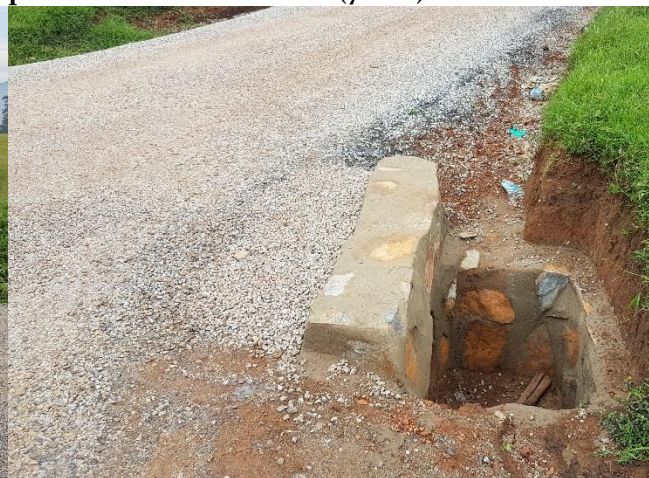
Culvert installation
