ROAD MAINTENANCE MONITORING REPORT

QUARTER 1-2 FY 2015/16 (July – Dec 2015)

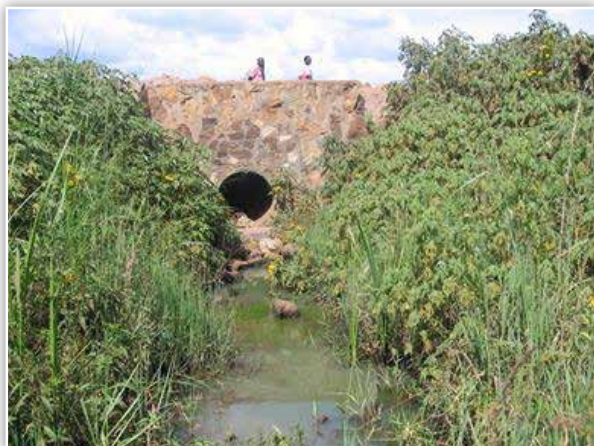
Figure 2.1: Photographs in Tororo UNRA

UNRA Tororo: A headwall constructed to retain the backfill at a culvert crossing on Tororo-Nagongera road (19.6km) under routine mechanized maintenance using term contracts

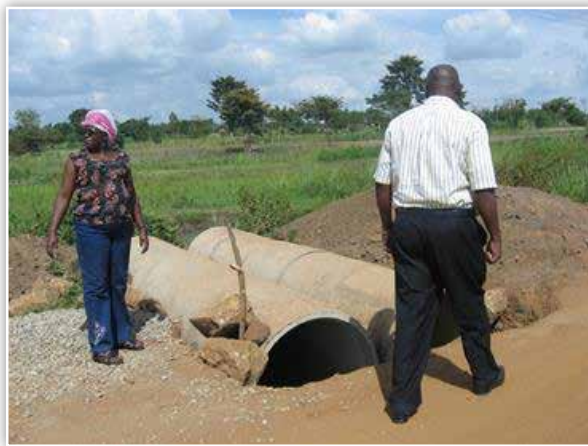
UNRA Tororo: Culvert installation at a swamp crossing on Tororo-Nagongera road (19.6km) under routine mechanized maintenance using term contracts

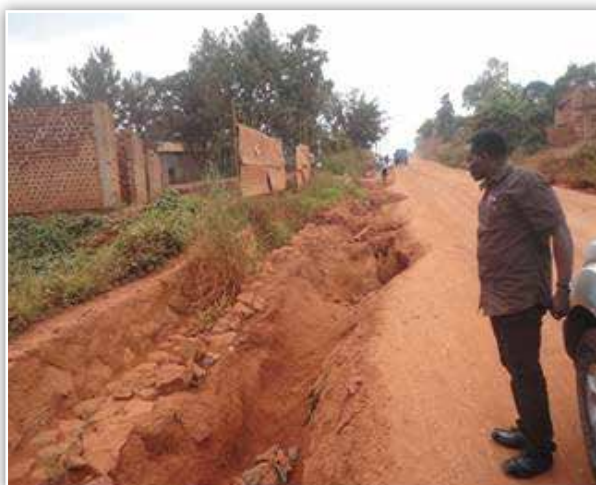
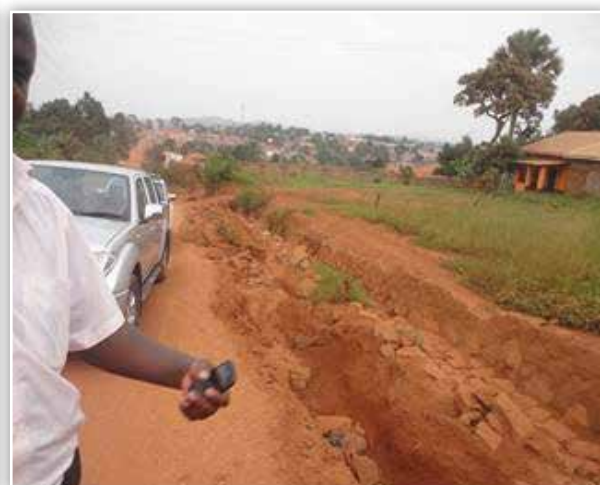
UNRA Kampala: Sections of Kabusu – Wankulukuku- Kitebi- Bunamwaya- Kajjansi (6.1Km) requiring erosion protection measure in the side drains.

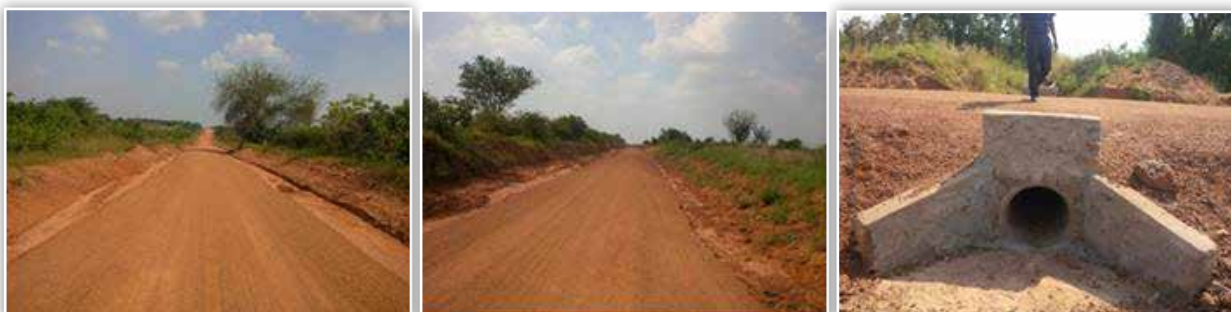
Figure 2.3: Photographs in Arua UNRA

UNRA Arua: Sections of Wandī – Rhino Camp road which received full regravelling using term maintenance contracts.

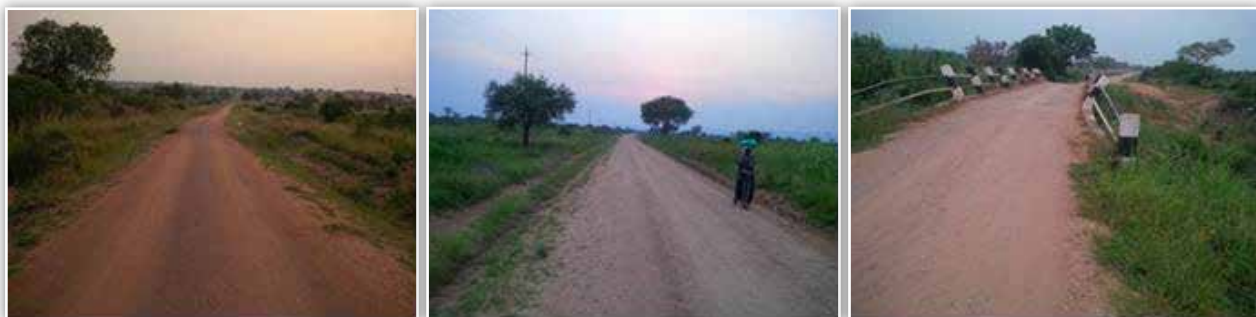
UNRA Arua: Sections of Pakwach – Panyimur road, which was worked on using force account.

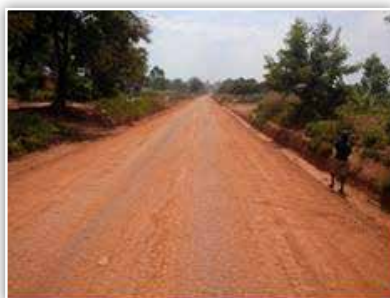
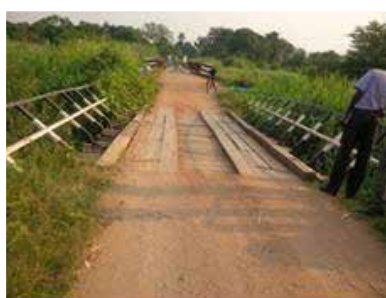
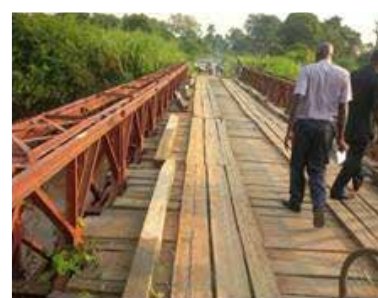
UNRA Arua: A Section of Manibe - Wandu road (L) and Ora Bridges I & II where the timber decks had been replaced in Q1 FY 2015/16

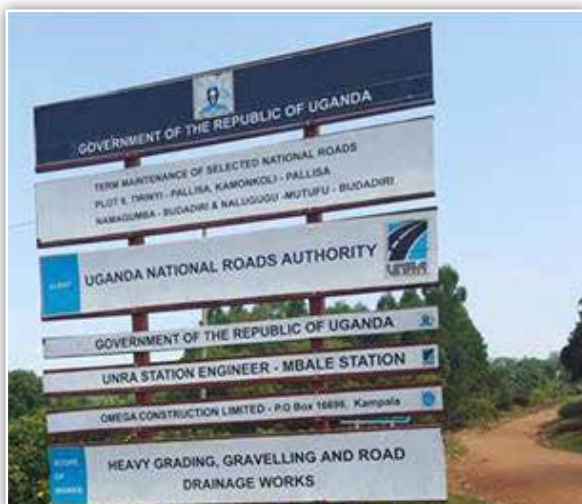
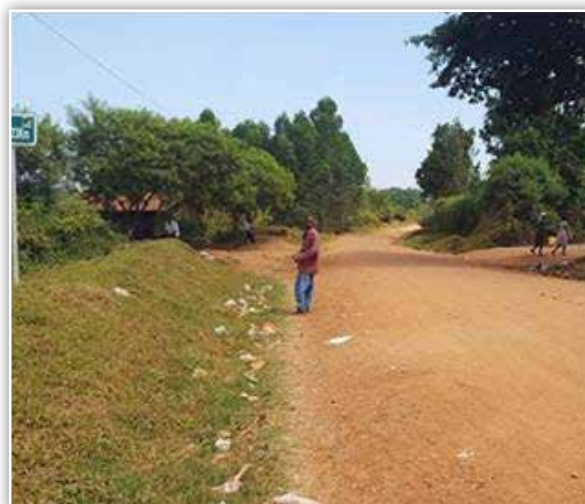
was not mobilized at the site with literally none of the required sets of equipment namely, three sets of graders, rollers and water bowsters for the term maintenance works. The road links inspected by team had been neglected with no maintenance activities since Q1 of FY 2015/16.

Mbale UNRA: The Beginning sections along Namagumba – Budadiri Road under Term Maintenance by OMEGA.

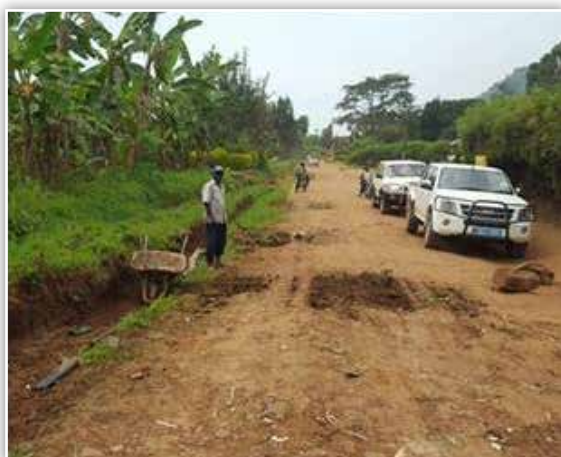
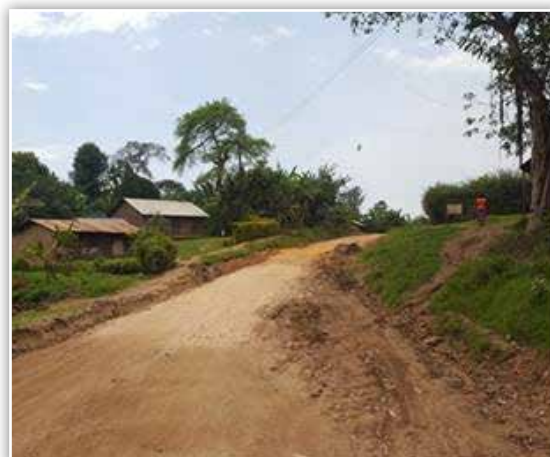
Mbale UNRA: Sections along Namagumba – Budadiri Road with locals improvising to keep the road motorable.

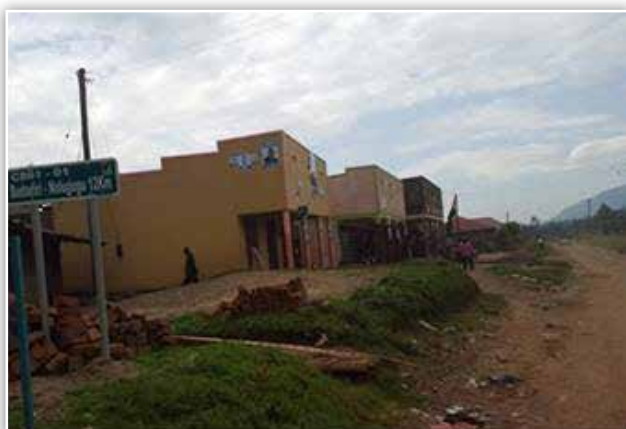
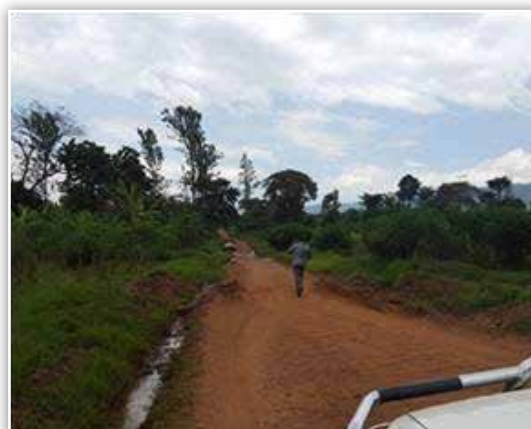
Mbale UNRA: Sections along Budadiri – Nalugugu Road with numerous impassable sections, UNRA was forced to restore connectivity using force account to keep road link motorable.

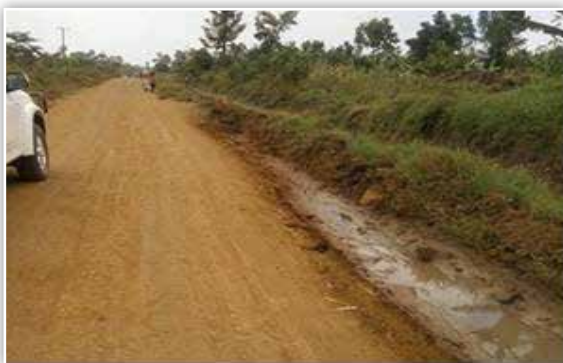
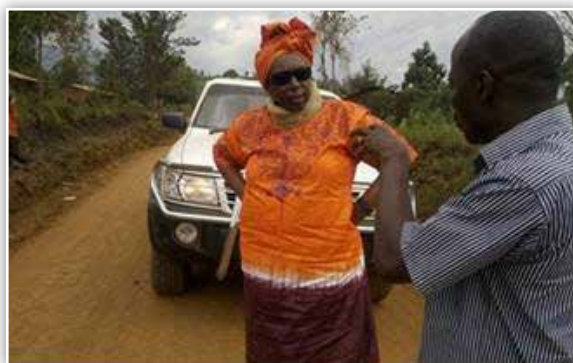
Mbale UNRA: Sections along Budadiri – Nalugugu Road with no offshoots leading to rainwater ponding on the road. The team leader discussing with the UNRA Station Manager on proposed remedies.

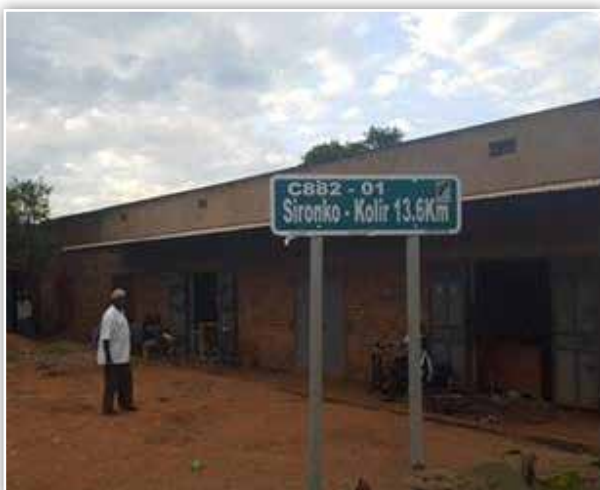
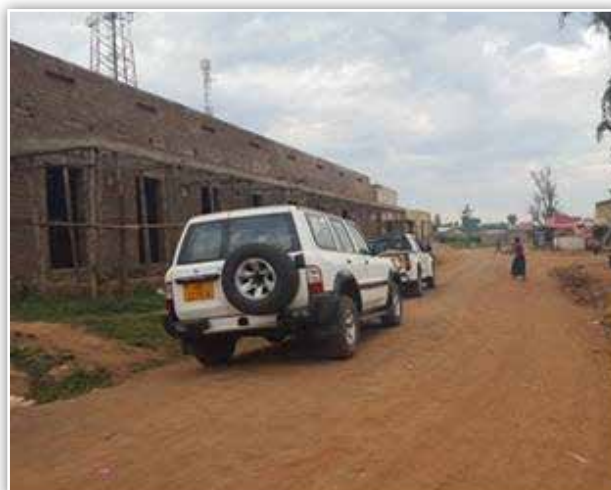
UNRA Mbale station carried out routine mechanised maintenance along sections of Sironko - Korir road link. The works involved grading and spot gravelling which was estimated to cost UGX 90.0m according to the UNRA work plan for FY 2015/16. The road was worked on by force account. Spot improvement was done involving mainly grading and graveling a few sections that were in a bad state. However, more sections need working on given the fast rate of pothole development. Drainage system needs addressing, the stagnation of water in side drains should be avoided, and silted offshoots opened.

Mbale UNRA: Sections along Sironko – Korir road that received routine mechanised maintenance during Q1 FY 2015/16.

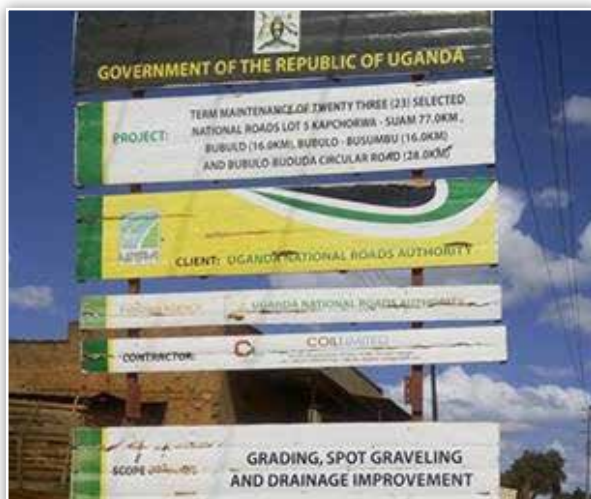
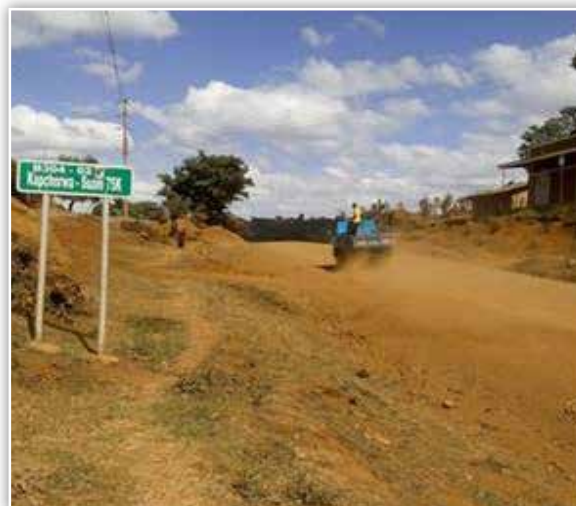
Mbale UNRA: The Beginning sections along Kapchorwa – Suam Road under Term Maintenance by COIL Limited.

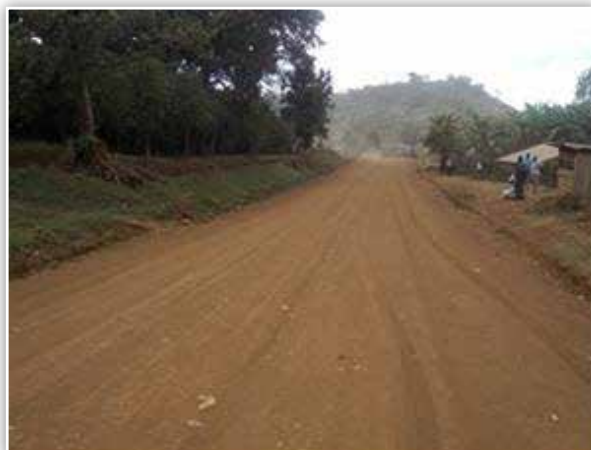
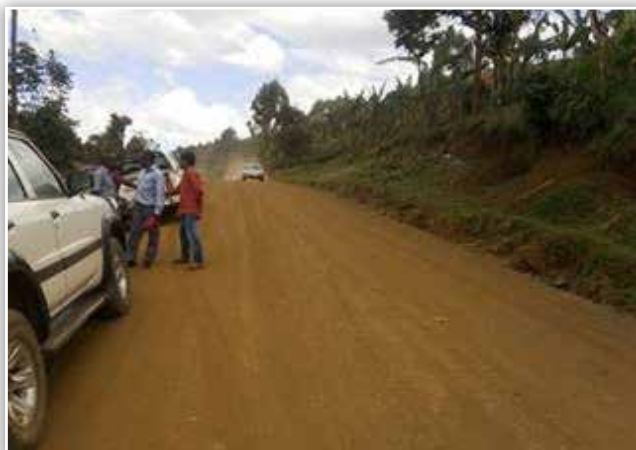
Mbale UNRA: Sections along Kapchorwa – Suam Road very good condition under Term Maintenance by COIL Limited.

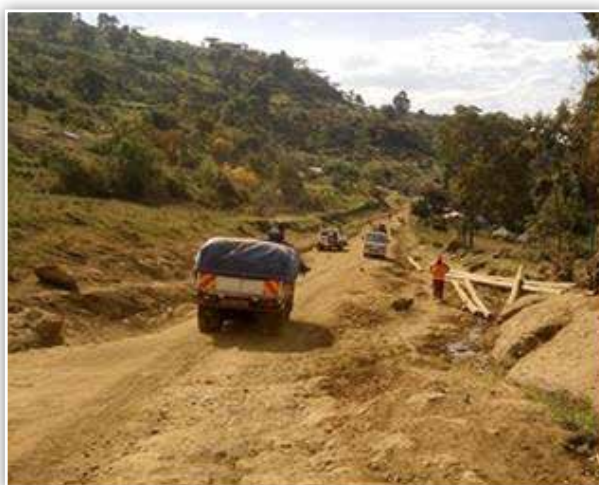
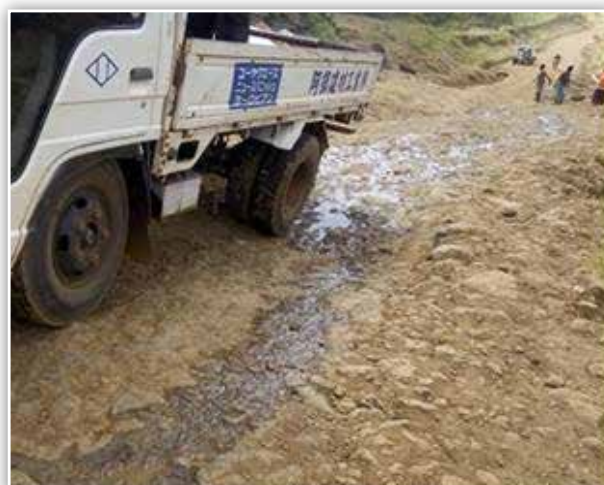
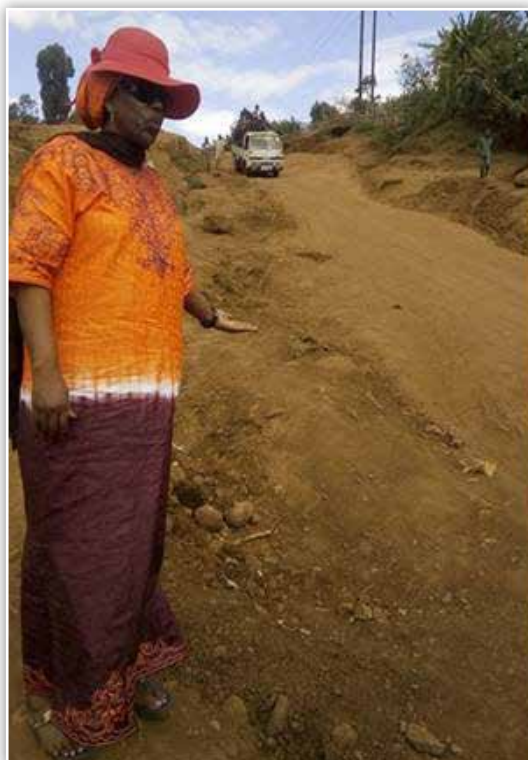
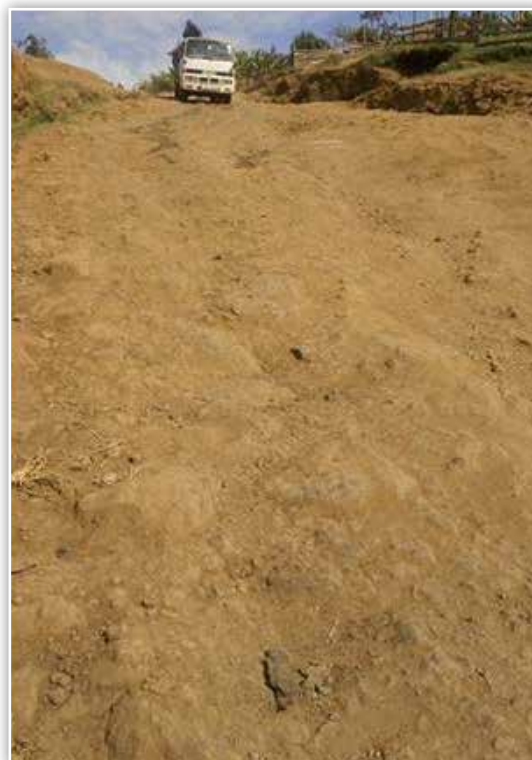
The worked on sections along the Kapchorwa – Suam road were found good under the term maintenance contract. However rock outcrops were observed along the road and made the rather good road impassable at such sections. A total of 15 sections were identified along the road but with no instruction to the contractor to handle them using any appropriate engineering methodology.

Mbale UNRA: Inspection of rock outcrop sections along Kapchorwa – Suam Road which render it impassable despite the fact that the rest of the road link is in a very good condition.

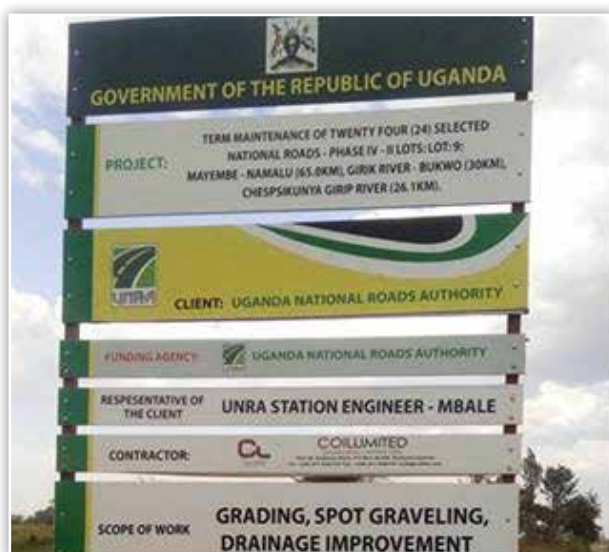
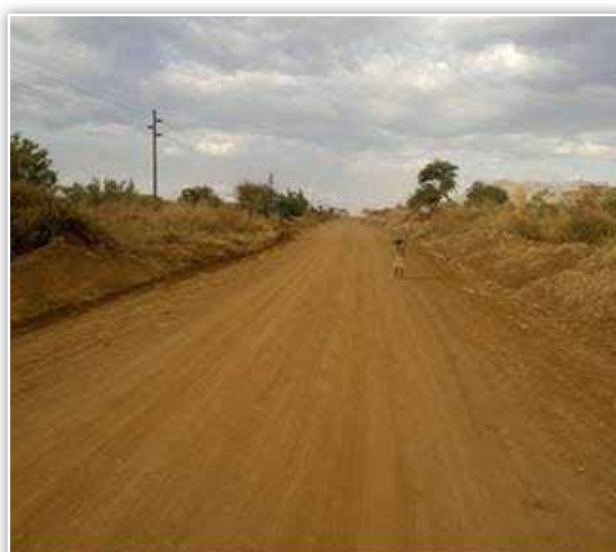
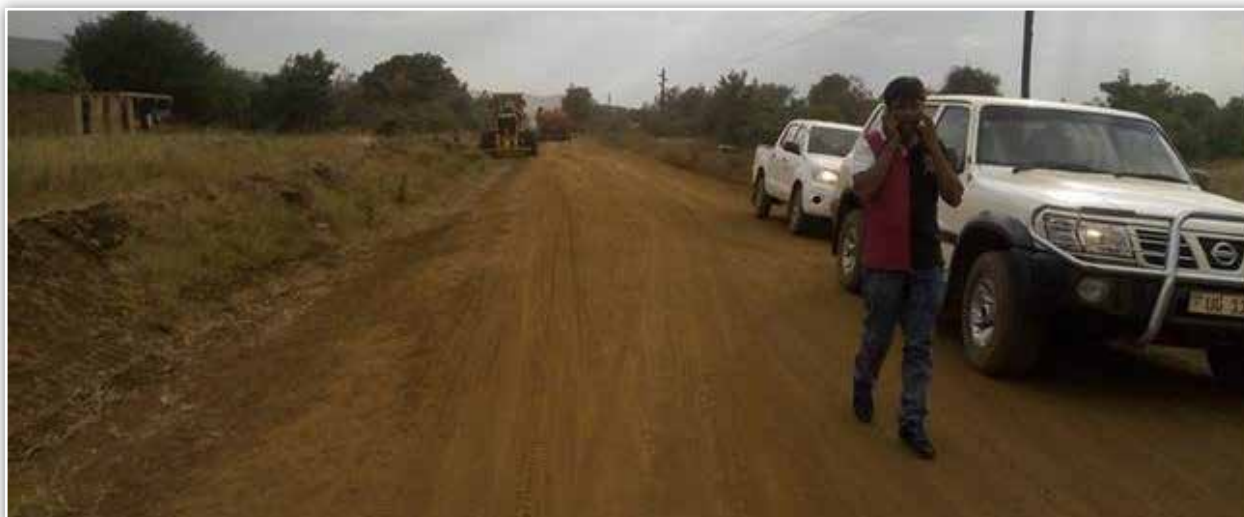
Another term maintenance contract inspected under Mbale Station was Muyembe - Namalu road which also had on-going term maintenance contracted to COIL Ltd. The contractor was well mobilized at the site with the required sets of equipment. The section of road link traversed was in very good condition and the contractor was fully onsite.

Mbale UNRA: Inspection of Muyembe – Namalu term maintenance works being undertaken by COIL Limited. The works were progressing satisfactorily with the contractor fully mobilised

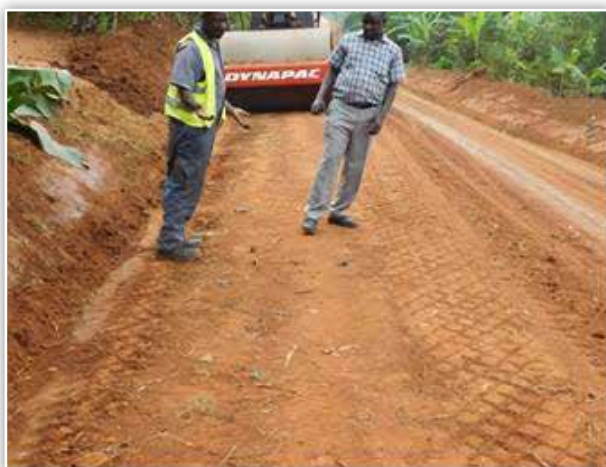
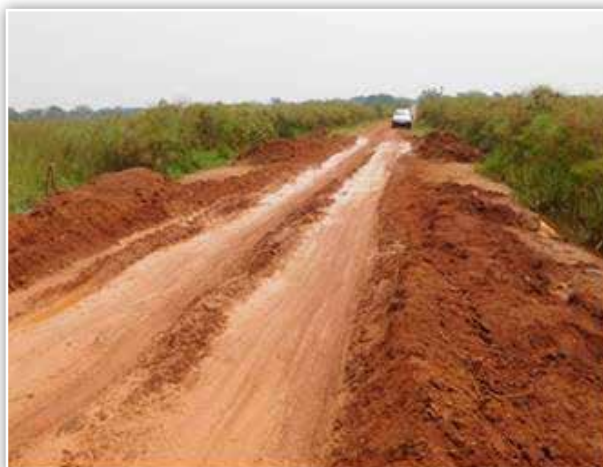
UNRA Luwero: The Ag. Station Manager UNRA Luwero puts a machine operator to task over compacting a section of the road before clearing debris on Zirowe Lwajali road under periodic maintenance

UNRA Luwero: Swamp raising at Nabisojjo swamp along Butalangu – Ngoma road under routine mechanised maintenance.

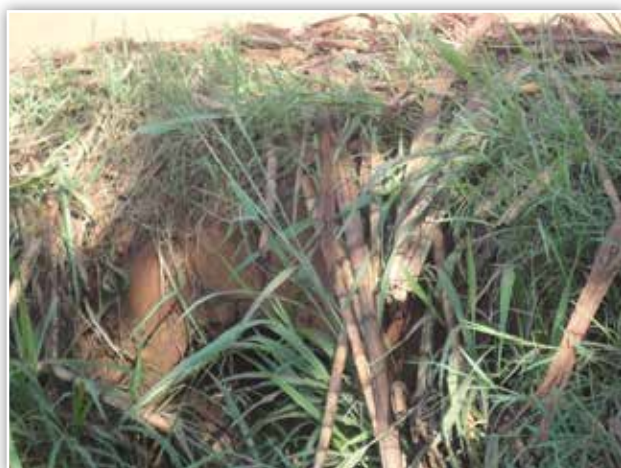
Figure 2.6: Photographs from Masindi UNRA Station

UNRA Masindi: The silted culvert on Masindi-Hoima road on Term maintenance

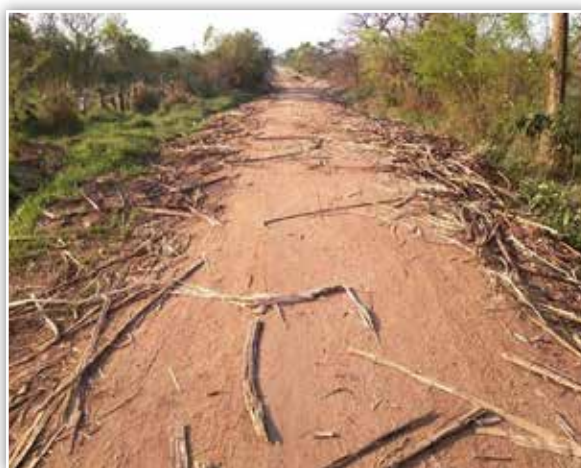
UNRA Masindi: Ihungu-Bulyamusenyi (42km) road littered with Sugar cane

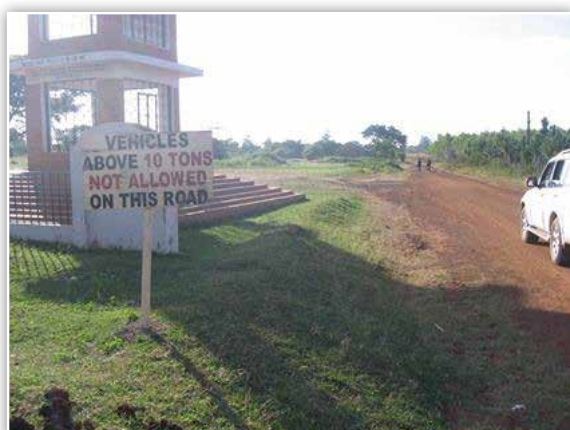
Tororo district: A road sign at the beginning of Osia-Kidera road (11km) to prevent heavy trucks from using and overloading the district road and its drainage structures.

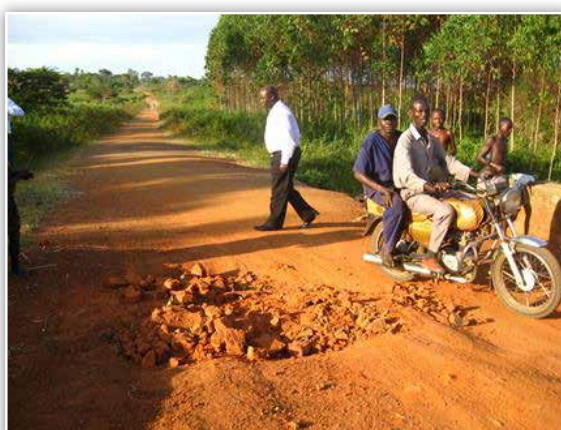
Figure 3.1: Photographs in Tororo District

Tororo district: A 2,100mm diameter double line Armco culvert caved in on Osia-Kidera road (11km) under the heavy weight of trucks that were using the road as a detour.

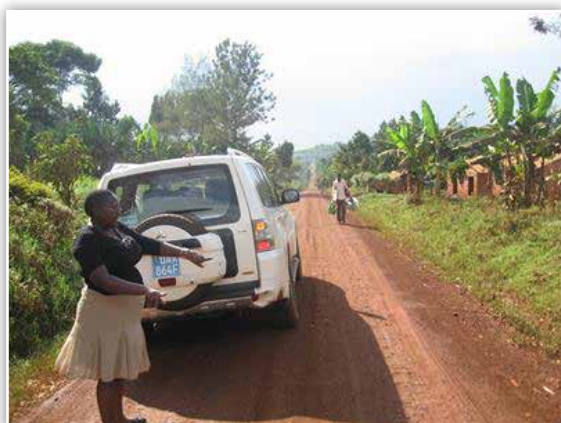
Figure 3.2: Photographs in Jinja District

Jinja district: A section on Kabowa-Budiima road (21.4km) that had received bush clearing and reshaping under RMeM.

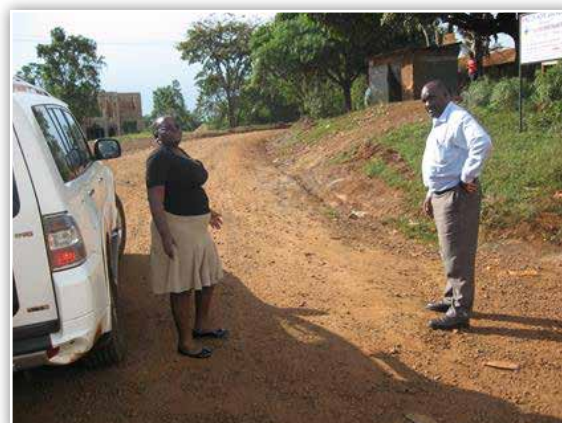
Jinja district: A section on Mafubira-Butiki road (4.4km) that had received bush clearing and heavy grading under PM.

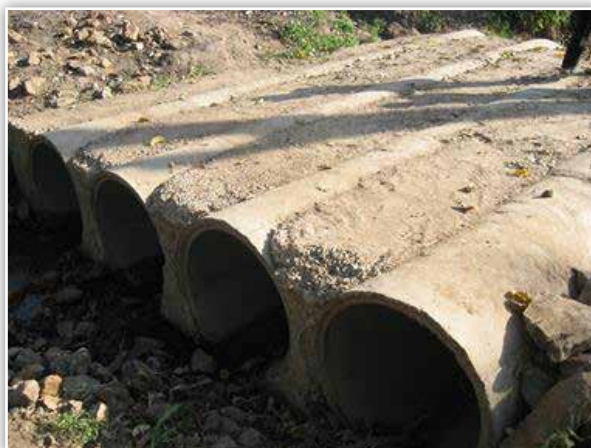
Figure 3.3: Photographs in Tororo Municipality

Tororo MC: Installation of a 4-line stream culvert crossing on Civic road (1.1km) that was being widened.

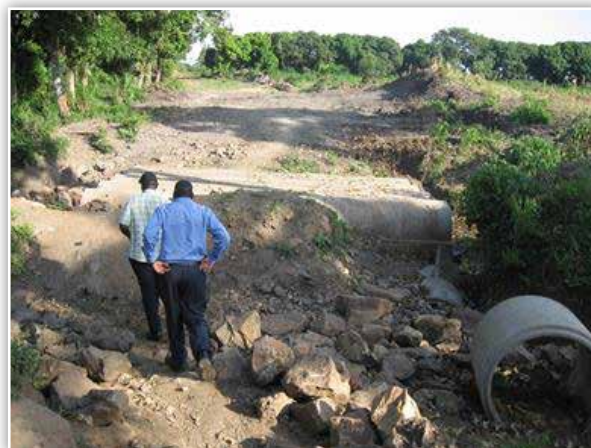
Tororo MC: Culvert installation works on Civic road (1.1km) that was being widened.

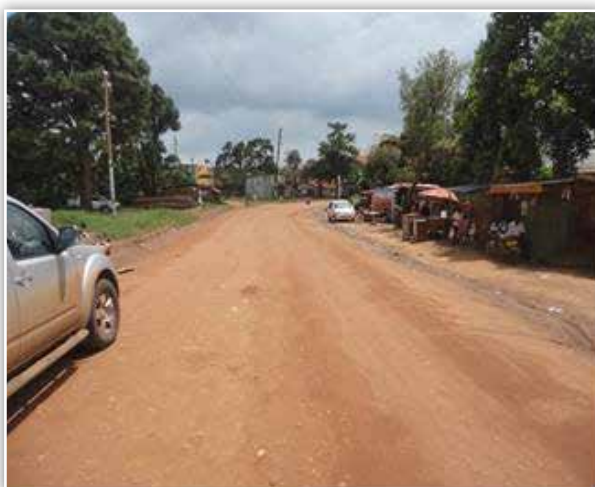
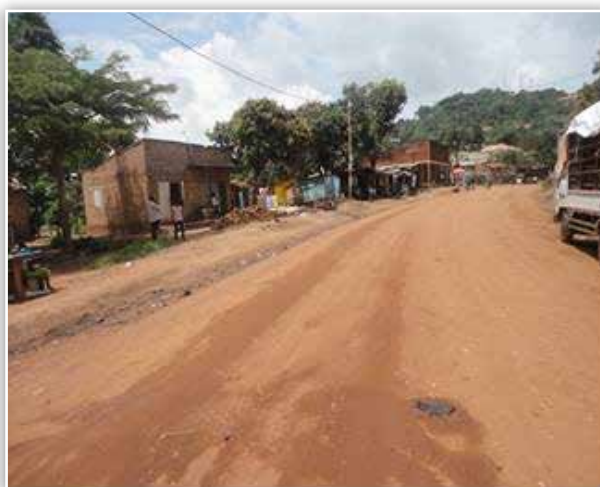
The Municipality had procured 400 tonnes of aggregates, 200 tonnes of lake sand and firewood in preparation for application of the second seal on the road. The grading & shaping and gravelling works on the road had been executed during Quarter two of FY 2015/16 using force account and the road was in a fair condition. It was noted the road works lacked a URF signpost and road safety sign posts at sharp corners. There was urgent need to commence the drainage improvement works since water was running along the carriageway. Below are some of the field photos taken along the road.

Mukono MC: Completed sections of Nabuti- Nsube road (5km) that had received routine mechanised maintenance

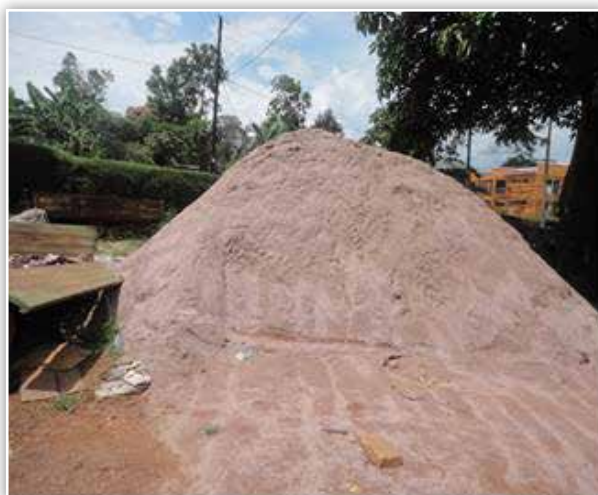
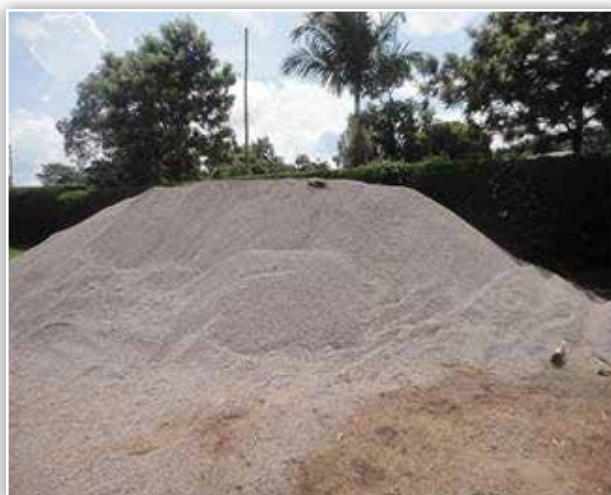
Mukono MC: Sand and stone dust materials procured for the second seal on the 1km section of Nabuti- Nsube road (5km)

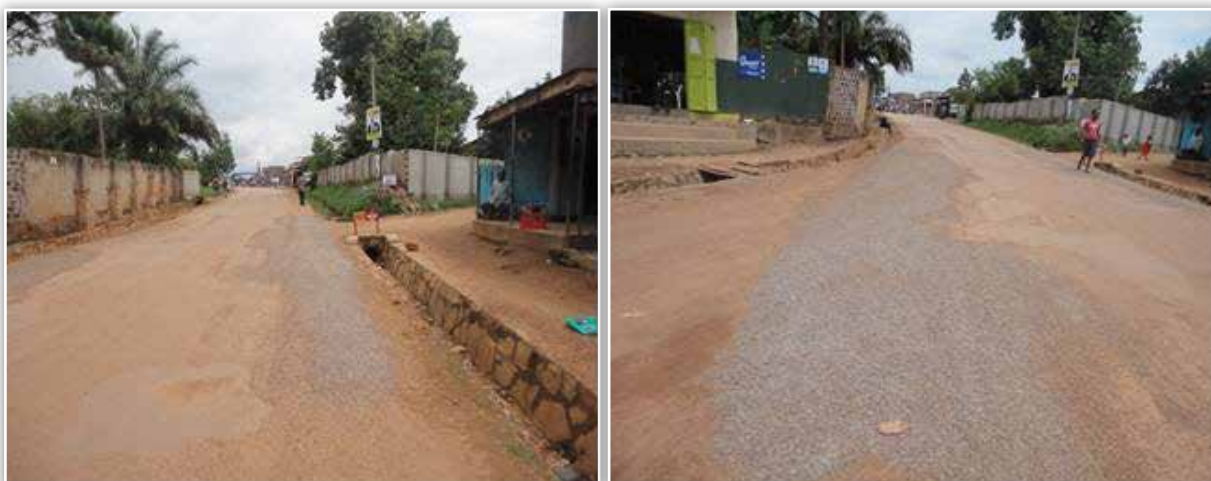
Ntaawo- Nakabago is a paved/gravel urban road (5.3 km) is part of the routine mechanised maintenance component of the annual workplan which had been planned to be executed in Quarter two of FY 2015/16. Planned works included pothole patching and works were still in progress. It was noted that there were too many loose stone chippings on the patched areas and that the road works lacked a URF signpost. Below are some of the field photos taken along the road.

Mukono MC: Pothole patching on paved sections of Ntaawo- Nakabago road (5.3 km) with loose stone chippings.

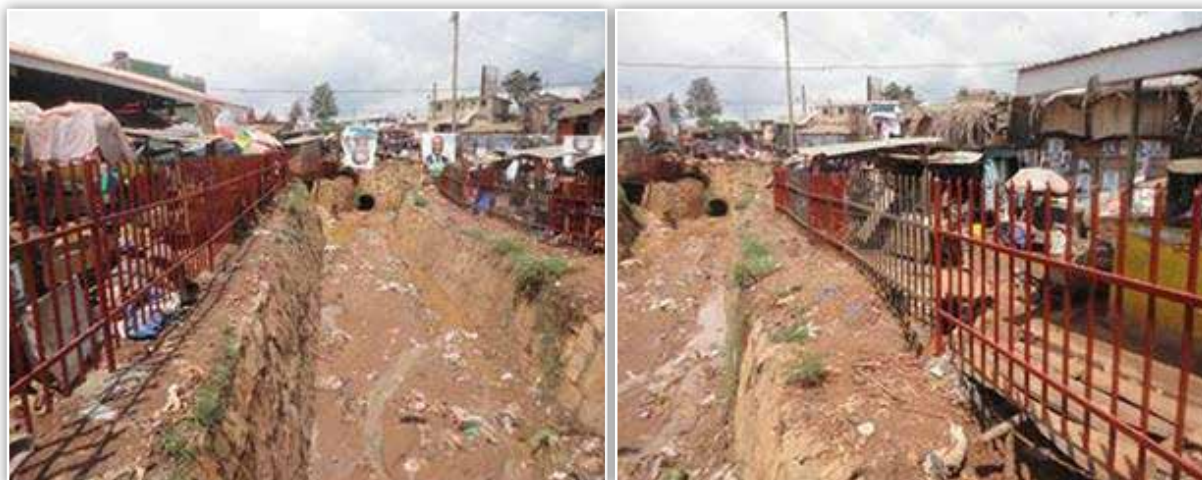
Figure 3.4: Photographs in Mukono Municipality

Kame valley road is a 6m wide paved urban road (1km) in Mukono municipality that connects to the Kampala- Jinja trunk road. Planned works included stone pitching and installation of guard rails along the drainage channels.

The stone pitching and installation of guard rails had been completed during Quarter one of FY 2015/16 using force account. The completed works lacked a URF signpost. Below are some of the field photos taken of the stone pitching works along the road.

Mukono MC: Stone pitching and guard rails installed on Kame valley road drainage channels

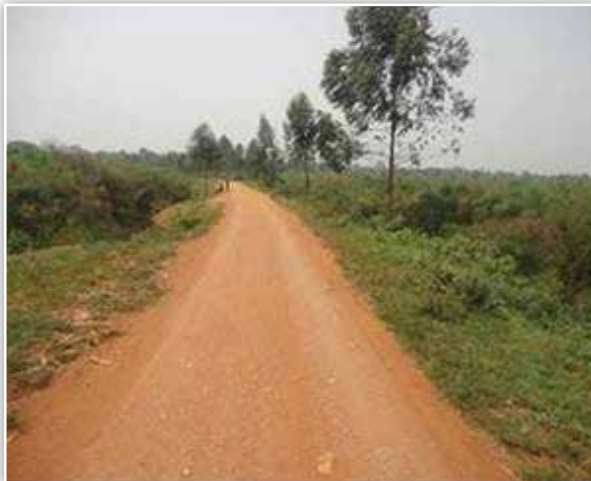
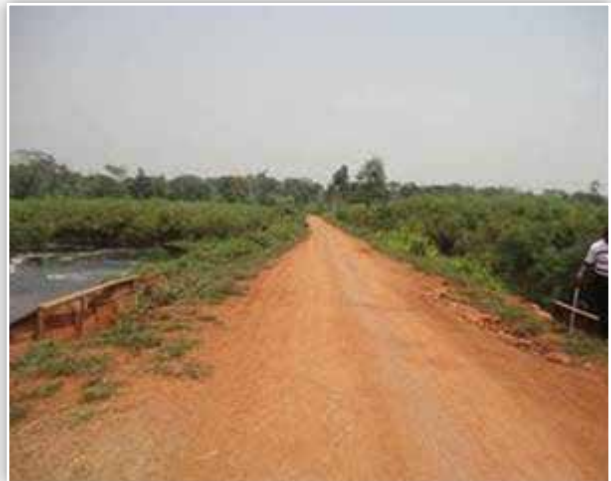
At the time of the visit, grading & shaping, swamp raising and installation of 9lines of concrete (3nos) and Armco (6nos) culverts had been executed during Quarter one and two of FY 2015/16 using force account. The road lacked a URF signpost and was currently in a in fair condition. Below are some of the field photos taken along the road.

Mukono DLG: Restored section of Sezibwa swamp at ch 6+500 on Kabimbiri- Nkoko- Kyabazala road (12km) that had been washed away by heavy floods.

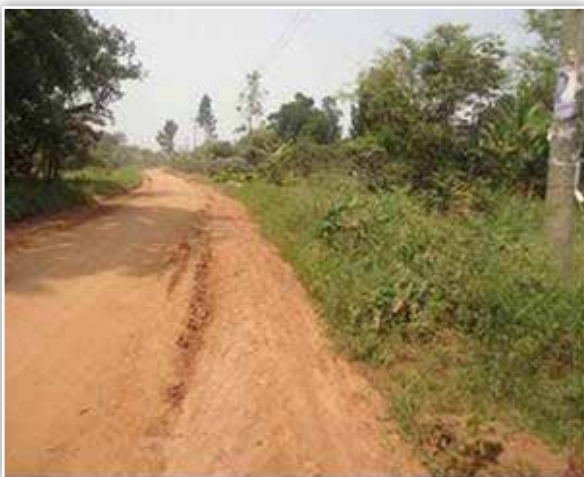
At the time of the visit, the grading & shaping and installation of 5 lines of 600mm concrete pipe culverts had been executed during Quarter two of FY 2015/16 using force account. The road lacked a URF signpost and was currently in a fair condition. Below are some of the field photos taken along the road.

Mukono DLG: Section of Kanana-Nacyeke-Luguje (8km) requiring erosion protection in road side drains.

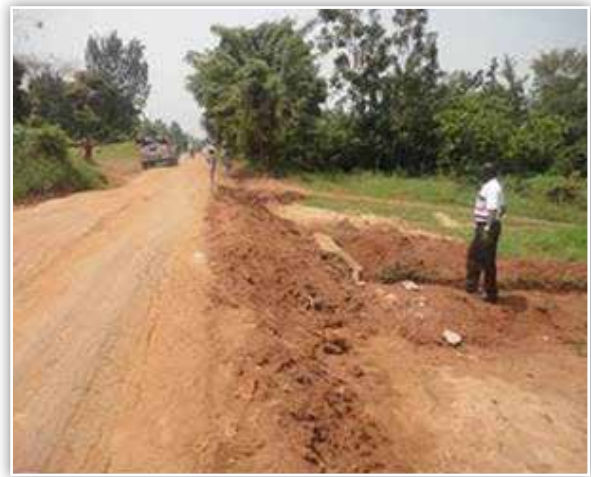
Poorly constructed headwalls that needed raising to the new road level.

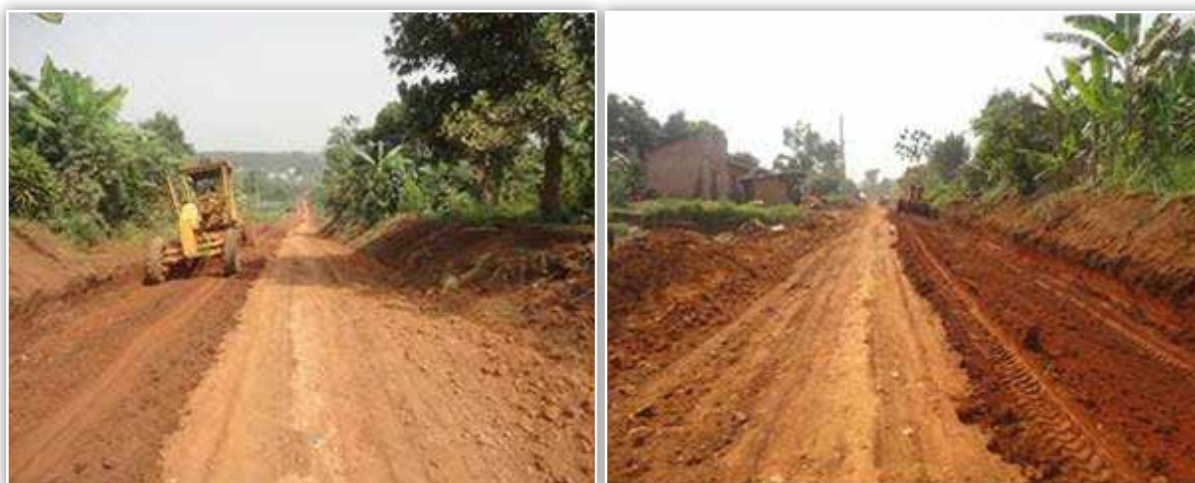
Figure 3.5: Photographs in Mukono District

At the time of the visit, the grading & shaping works were in progress using force account and the gravelling and installation of four lines of culverts were to commence in Q3- FY 2015/16. Below are some of the field photos taken along the road.

Mukono DLG: Routine mechanised maintenance works in progress on Kigombya- Seeta- Sezibwa road (14 km)

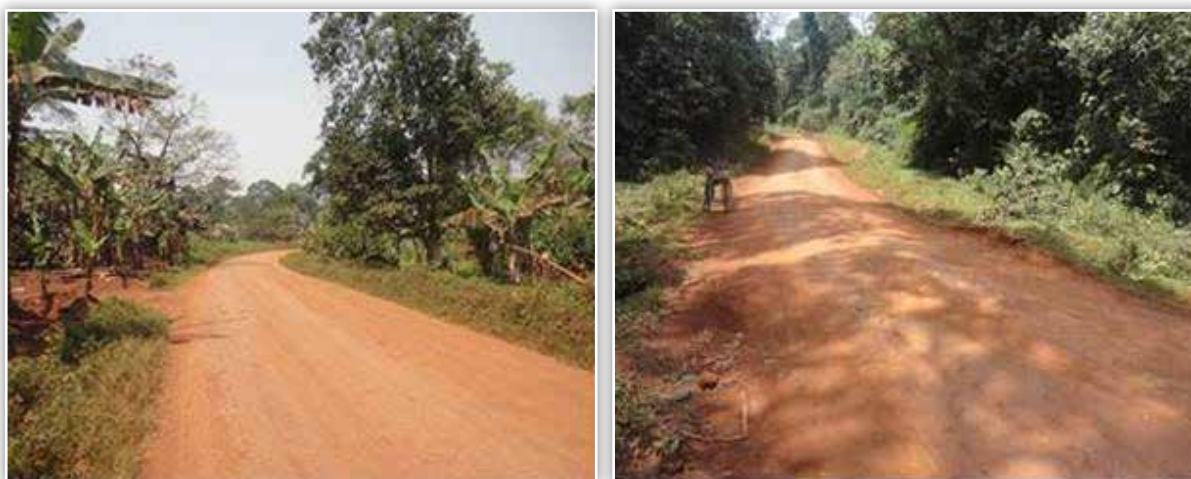
At the time of the visit, grading and shaping, spot gravelling and installation of one culvert line at ch 8+400 had been executed in Q1- FY 2015/16 using force account. It was observed that the road lacked road safety signposts in sharp corners and URF sign posts. The road was still in good condition and below are some of the field photos taken along the road.

Buikwe DLG: Sharp corners on the graded and shaped sections of Kawomya- Senyi road (9.8km) lacking road safety signposts completed in Q1- 15/16.

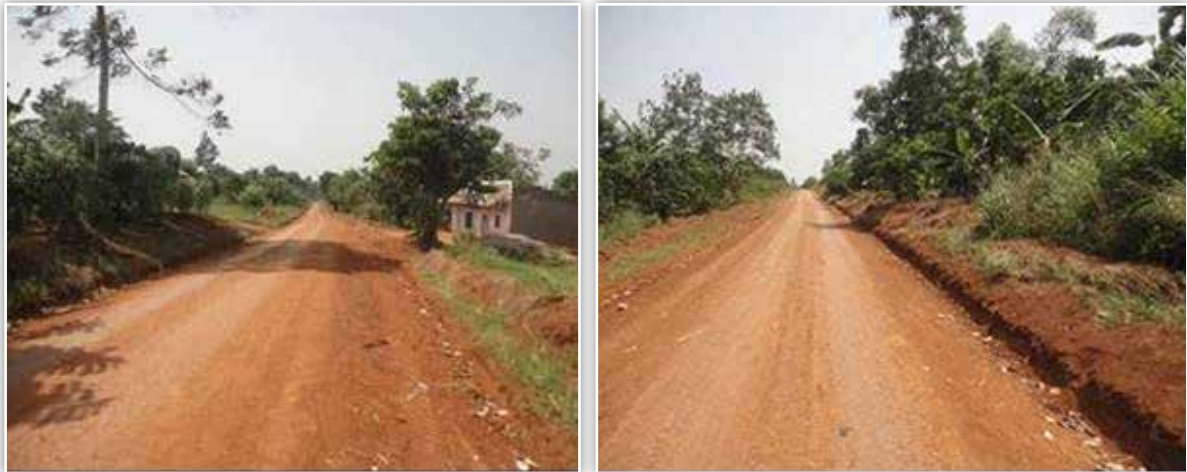
Lweru – Makindu road (7 km) is a 5m wide earth/gravelled district road, that had undergone periodic maintenance using force account. Planned works on this road included bush clearing, grading & shaping and drainage improvement works. At the time of the visit, the bush clearing, grading & shaping and installation of 3 lines of culverts had been completed using force account. The road lacked a URF sign post and was still in good condition. Below are some of the field photos taken along the road.

Buikwe DLG: Graded and shaped sections on Lweru – Makindu road (7 km) road completed in Q2- 2015/16.

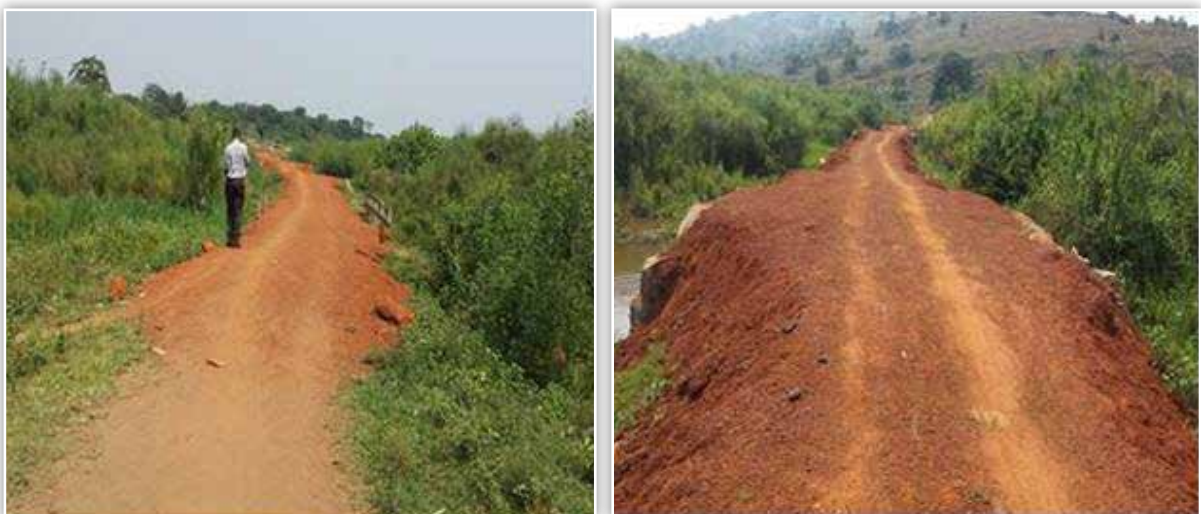
At the time of the visit, the swamp raising, gravelling and installation of 8 lines of concrete pipe culverts had been executed in Q1 and Q2- FY 2015/16 and the swamp was now passable. The road had many other sections that were impassable that needed special intervention. It was also observed that some of the installed culvert lines lacked headwalls and the road lacked a URF sign post. Below are some of the field photos taken along the road.

Buikwe DLG: Swamp improvement works at Mubeya swamp located at ch 4+00 on Kidokolo- Mubeya road (8km)

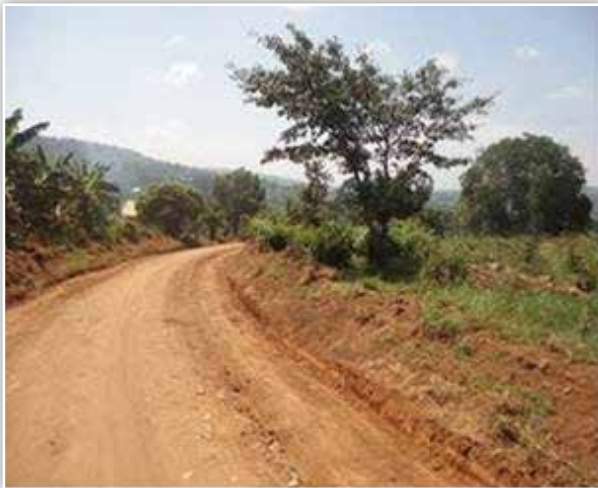
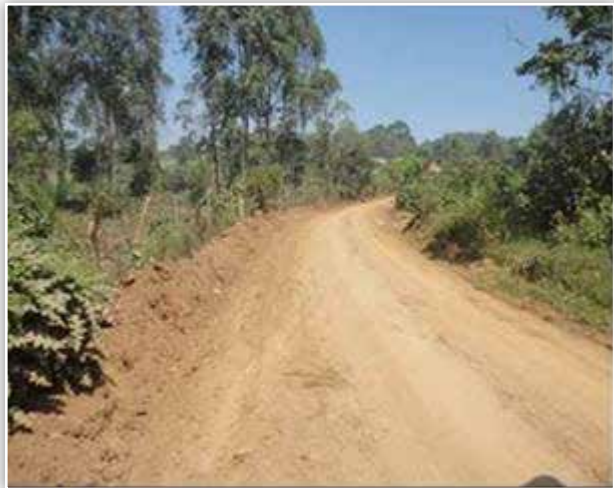
At the time of the visit, works were in progress with the grading and shaping works completed while the swamp raising and culvert installation were yet to commence. It was observed that the road had been compacted and had poor alignment with many sharp corners which lacked road safety signposts. The road lacked a URF funding sign post and below are some of the field photos taken along the road.

Masaka DLG: Sharp corners on the graded and shaped sections of Bulayi- Kigaato- Kiyimba road (5km) lacking road safety signposts.

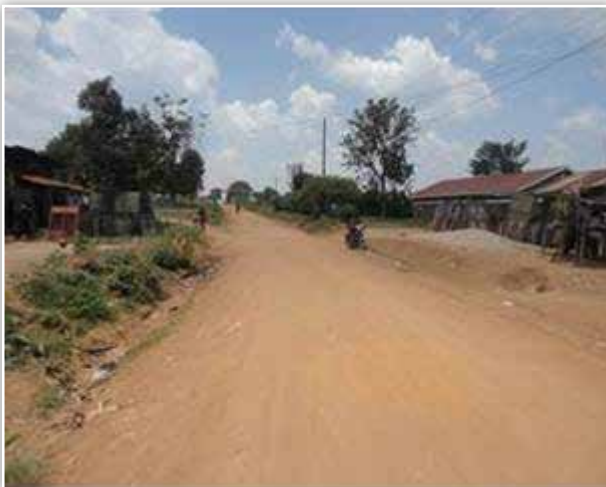
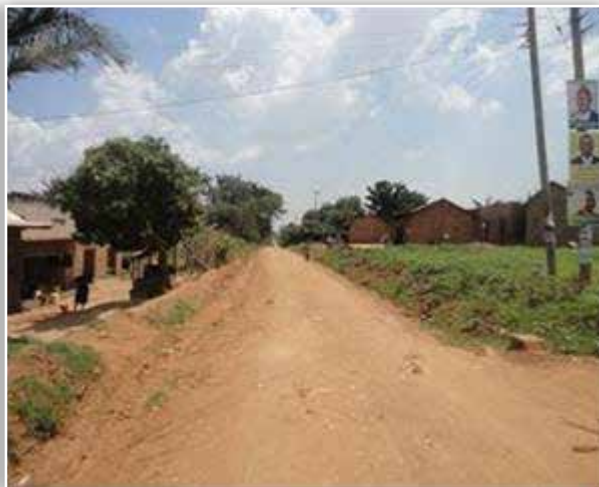
Kyanamukaaka– Buyaga road (11km) is a 6m wide earth/gravelled district road that had undergone routine mechanised maintenance using force account. Planned works on this road included only grading & shaping to be executed in Q2- FY 2015/16. At the time of the visit, the grading & shaping works had been completed in Q2- FY 2015/16 using force account. It was observed that the road required erosion protection measures in the steep side drains. The road lacked a URF funding sign post and was in good condition. Below are some of the field photos taken along the road.

Masaka DLG: Graded and shaped sections on Kyanamukaaka– Buyaga road (11km) completed in Q2- 2015/16.

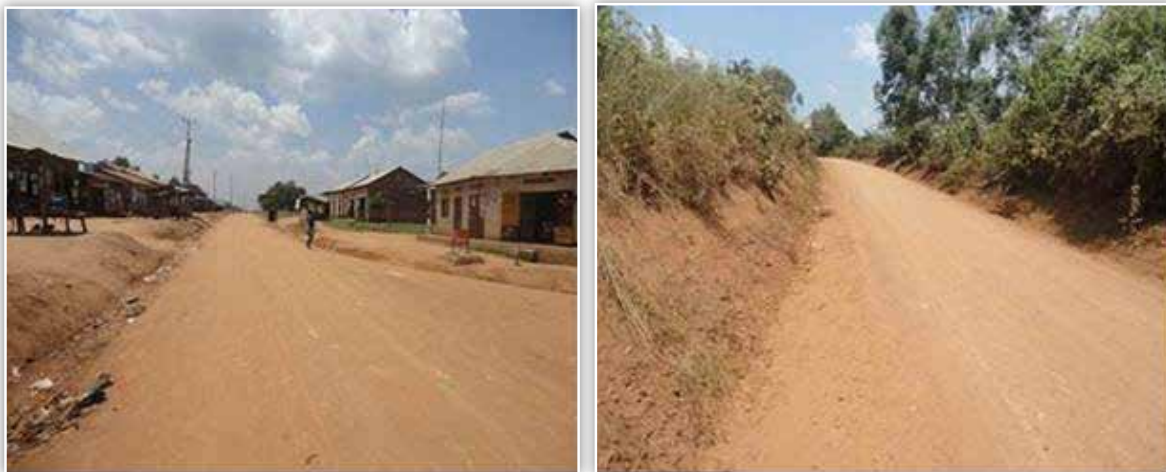
At the time of the visit, the grading & shaping works had been completed in Q2- FY 2015/16 using force account. It was observed that the road required installation of some culvert lines and erosion protection measures in the steep side drains. The road lacked a URF funding signpost and was still in good condition. Below are some of the field photos taken along the road.

Masaka DLG: Graded sections on Kyanamukaaka- Bukunda road (8km) completed in Q2- FY 2015/16.

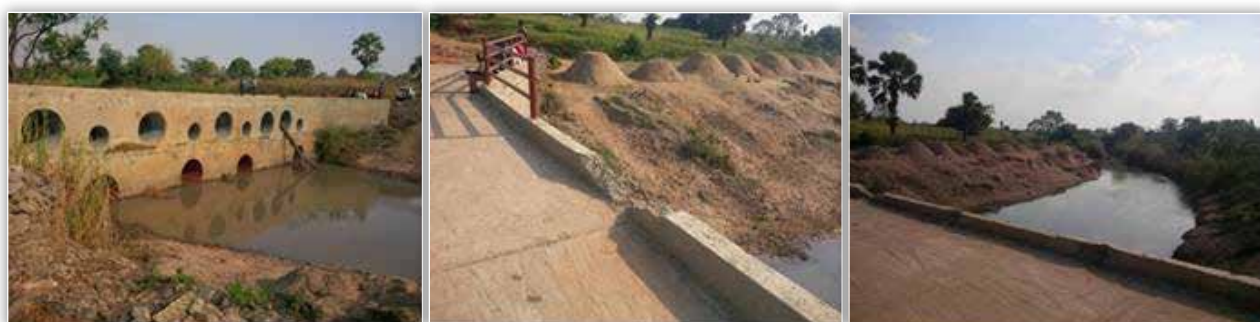
Sn	Road Name	Site Observations
1.	Kochi Vented Drift Bridge <i>Completion of construction works rolled over from FY 2014/15</i>	<p>Works done on the vented drift bridge included installation of additional 5 lines of 1500mm diameter culverts, 5 lines of 900mm diameter culverts; river training; backfilling and construction of concrete decking of 36m span, 4.8m wide; construction of abutments; installation of gabion retaining walls on the approaches (Approx 50m); provision of guardrails and backfill of the approaches. The works had been progressed to substantial completion before occurrence of a massive flood (more than 50yr return period) which swept the gabion walls, backfill on the approaches, ripped off the guardrails and cracked the concrete decking. The contractor was however still on site undertaking remedial works under force majeure provisions.</p> <p>The monitoring team observed that the site was most suited for a clear span bridge rather than a vented drift bridge given the size of the river, which was approx 30m wide and more than 5m deep. The team recommended a review of the design for assurance of structural adequacy of the vented drift option.</p>

Yumbe DLG: Sections of Kochi Vented Drift Bridge showing the works that had been done before being destroyed by flash floods.
