ROAD MAINTENANCE MONITORING REPORT

QUARTER 1-2 FY 2015/16 (July – Dec 2015)

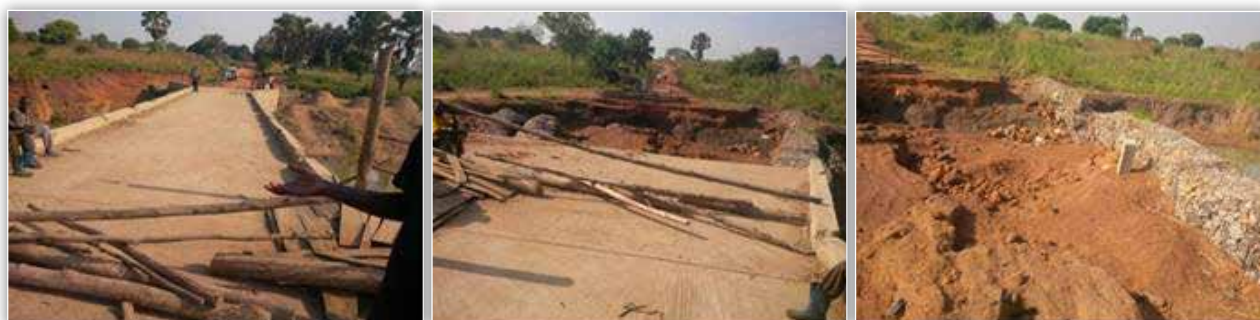
Figure 3.8: Photographs in Yumbe District

Yumbe DLG: Sections of Kochi Vented Drift Bridge where the guardrails and approaches had been swept following flash floods.

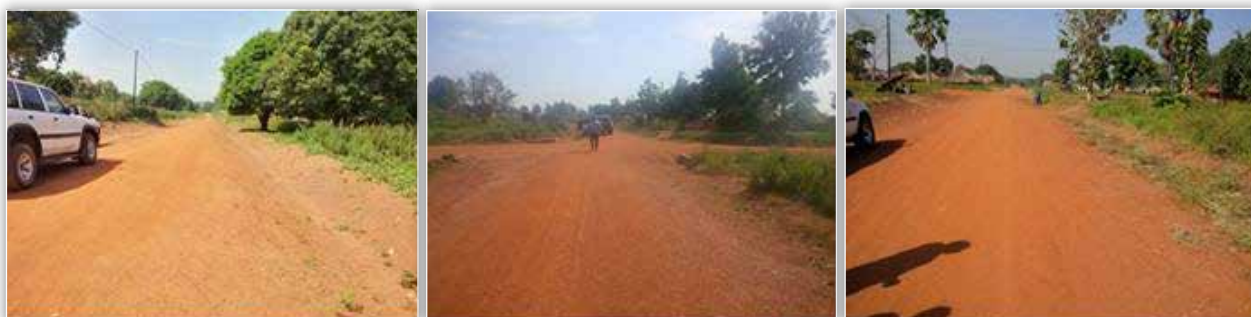
Yumbe TC: Gravelled sections of Abadaki road (L); Biragonga road (C); and Odriga road (R). The roads had been graded in FY 2014/15

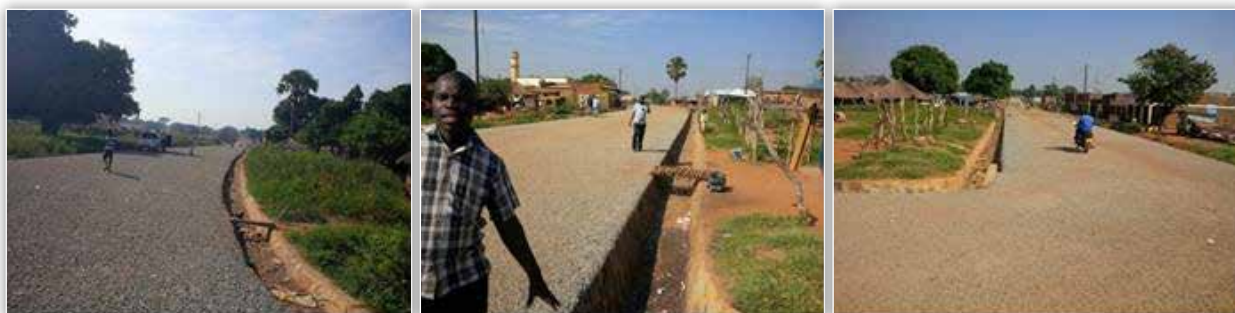
Sn	Road Name	Site Observations
1.	Kuri road (0.1Km); Awule road (0.4Km); Henry road (0.1Km) undergoing tarmacking	The works involved tarmacking of selected roads in the central business area of the town council. The completed works on all the 3 roads included clearing and widening, earthworks, sub-base and base construction, stone lining of side drains, installation of 8no. 600mm diameter culverts. The surfacing was at priming level on Kuri road, first seal on Awule and part of Henry road, and 2nd seal on 50m of Henry road. Outstanding works included completion of stone lining of the side drains, headwalls construction, installation of access culverts and completion of the 2nd seal. The roads were on average 8.0m wide and the works were visually of good quality. These being the first paved roads in the town council, the social and economic impact of the intervention was evident.

Yumbe TC: Sections of Kuri, Awule and Henry roads which were tarmacked under the Board Special Project for Tarmacking TC roads

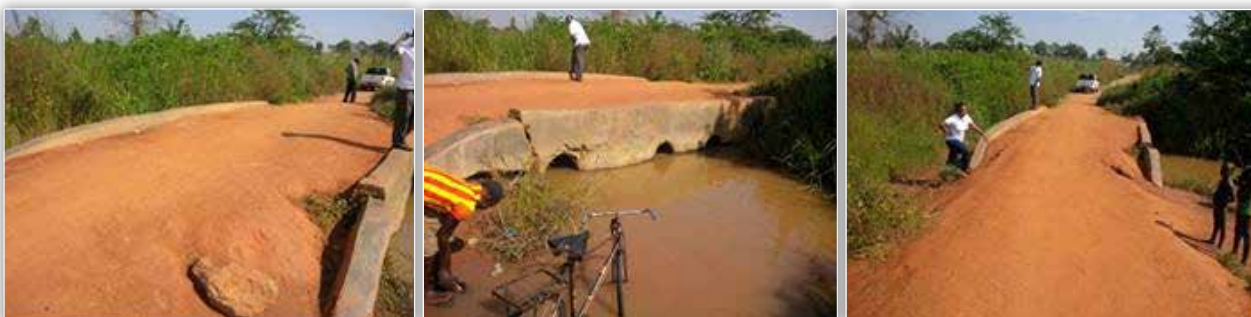
Figure 3.9: Photographs in Yumbe Town

Yumbe TC: Okwaliku Culvert Bridge crossing, where emergency works were reported to have been done.

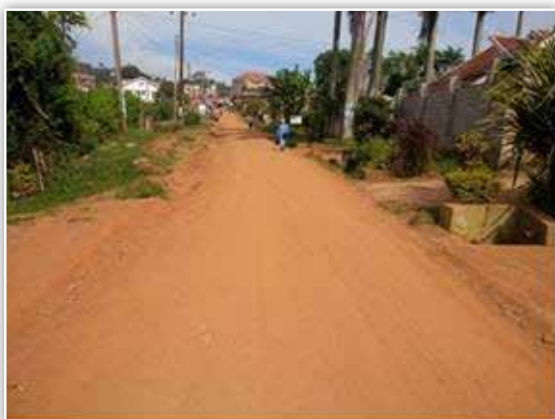
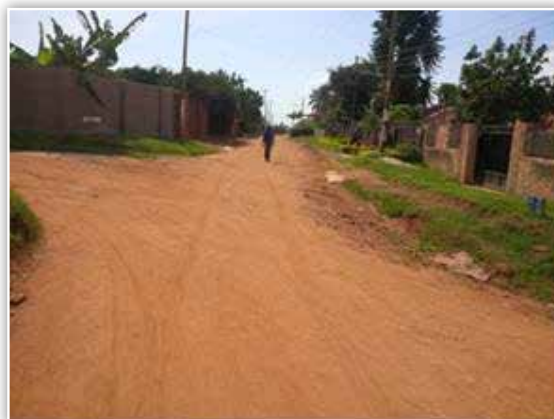
Sn	Road Name	Site Observations
1.	Kiwafu Close (1.0Km) <i>planned for routine mechanised maintenance</i>	The road had been graded to formation, however the spot gravelling reportedly done on the road was not seen.
2.	Sewabuga road (1.0Km) <i>planned for resealing</i>	Works done on the road involved upgrading of the road to paved standard. Construction works on the road had been substantially completed with double surface dressing, stone lined drains, and installation of culverts. The works were generally of good quality, by visual inspection, however failures were observed on the LHS of the junction where the road starts. These failures included heaving of the base and bleeding of the surface along a section of about 10m. This could have been caused by tyre traction of turning trucks joining the road.

Entebbe MC: Sections of Kiwafu Close, which received routine mechanised maintenance – essentially grading.

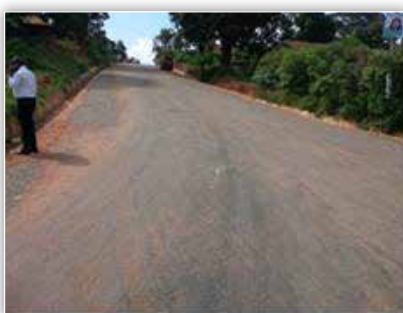
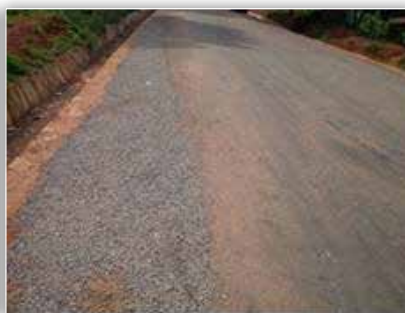
Figure 3.10: Photographs in Entebbe Municipality

Entebbe MC: Sections of Sewabuga road, which received resealing and lining of side drains. Surface failures were seen (L) and (C) at start of the road.

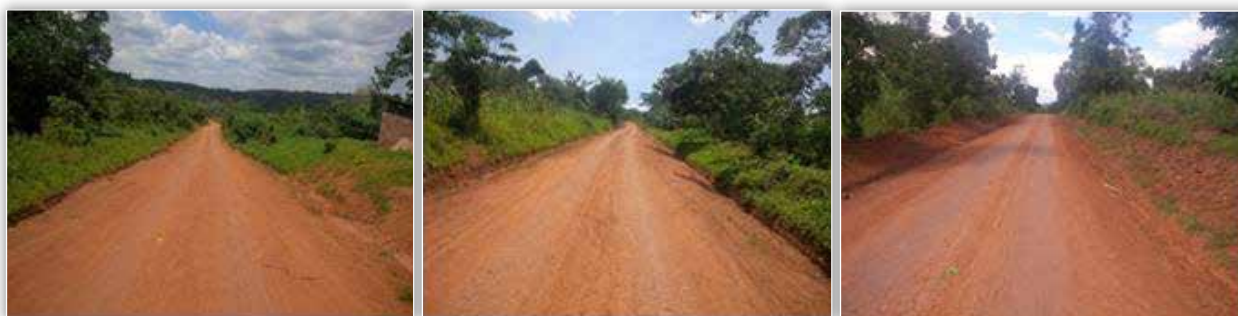
3.	Kituutu – Muyanga (5.8Km) <i>planned for routine mechanised maintenance</i>	The road had been graded to formation and compacted. Outstanding works included swamp raising, drainage improvements and provision of mitre drains. Some sections of the road had however been damaged by the rains and some sections were overgrown with grass along the side drains and shoulders.

Mpigi DLG: Sections of Katebo - Buyaaya road (L) and (C); and Kituntu – Muyanga road (R). The roads received routine mechanised maintenance

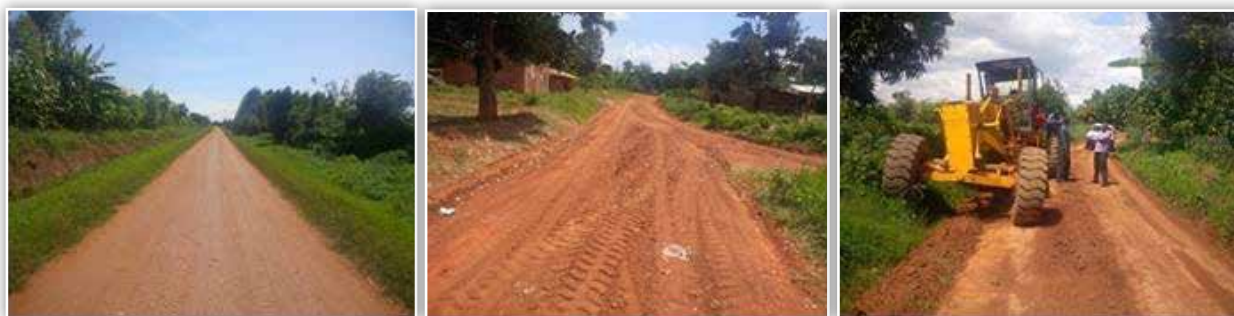
Figure 3.11: Photographs in Mpigi district

Mpigi DLG: Sections of Kituntu – Muyanga road (L) and Muyanga - Degeya road (C) and (R). The roads received routine mechanised maintenance

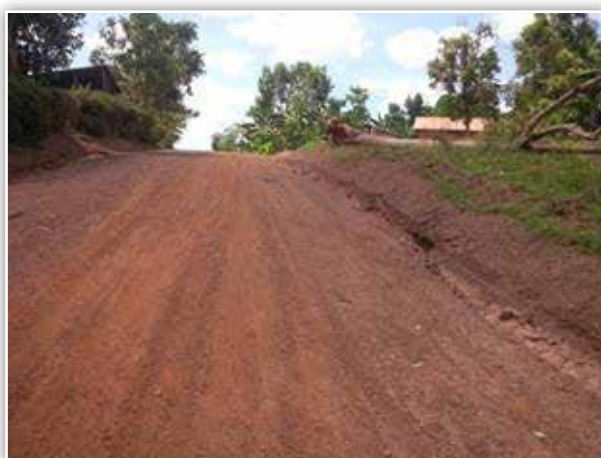
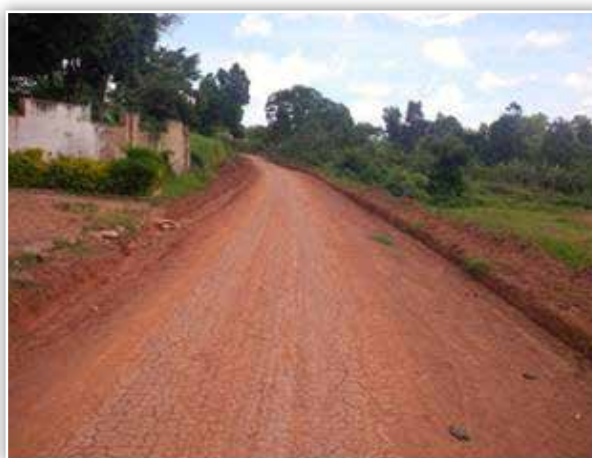
*Mpigi TC: Sections of Boza – Vvuna road, which received routine mechanized maintenance*

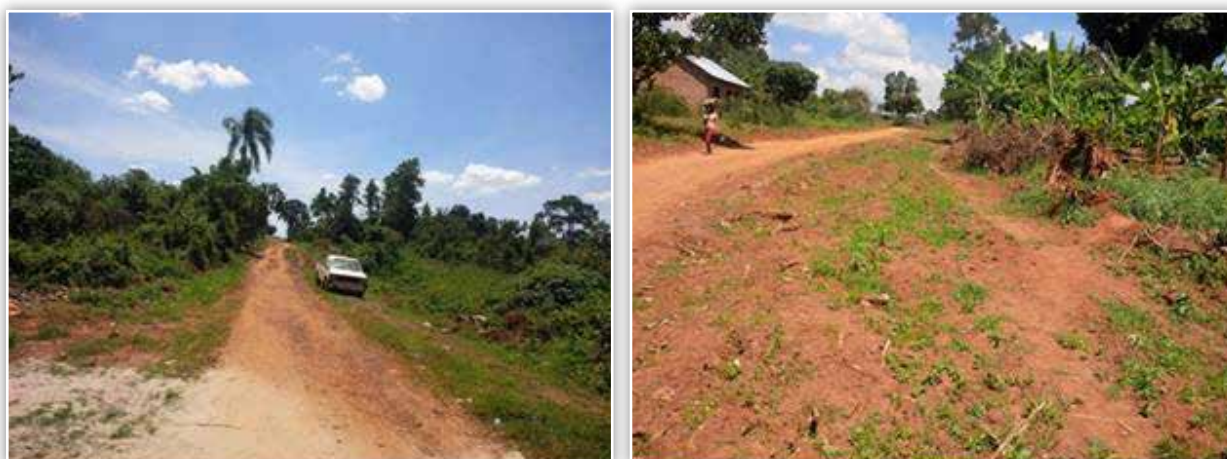
Figure 3.12: Photographs in Mpigi Town

Sn	Road Name	Site Observations
1.	Kiyanja - Nakaligi (2.2Km) <i>planned for routine mechanised maintenance</i>	Works done on the road included only road opening and removal of trees. Outstanding works included grading, gravelling and culvert installation.
2.	Boza - Vvuna (2.0Km) <i>planned for routine mechanised maintenance</i>	Works done on the road included road opening, tree removal and grading to formation. Outstanding works included gravelling and culverts installation. Some sections of the road had however been damaged and required reshaping.

Mpigi TC: Sections of Kiyanja – Nakaligi road where opening and tree removal had been done

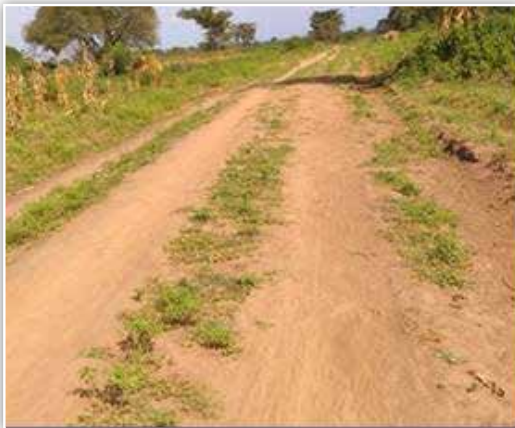
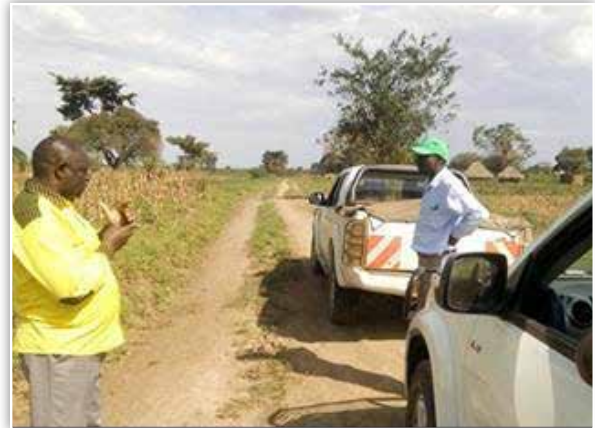
Kumi DLG: Inspection of Mukongoro – Kamaca – Bukedea road. It received routine mechanised maintenance in Q1 of FY 2015/16

Mukongoro – Kamaca – Bukedea road is a road in a fair condition after having undergone routine mechanised maintenance in Q1 of FY 2015/16. However it was found with overgrown vegetation along the carriageway indicating inadequate routine manual maintenance; there were also no visible offshoots.

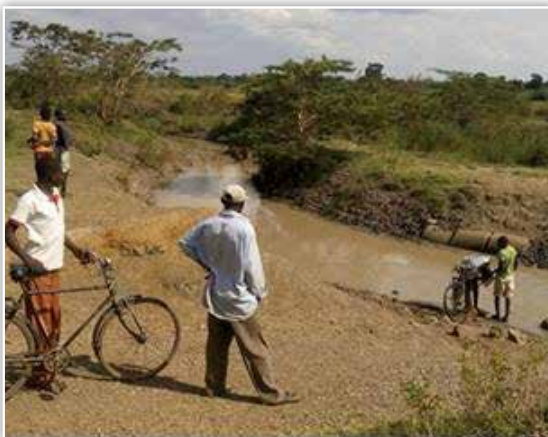
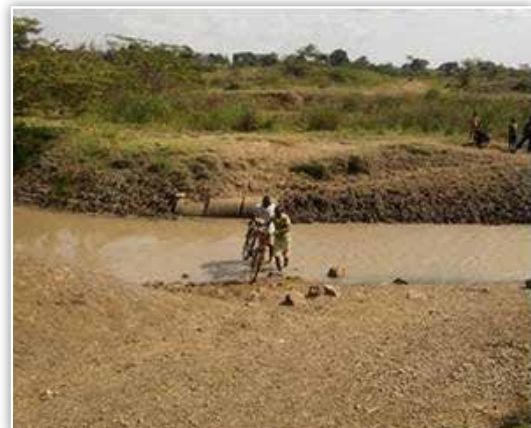
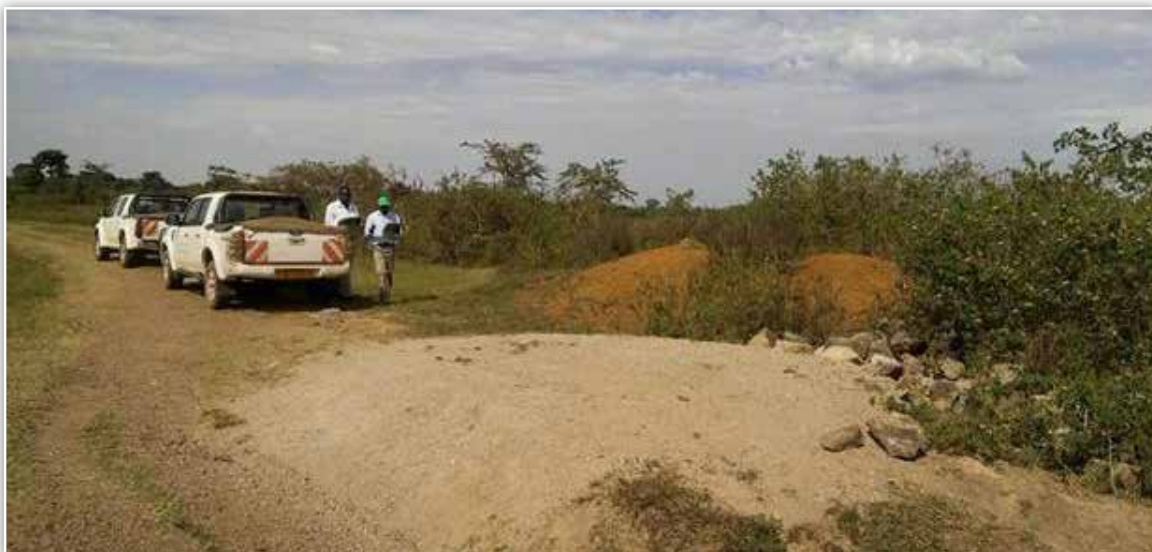
Kumi DLG: Inspection of Okokor Bridge site along Kobuko – Kamenya – Nyero road. The Bridge was contracted out by MoWT but was never completed and remains a bottleneck on the road

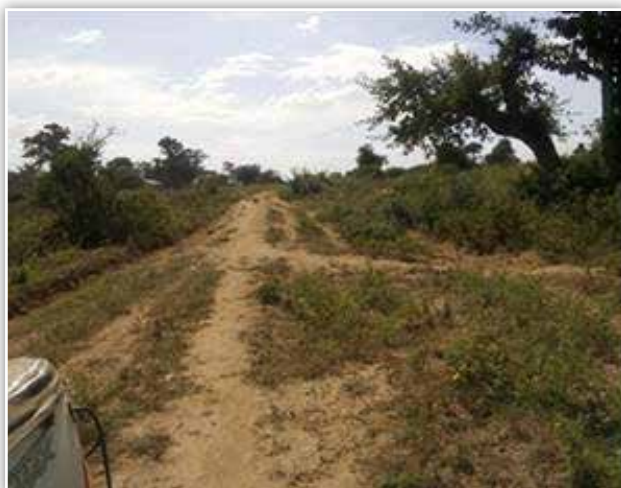
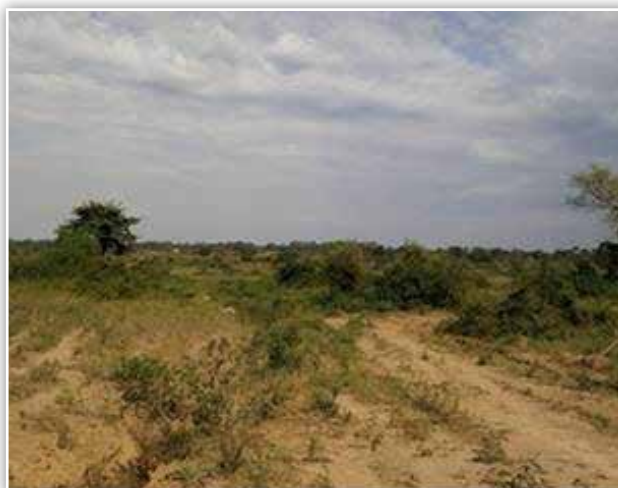
Kumi DLG: The team inspected Kalapata-Kamenya-Atoot road, which benefited from routine mechanised maintenance during Q2 of FY 2015/16

Kalapata-Kamenya-Atoot road though purportedly received routine mechanised maintenance during Q2 remains in poor state. The team was informed that the grader developed mechanical problems during implementation of works. The remainder of the works were scheduled for Q3 FY 2015/16.

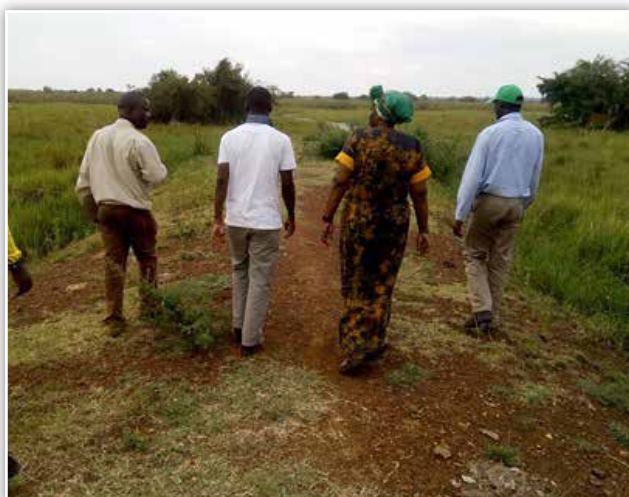
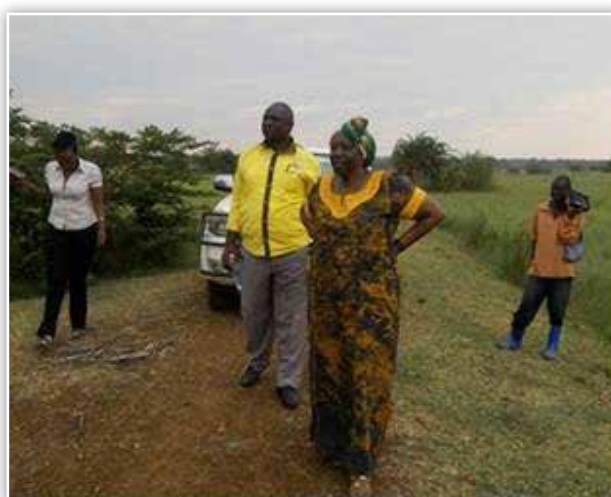
Kumi DLG: Inspection of Ongino-Tiisai road which links the main land of Kumi to Tiisai Islands. The first portion of the road was funded by CAIIP but didn't not reach the Islands

Ongino – Tiisai benefited from CAIIP funding worth UGX 400m including periodic maintenance of the 14km road and swamp filling of up to 0.5km of the 3.5km stretch connecting to the Island. The District team informed us that the Islands are a food basket and dairy farming. The districts estimated the remainder of the swamp raising and drainage works to cost UGX 2.0bn.

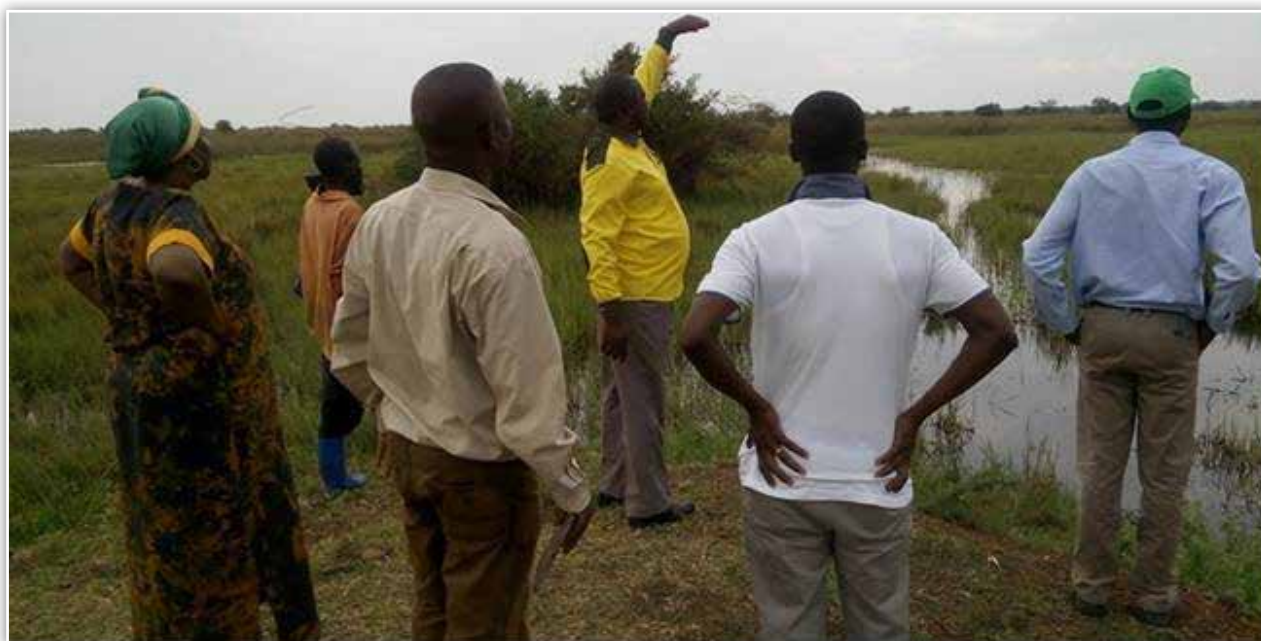
Figure 3.13: Photographs in Kumi District

Kumi DLG: The team inspected the road up to 0.5km which was raised leading to the Island at a distance of approximately 3.0km

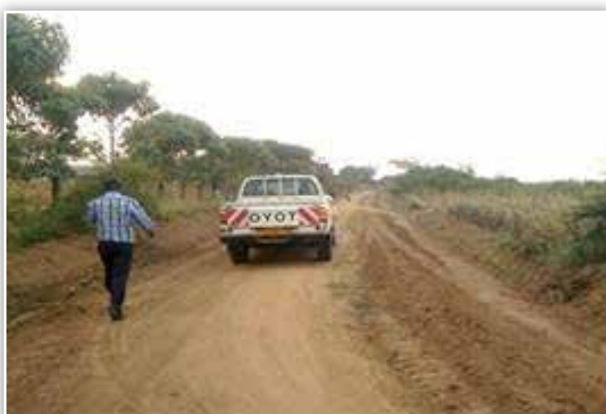
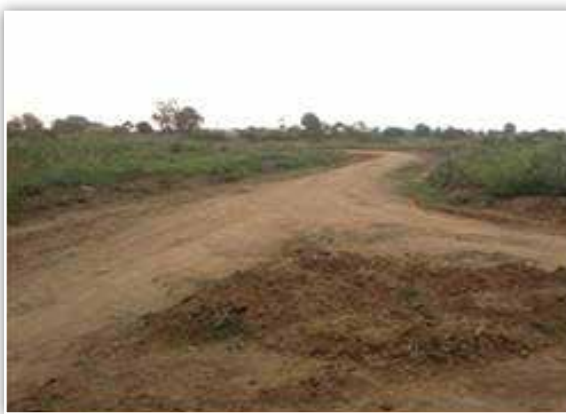
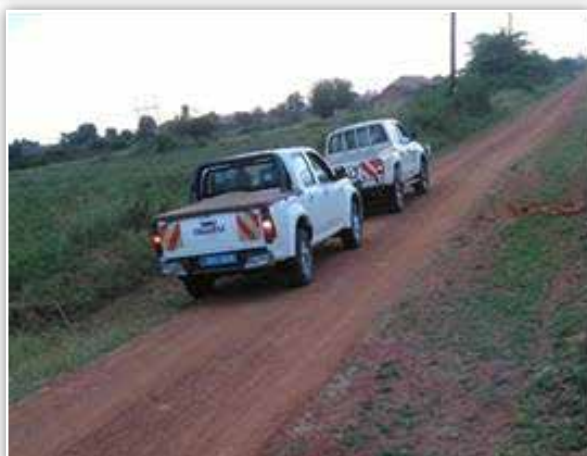
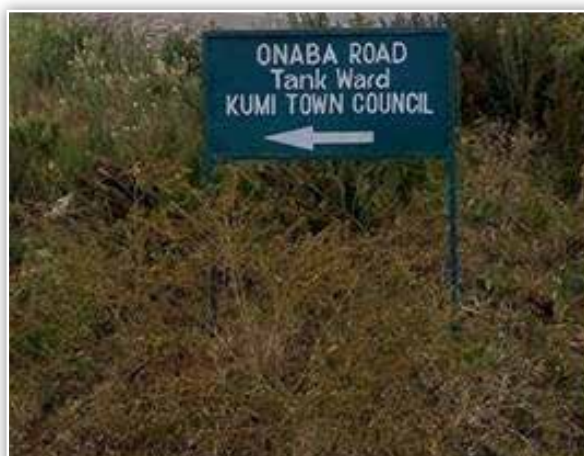
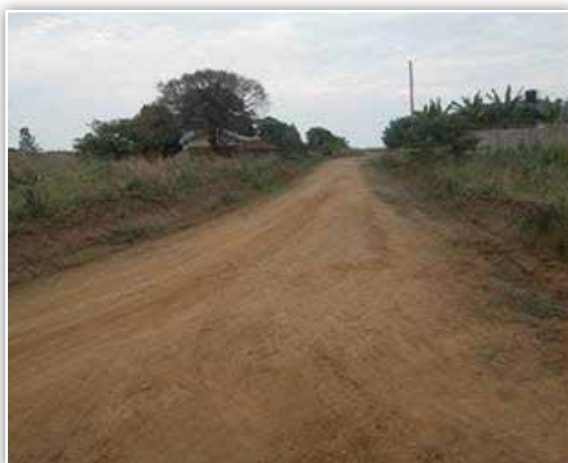
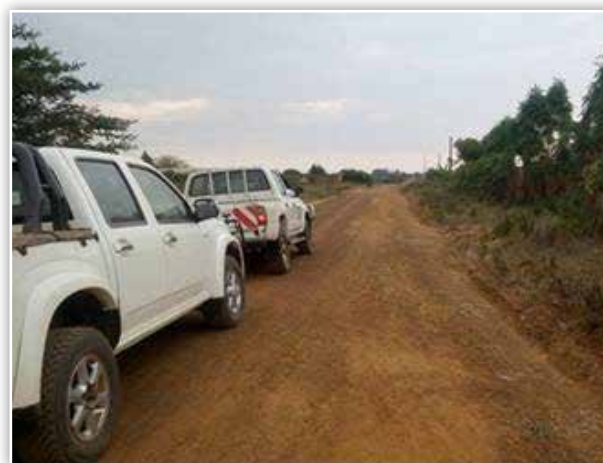
Kumi TC: The team inspected five roads above namely: Dr. Aprou Akol, Dr. Obote, Kaguta, Opejo and Onaba which all received routine mechanised maintenance during Q1 and Q2

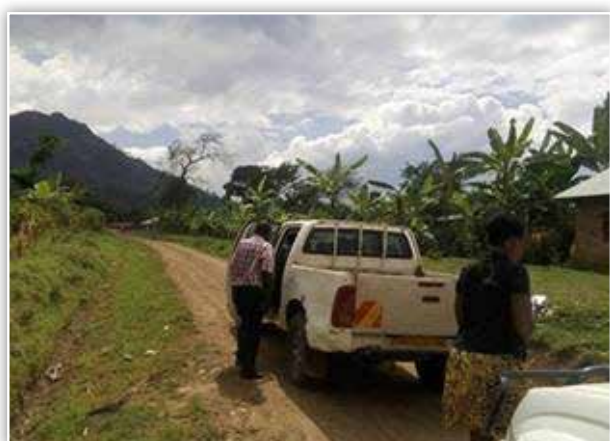
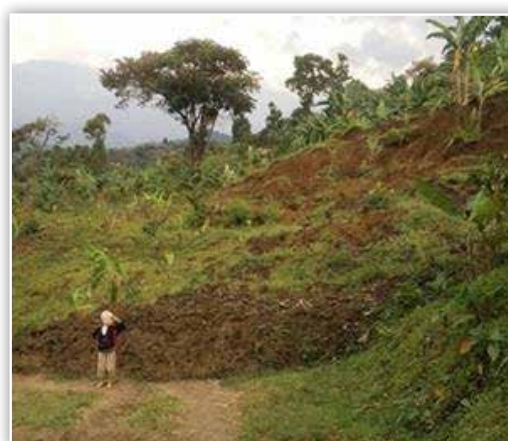
Sironko DLG: Inspection of Bugusege - Bunazami road. It received routine mechanised maintenance in Q1 & Q2 of FY 2015/16 but a section of around 500m of the road was washed away by landslides

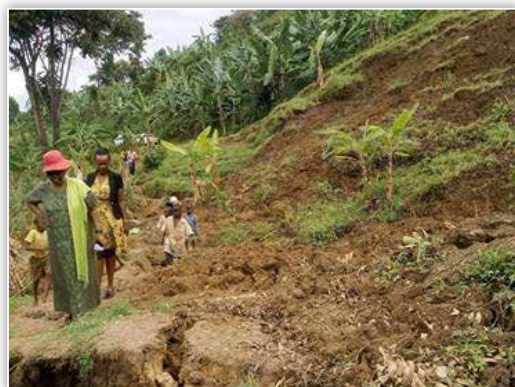
Sironko DLG: The team inspects sections of the 500m stretch that was washed away by landslides after heavy rains in the hills.

Bugusege – Bunazani Road (Fig 5.1 and 5.2) in Sironko District was among the road projects that benefited from Routine mechanised maintenance in Q1 and Q2 of FY 2015/16. Upon completion, the

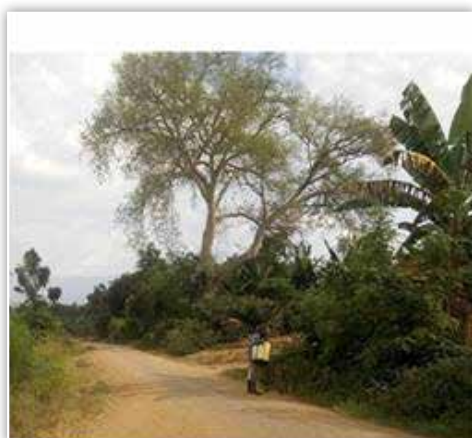
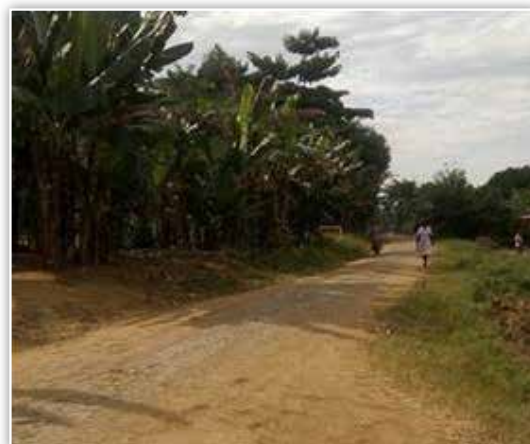
Sironko DLG: Sections along Elgon Road and Nangodi Road in Sironko and Budadiri Town Council respectively which received routine mechanised maintenance in Q1 and Q2 FY 2015/16

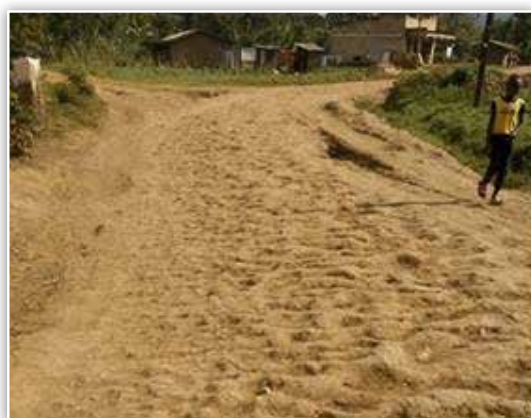
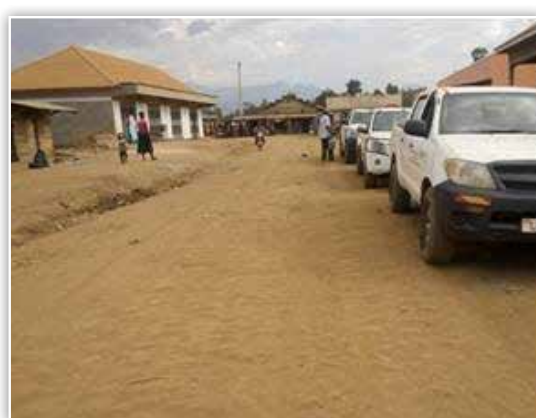
Figure 3.15: Photographs in Sironko District

Sironko DLG: Sections Maridadi road and Bishop Masaba Road in Sironko Town Council. The roads received routine mechanised maintenance in Q1 and Q2 of FY 2015/16

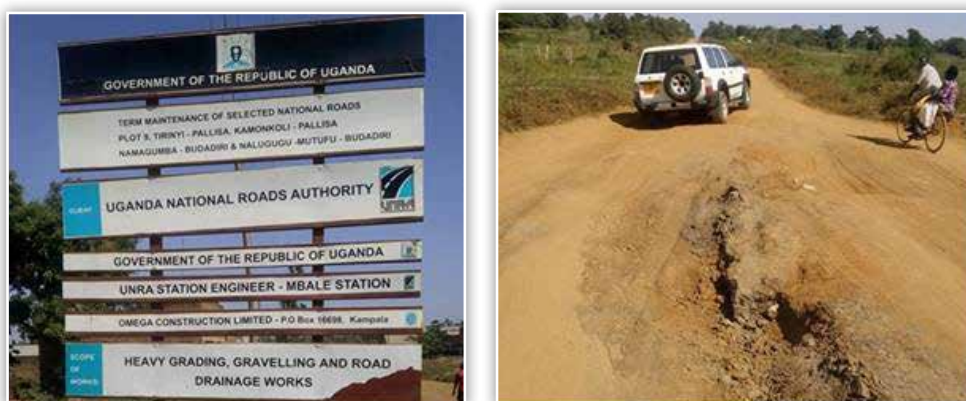
Pallisa DLG: Inspection of Tirinyi – Pallisa and Kamonkoli – Pallisa road both under Term Maintenance by OMEGA Construction Company Ltd during 2015/16

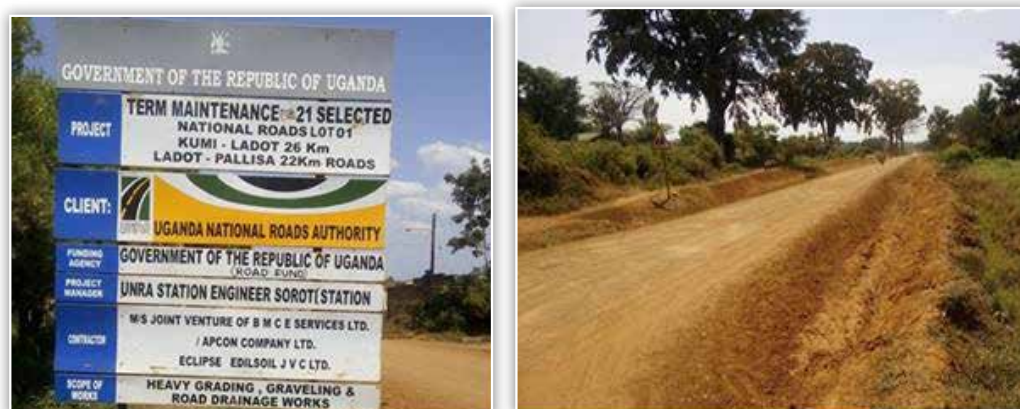
Pallisa DLG: Inspection of Pallisa – Ladot – Kumi road both under Term Maintenance by BMC Services/ APCON/ECLIPSE Ltd during 2015/16

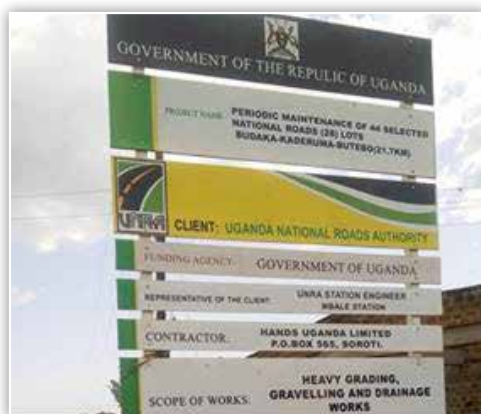
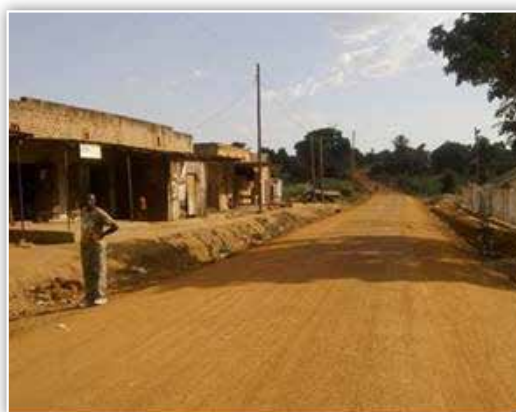
Pallisa DLG: Inspection of Budaka – Kaderuma – Butebo road Periodic Maintenance by HANDS Uganda Limited

The team also inspected periodic maintenance works on Budaka – Kaderuma – Butebo road which is under Mbale UNRA station. The Contractor was fully on site and the works were progressing satisfactorily. The Contractor had gravelled up to 70% of the 21.7km road stretch.

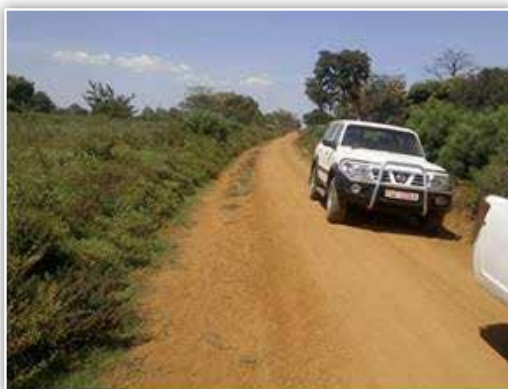
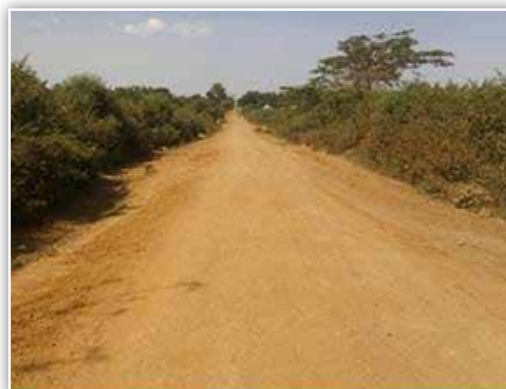
Pallisa DLG: Inspection of Pallisa – Agule road which received routine mechanised maintenance intervention under Pallisa DLG Q2 FY 2015/16

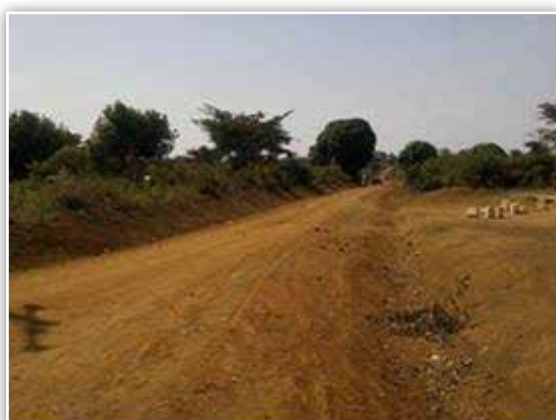
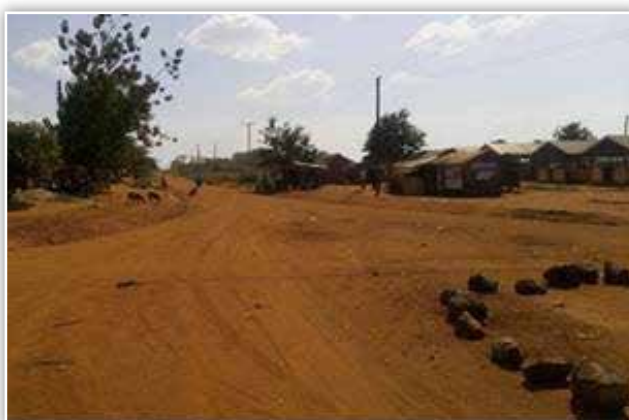
Pallisa DLG: Inspection of Ladoto - Butebo road which received routine mechanised maintenance intervention under Pallisa DLG Q2 FY 2015/16

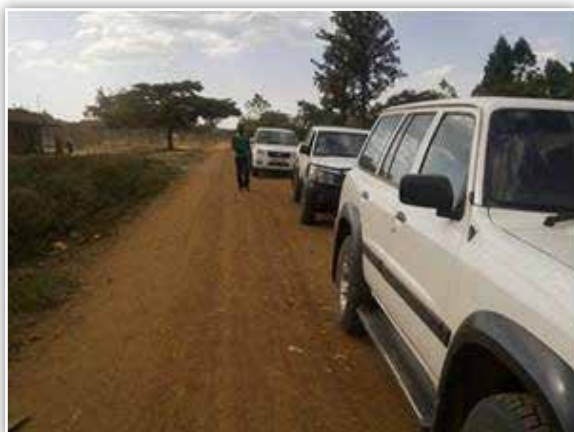
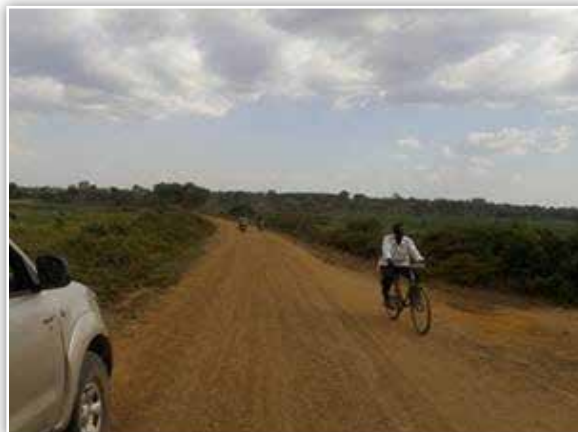
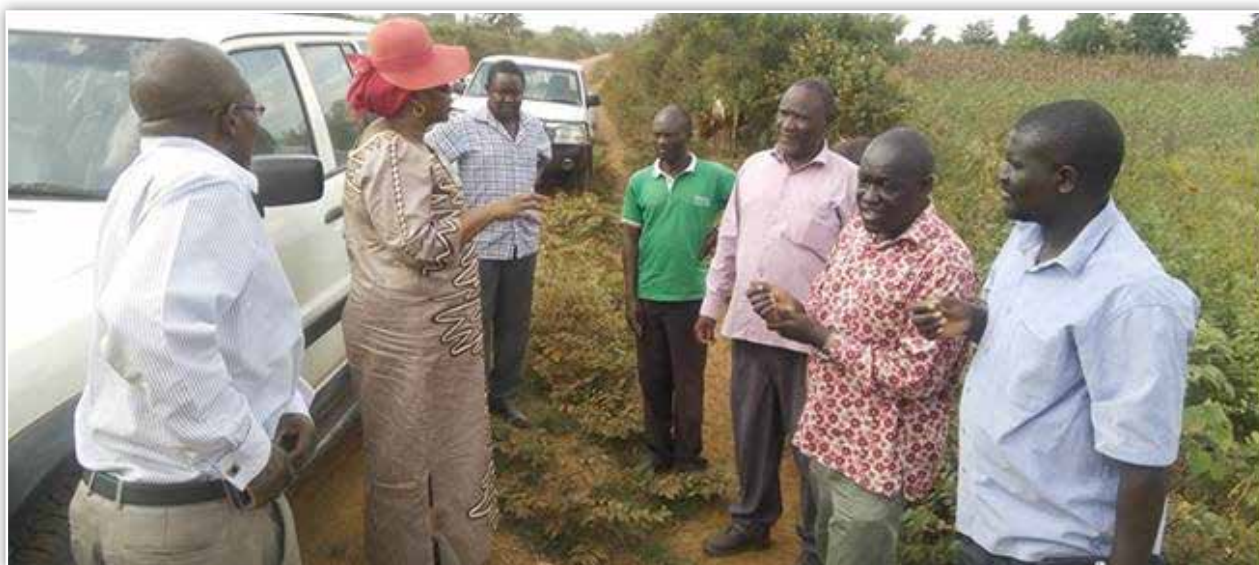
Figure 3.16 Photographs in Pallisa District

Pallisa DLG: Inspection of Agule-Kameke - Ladoto road which received routine mechanised maintenance intervention under Pallisa DLG Q2 FY 2015/16

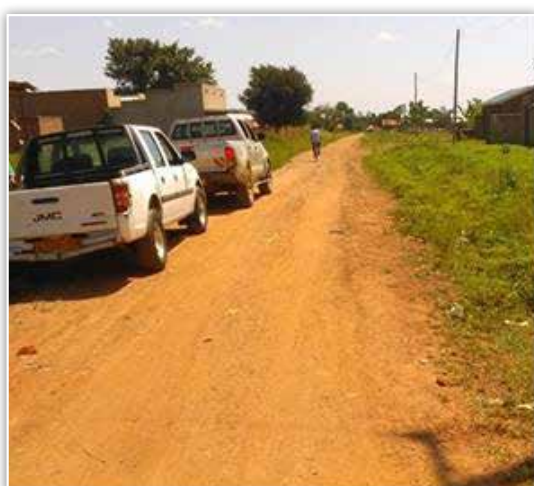
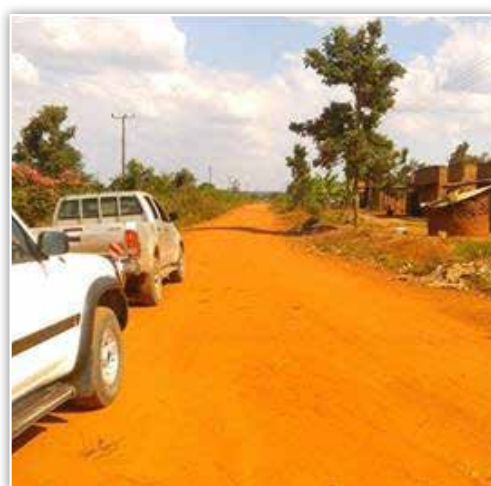
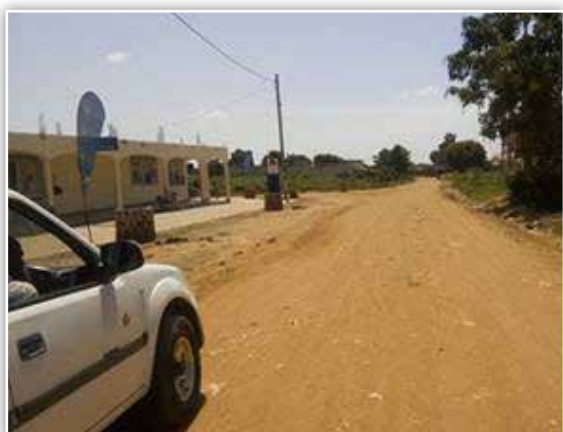
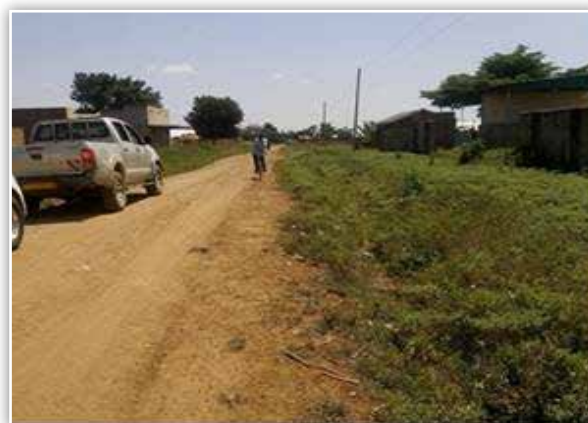
Pallisa TC: The team inspected five roads above namely: Omaido, Kaguta, Okaude, Anguria and Mutembe roads which all received routine mechanised maintenance during Q1 and Q2

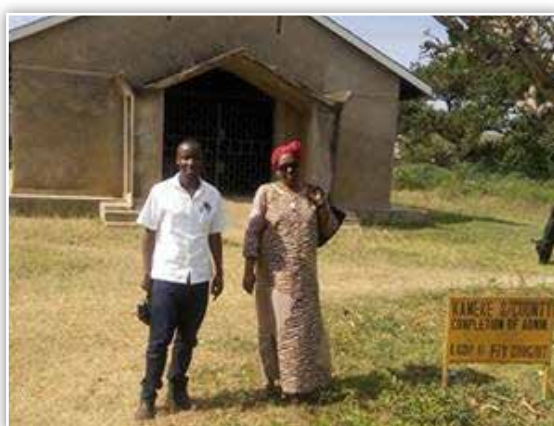
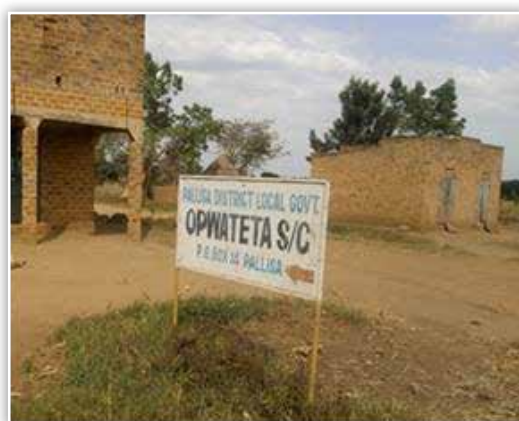
Pallisa DLG: The team leader visiting Kameke and Opwateta SC in Pallisa District, at both sub counties works had not commenced and the offices were found deserted

The monitoring team visited the sub counties of Kameke and Opwateta but the offices were deserted with no noticeable activities. Majority of the sub counties had not yet carried out the physical works.

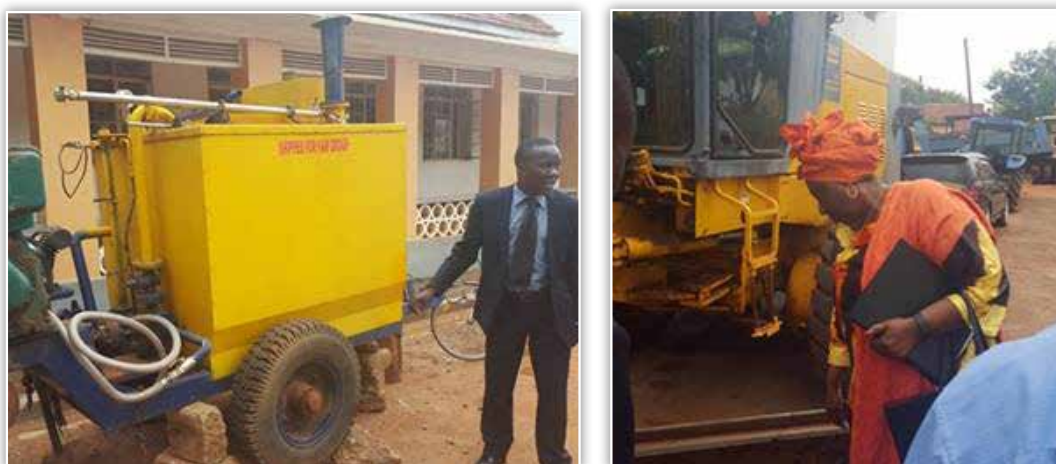
Mbale MC: Inspection of FAW equipment at the Municipal yard – the Unit of Bitumen Distributor was delivered faulty and had never been used by the Council.

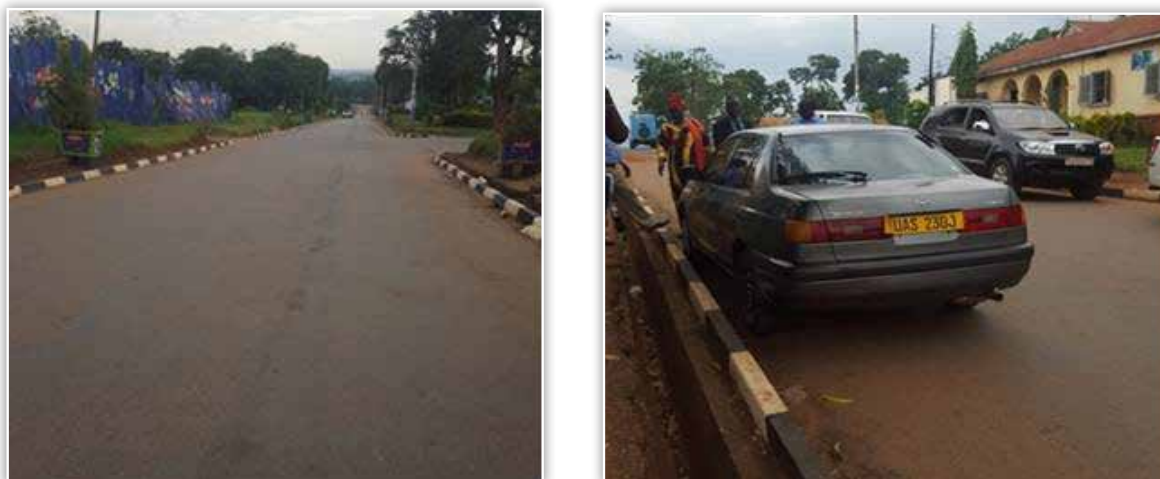
Mbale MC: Inspection of Majanga Road – the 0.4km section of the roads was upgraded to bituminous standard during Q1 and Q2 of FY 2015/16

- Majanga road was upgraded to bituminous surface using force account, a section of 0.4km was upgraded at cost of UGX 119.8m.

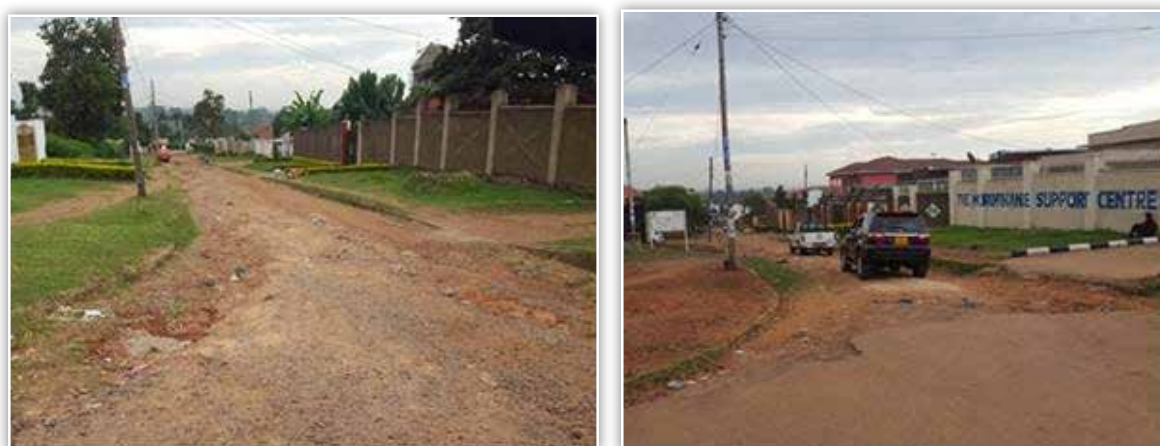
Mbale MC: Inspection of dilapidated roads in the Indian Quarters of Mbale MC – they are about 150m each covering up to 22km of roads in this dilapidated state and require reconstruction

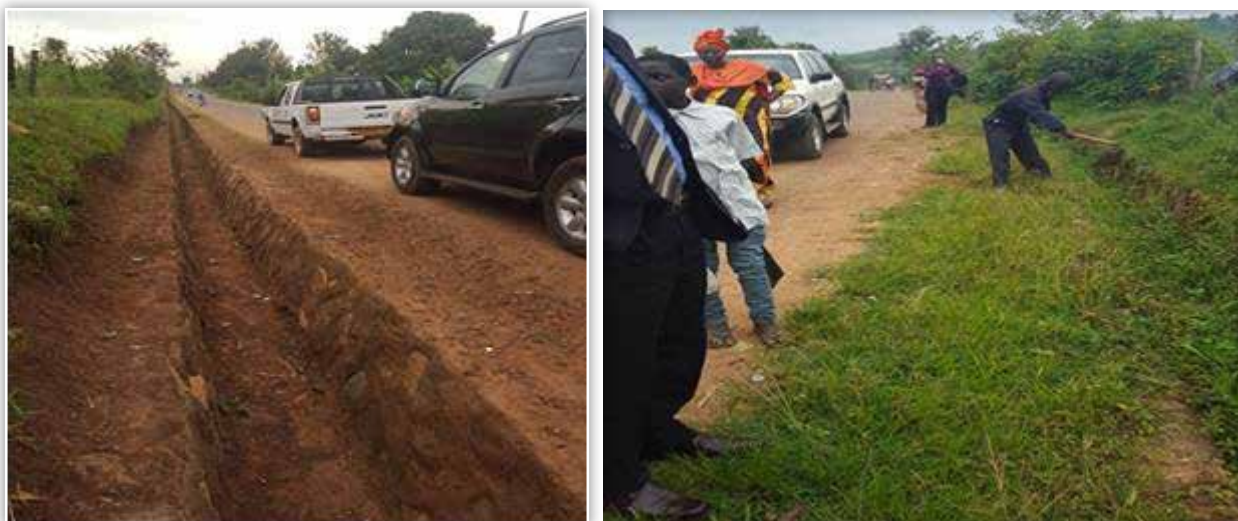
Mbale MC: Inspection of routine manual maintenance contractors carrying out grass cutting and de-silting of side drains of the Municipal network

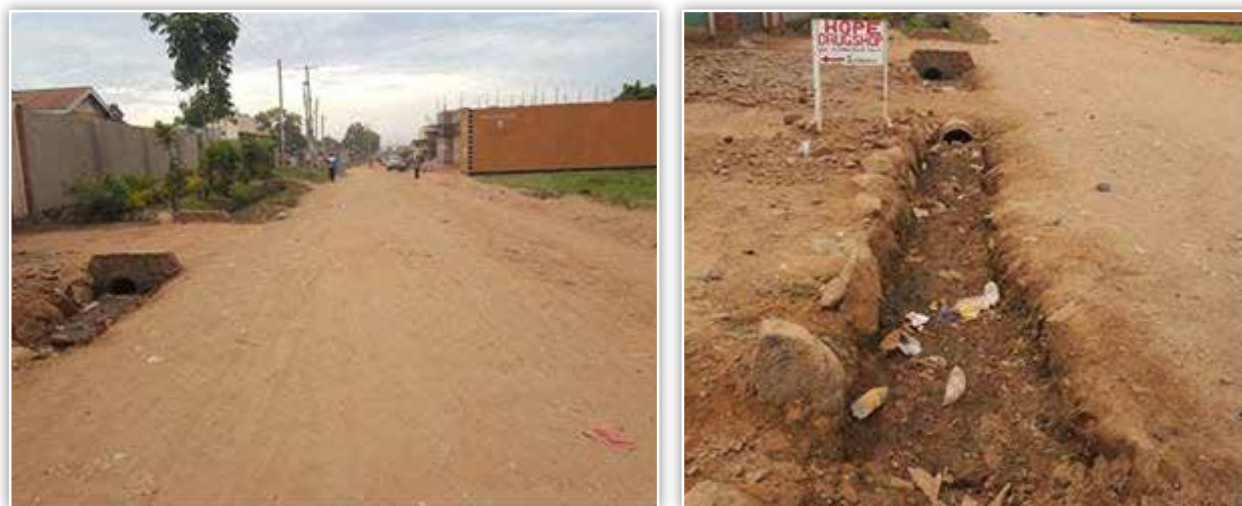
Figure 3.18 Photographs in Mbale Municipality

Mbale MC: Sections of Mutumba Road and Alice Kityo programmed for gravelling in FY 2015/16, the Municipal carried out shaping and grading during Q2.

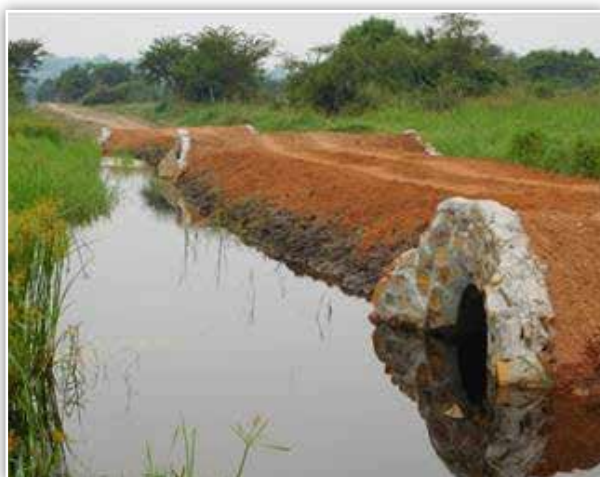
Lwengo district: Culvert crossings on swampy section of Bunyere-Kiryangoma-Nkunyu Rd.

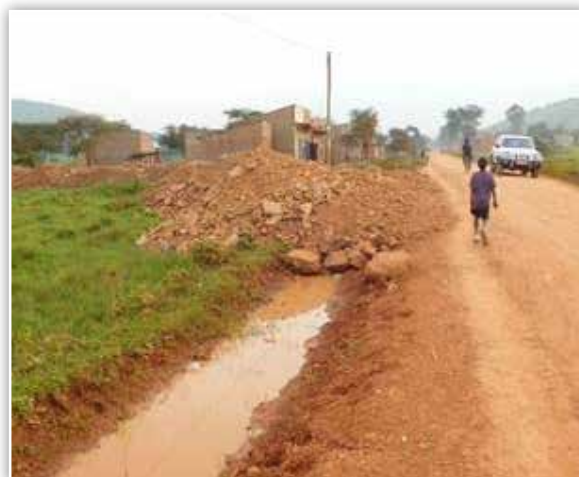
Figure 3.19 Photographs in Lwengo District

Lwengo district: Building materials dumped in side drain along Bijjaba Road which was undergoing routine mechanised maintenance.

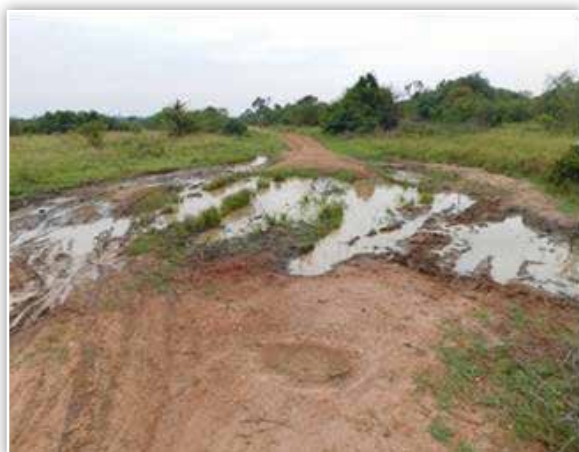
Nakaseke district: A flooded section on Rwamahungu – Kakoona road planned for reshaping, gravelling and culvert installation under RMeM.

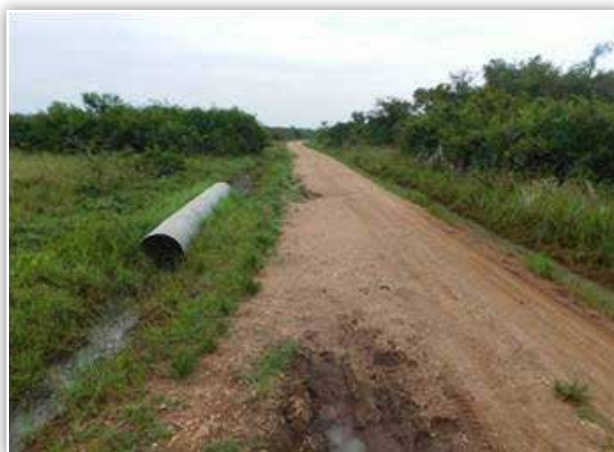
Figure 3.20: Photographs in Nakaseke District

Nakaseke district: An ARMCO culvert lies seemingly abandoned pending more favourable weather to be installed on a low lying section of Rwamahungu – Kakoona road.

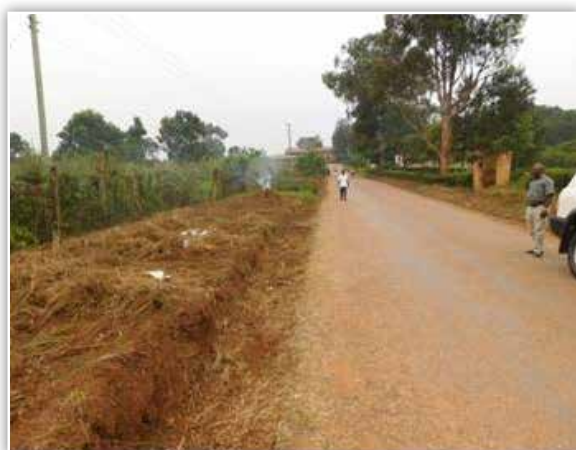
Masaka MC: Bush clearing on Church Road under Routine Manual Maintenance

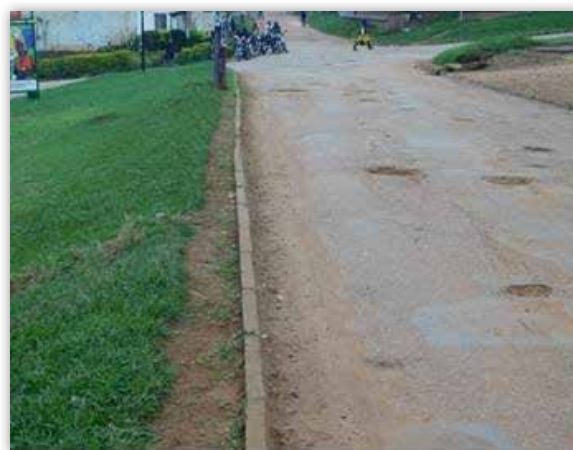
Figure 3.21: Photographs in Masaka Municipality

Masaka MC: Grass clearing and grubbing on Hobbart street under Routine Manual Maintenance.
