ROAD MAINTENANCE MONITORING REPORT

QUARTER 1-2 FY 2015/16 (July – Dec 2015)

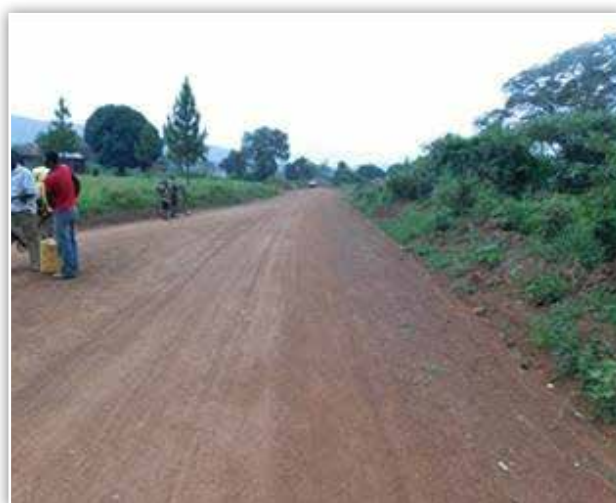
Kiboga district: Lwamata – Kambuggu (20km) one of the district roads that was graded under RMeM.

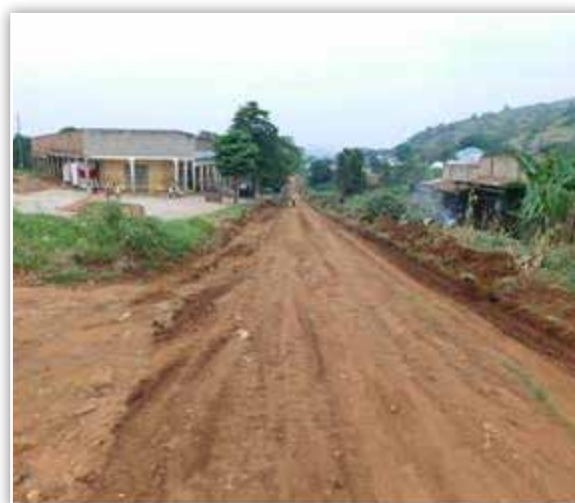
Figure 3.22: Photographs in Kiboga District

Kiboga district: Emergency works on 2nd Street under Kiboga Town Council
