ROAD MAINTENANCE MONITORING REPORT QUARTER 3 (July 2012 – March 2013) – FY 2012/13

APRIL 2013

This is a monitoring report of road maintenance programmes funded by URF in FY 2012/13 covering the period July 2012– March 2013.

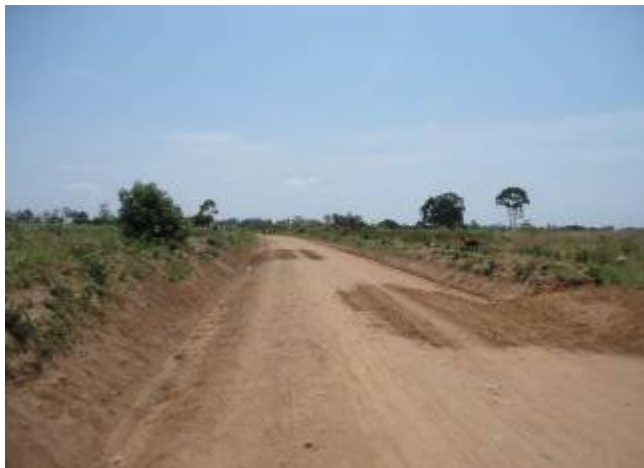
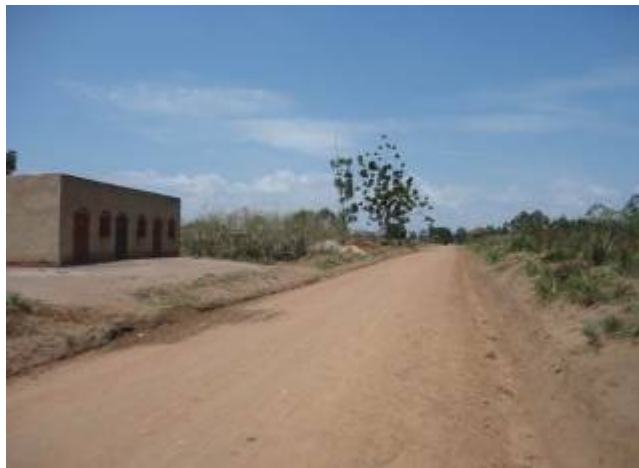
Arua – Bileafe – Otrevu road (36km) which is 10m wide is part of the additional network which traverses the sub counties of Orunko, Riki and Bileafe sub counties in Arua district. At the time of the visit, the road was receiving both routine manual and mechanised maintenance by labour based contractors and force account respectively. Planned works on the road included grass cutting, grading and shaping, spot gravelling and drainage improvement that had commenced in January 2013. Grading and shaping works had been done on only 16km with limited drainage improvements. The graded section required urgent drainage works such as off shoot excavation, installation of scour checks and side drain cleaning. The road was still in fair condition.

UNRA Arua: Completed sections of Arua – Bileafe – Otrevu road maintained in Q2, FY 2012/13 using force account

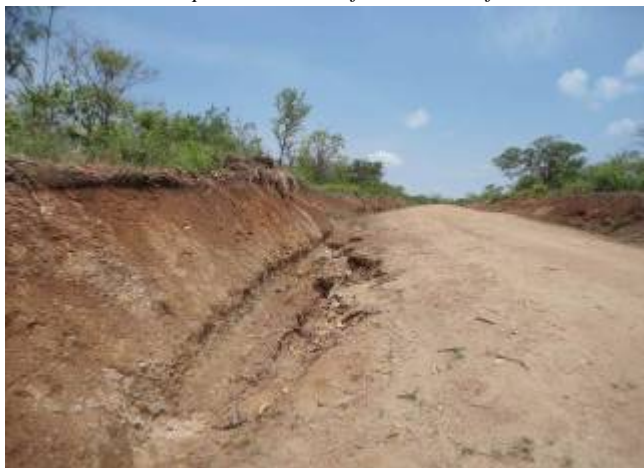
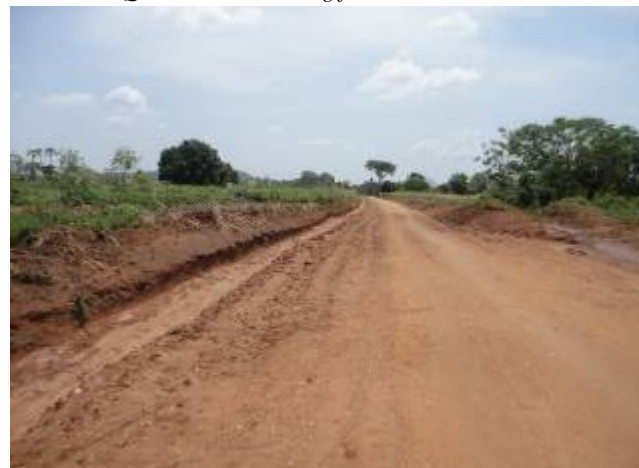
UNRA Arua: Completed sections of Arua – Bileafe – Otrevu road that require drainage protection

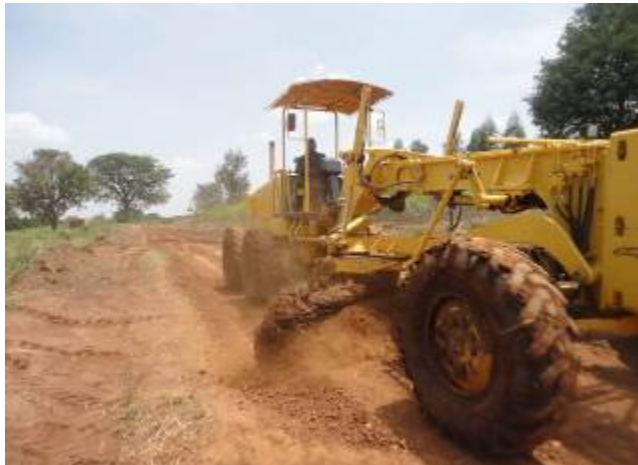
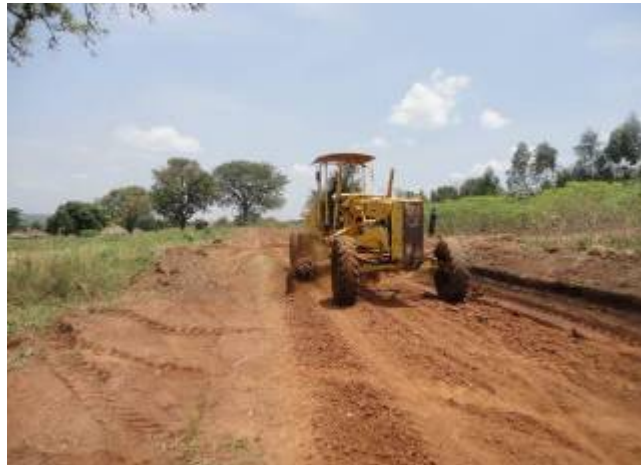
UNRA Arua: Works in progress on Arua – Bileafe – Otrevu road under force account

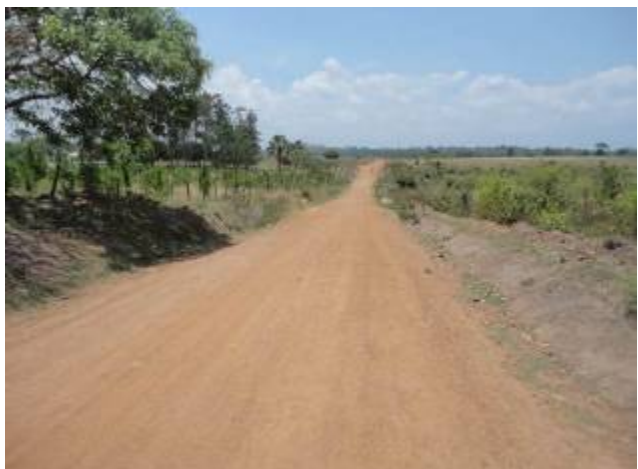
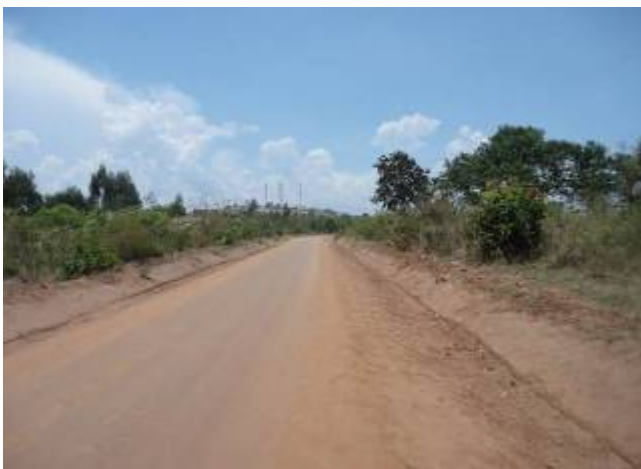
Arua – Muni PTTC- Eruba road (6km) which is 9m wide is part of the additional network that was upgraded to national roads in FY 2009/10. At the time of the visit, the road had received mechanised maintenance by force account. Planned works on the road included grading and shaping, spot gravelling and drainage improvement that had commenced in January 2013. Most of the planned works had been executed and the road was in good condition.

UNRA Arua: Completed sections on Arua – Muni PTTC- Eruba road (6.0km) maintained in Q2, FY 2012/13 using force account.

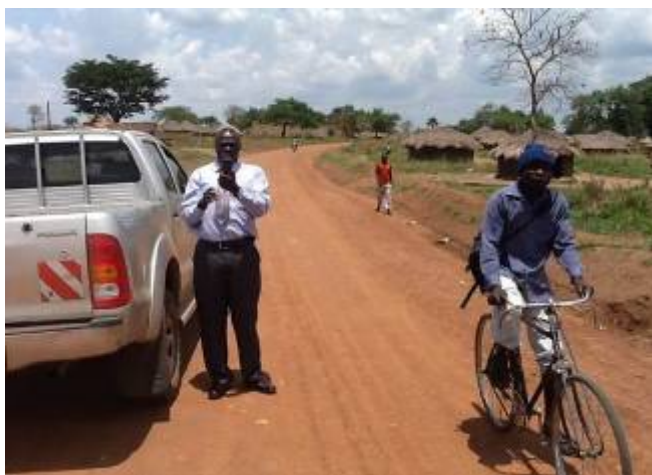
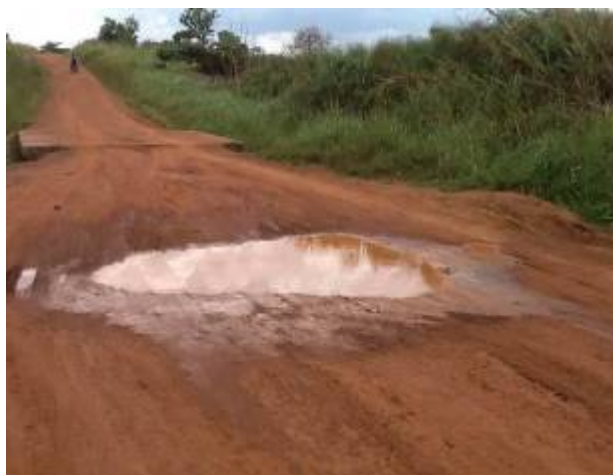
UNRA Gulu: Gulu- Olwiyo road under term contract (L); The whole stretch has been graded and shaped and a spot (R) at chainage 4.000 from Gulu UNRA station on katikati-Nwoya to be worked on in Q4.

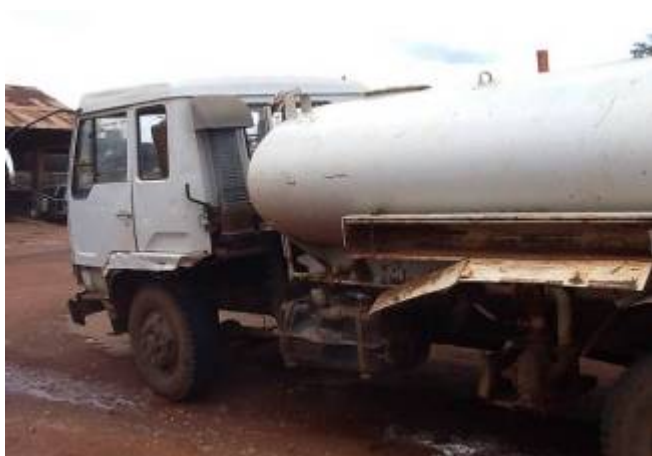
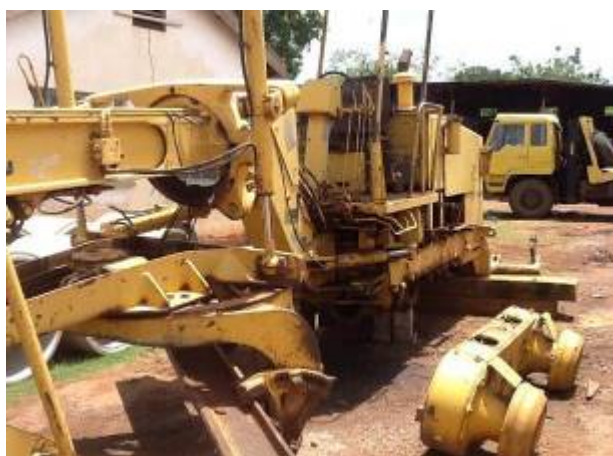
UNRA Gulu: Grounded water bowser(L) at Gulu UNRA station under repair and Overhauled grader (R) in sorry state under repair at Gulu UNRA Station

- A good number of plant and equipment were either very old and inefficient or non-functional See photos above;
- Understaffing was also observed as a big impediment to the implementation of planned activities;

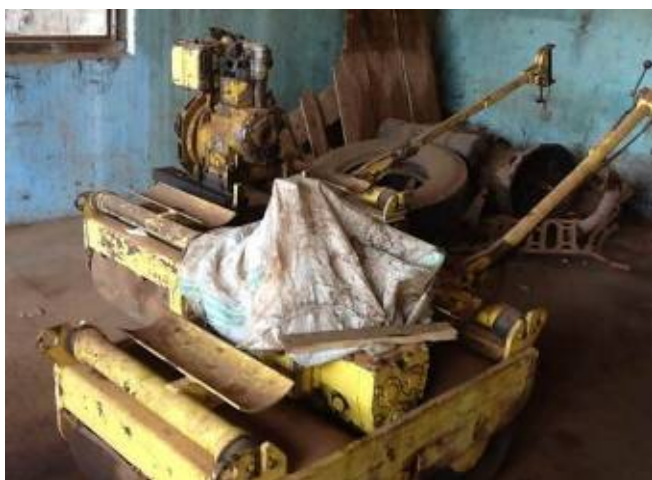
UNRA Gulu: Pedestrian roller under repair at Gulu UNRA Station

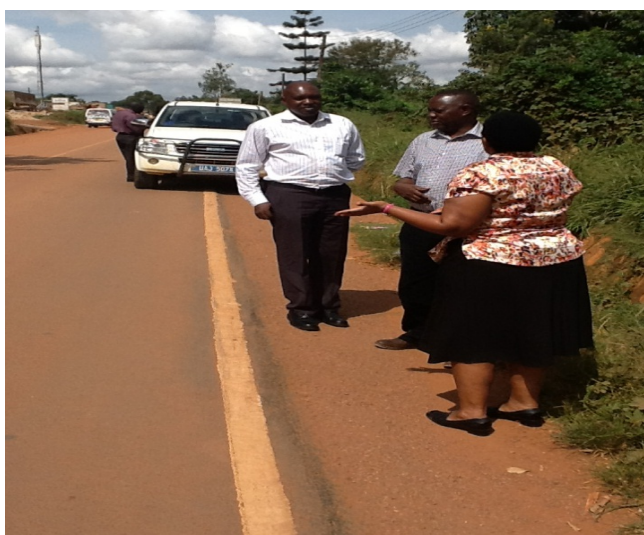
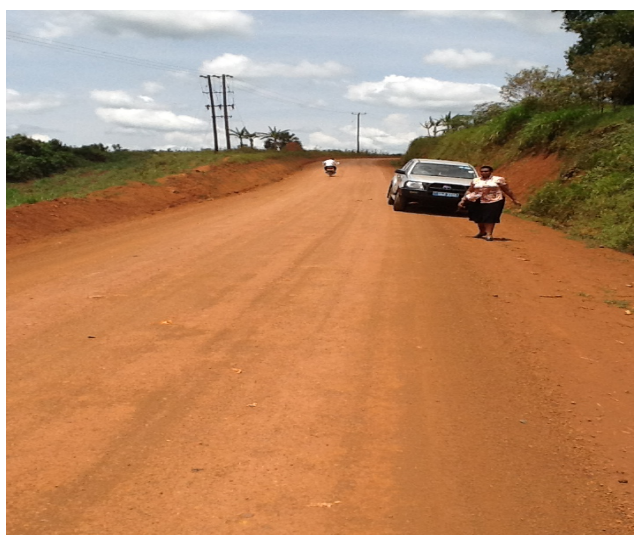
UNRA Kampala: Eng. Matovu, Mr Semugoma and Ms. Lutaaya at the end of the tarmac section on Kireka – Namugongo Road (L). Note the overgrown drainage channels. Multiplex abandoned the works 6 months ago and the regravelled Lugazi to Buikwe Road in very good condition – could achieve over 90kph (R).

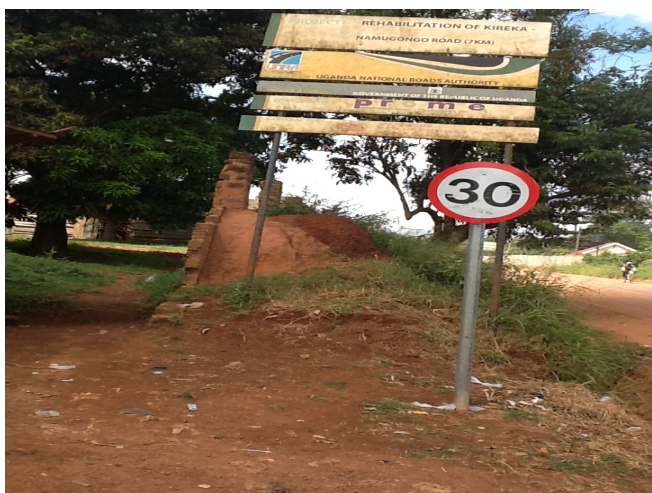
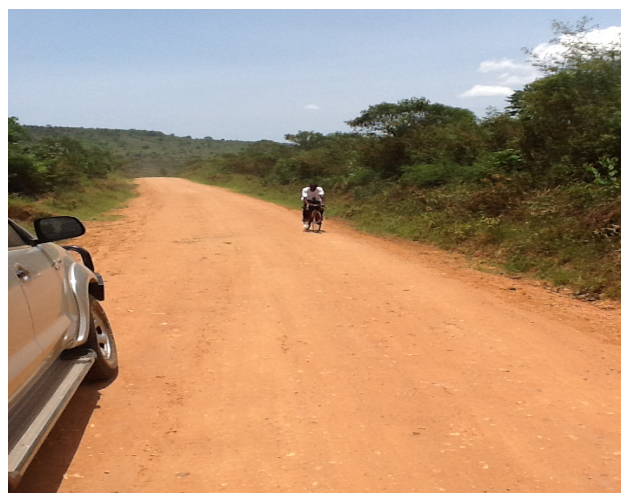
UNRA Kampala: Project signboard for Kireka – Namugongo Road – Consultant is PROME (L) and Regravelled Buikwe to Kiyindi Road in good condition but no side drains and/or mitre drains in some sections (R).

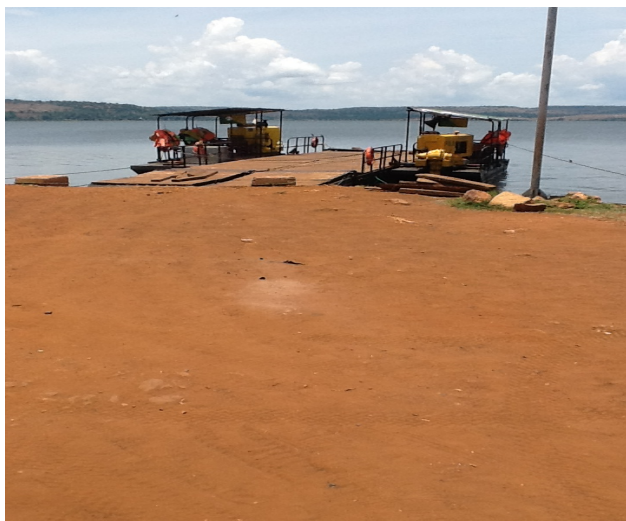
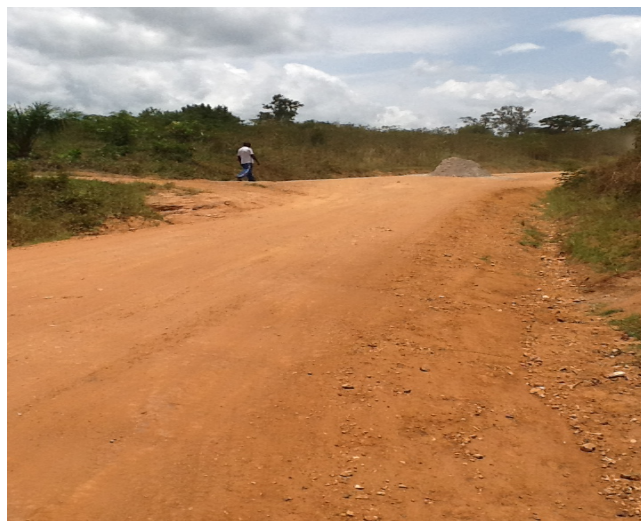
UNRA Kampala: Ferry at Kiyindi Landing site (L) and Kisoga - Nkokonjeru – Najja with sand dumped in the middle of the road!(R).

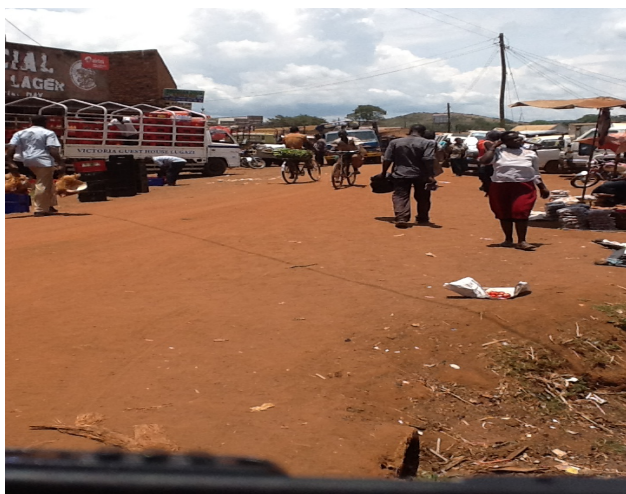
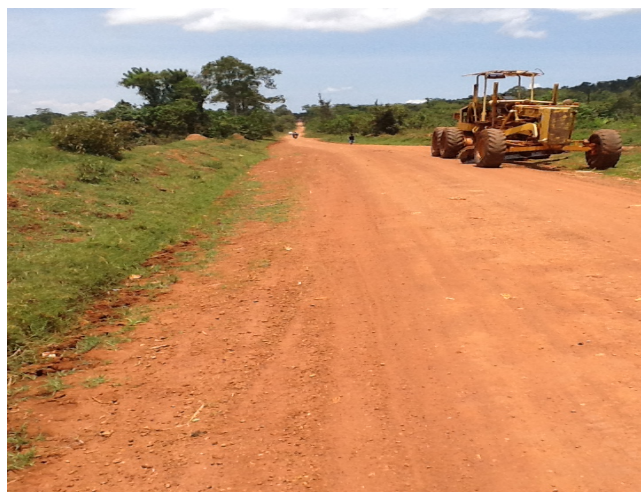
UNRA Kampala: Trading centre at Kiyindi Landing site (L) and Grading of Kisoga - Nkokonjeru – Najja Road (R).

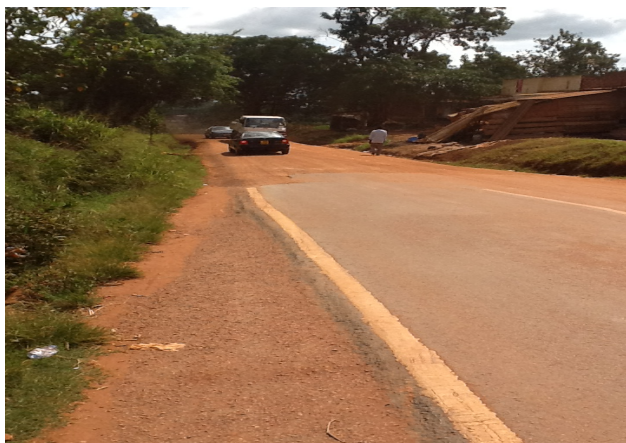
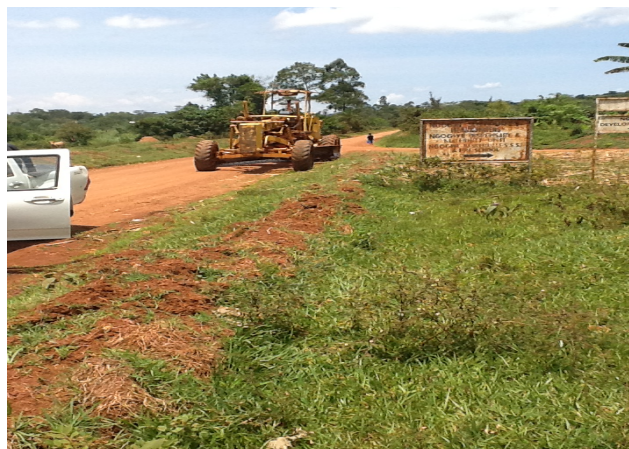
UNRA Kampala: End of tarmac on Kireka to Namugongo Road (L), the road needs upgrading to bitumen standard given the high volumes of traffic and grading at Ngogwe; Raising and Swamp filling required (R).

4.	Kampala station has many heavily trafficked gravel roads.	Maintaining heavily trafficked gravel roads is a false economy	It is recommended that they are upgraded to bitumen standard due to the heavy gravel

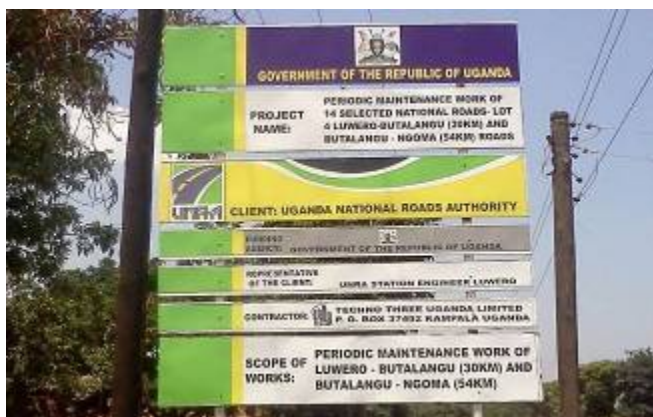
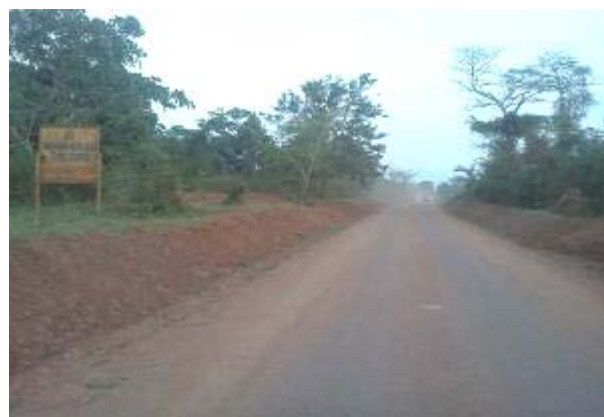
The Contractor had as at the time of monitoring graded and shaped 39km (46.4%) out of the 84km, they had not done any gravelling but were still progressing with works. Below is the pictorial representation of the works done to date and on-going activities at the site.

UNRA Luwero: Sign Post (L) erected for PM works of Luwero – Butalangu - Ngoma road – BUT doesn't not recognize URF as the funding agency; The UNRA station Engineer and Contractor were advised to correct the anomaly and Luwero – Butalangu - Ngoma road (R)– recently graded and shaped section

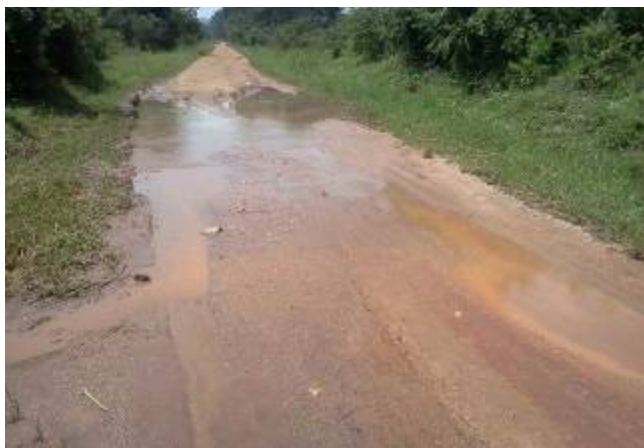
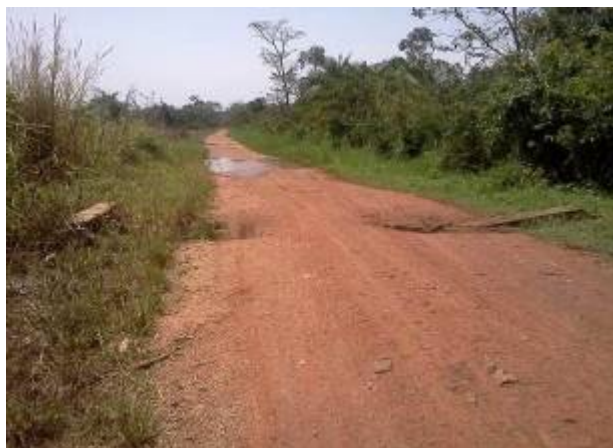
UNRA Luwero: Sections along Kalule – Bowa – Nakaseke - Kiwoko (37km) which was planned for RMeM in FY 2012/13 and has not received any intervention to date.

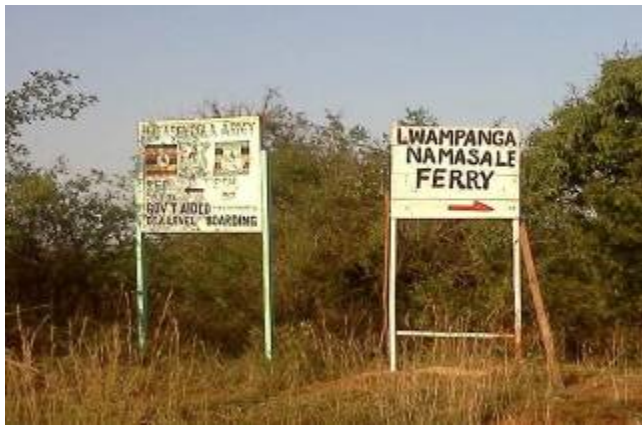
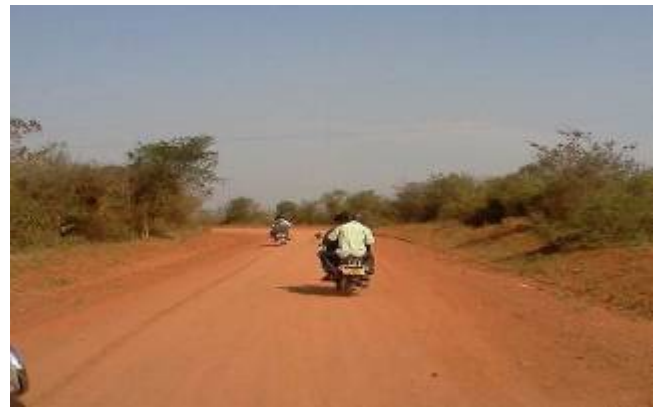
UNRA Luwero: Sections along Nakasongola – Lwampanga - Zengebe (30km) which was worked on using Force Account in Q1 and Q2 of FY 2012/13, was well graded, shaped and had a very smooth ride.

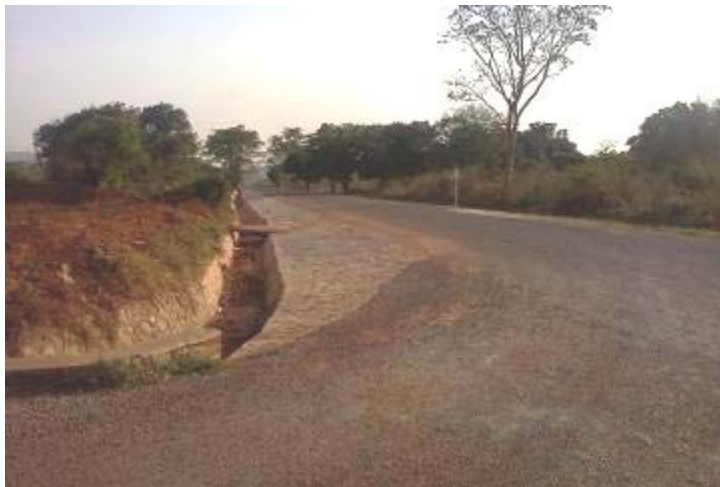
UNRA Luwero: Nakasongola loop + Airbase (20km) – the road was newly constructed and only requires off-pavement manual maintenance. Though a budget of UGX 50.0m was set aside for on-pavement works during FY 2012/13.

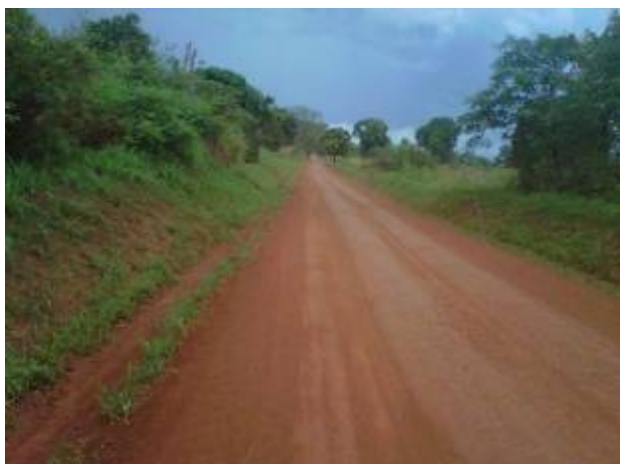
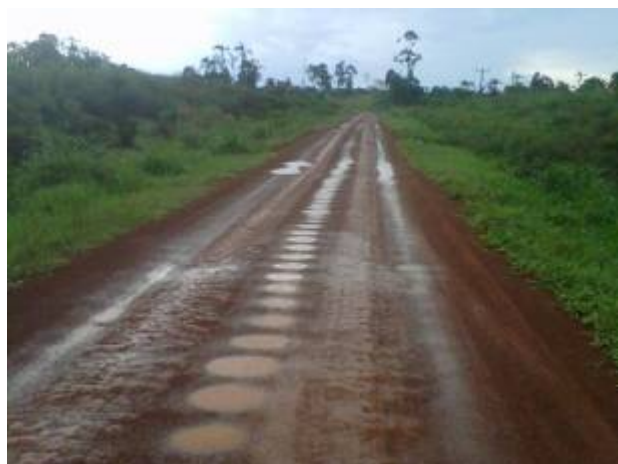
UNRA Masindi: Sections of Masindi – Kisalizi (Hoima Bdr) road maintained by contract that completed in Q2 FY 2012/13

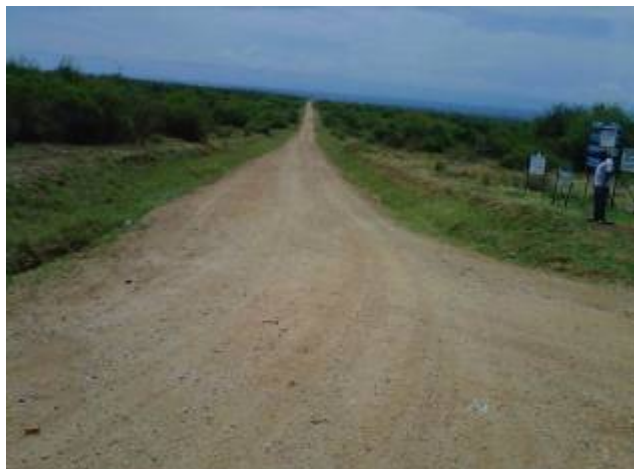
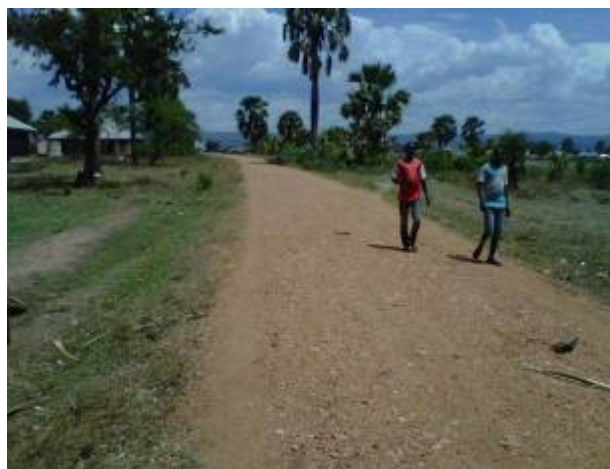
UNRA Masindi: Sections of Bukumi - Butiaba road maintained in Q1& Q2, FY 2012/13 using force account

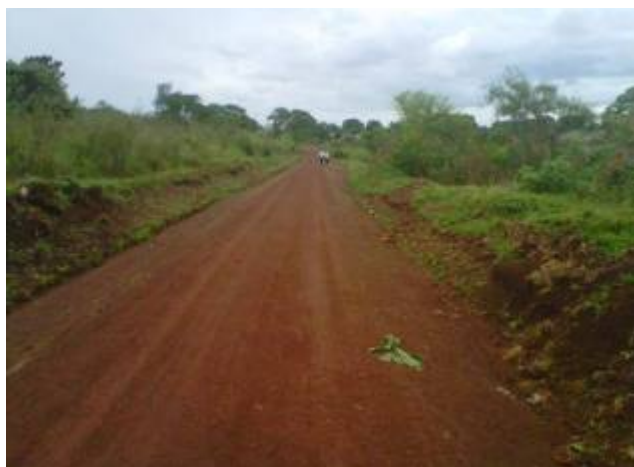
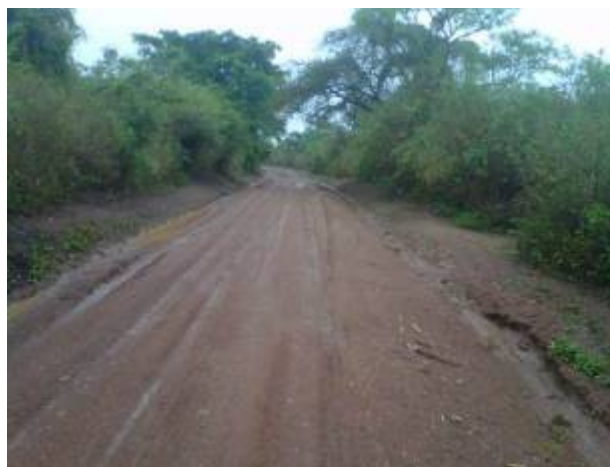
UNRA Masindi: Sections of Ihungu - Bulyamusenyu road maintained where maintenance was in progress using force account

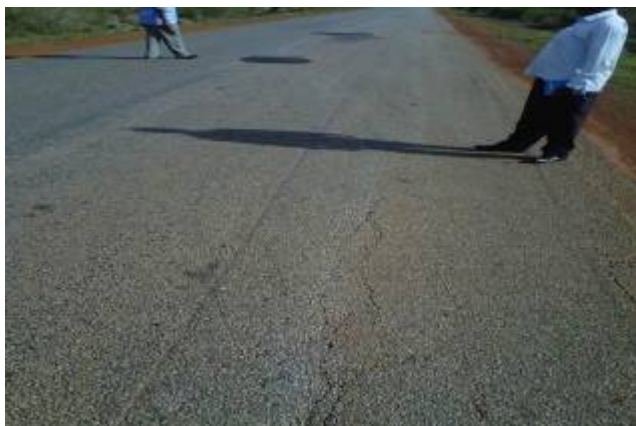
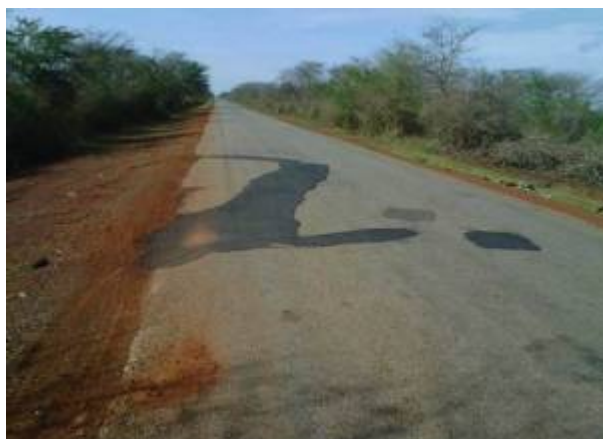
UNRA Masindi: Sections of Kafu – Kigumba road showing surface cracking and deferential settlement (L); Pothole patching (R)

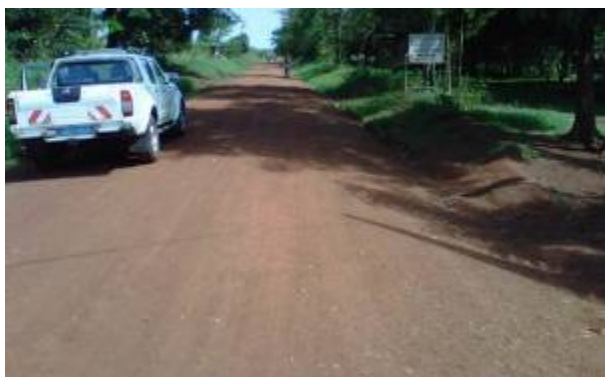
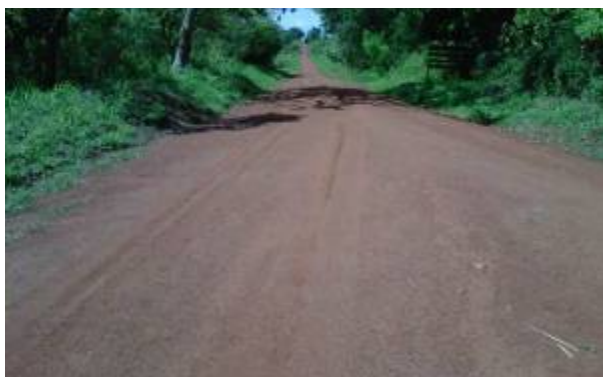
UNRA Masindi: Sections of Kisanja – Park Junction maintained in Q2, FY 2012/13 using force account

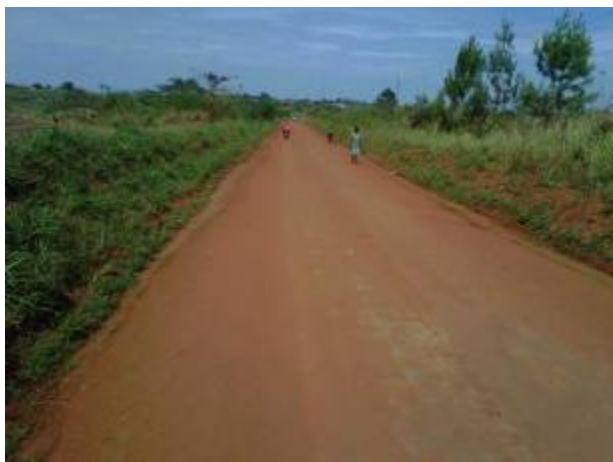
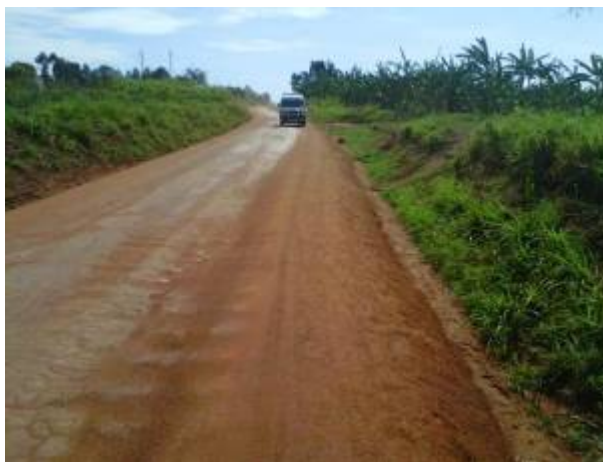
UNRA Masindi: Sections of Masindi – Kigumba road maintained in Q1 & Q2, FY 2012/13 using force account

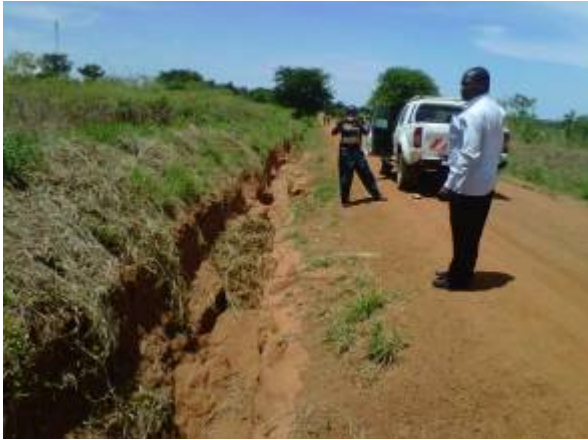
UNRA Masindi: Sections of Bulisa – Park Junction road showing heavy scouring in side drain (L); loose riding surface (R)

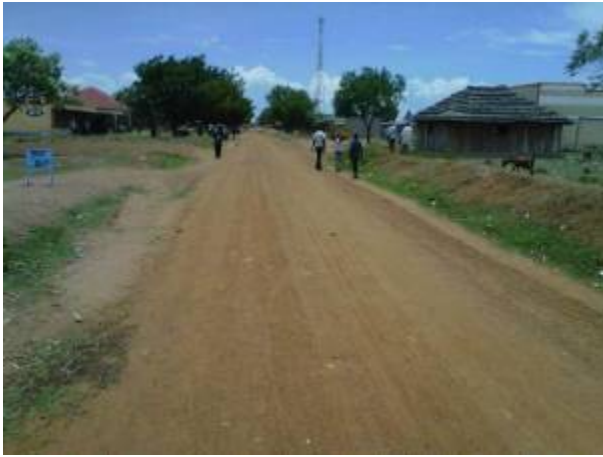
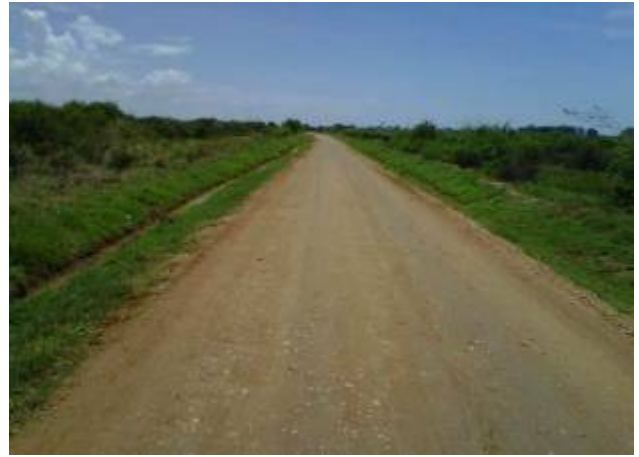
UNRA Masindi: Sections of Bukumi – Bulisa – Wanseko road maintained in Q1 & Q2, FY 2012/13 using force account

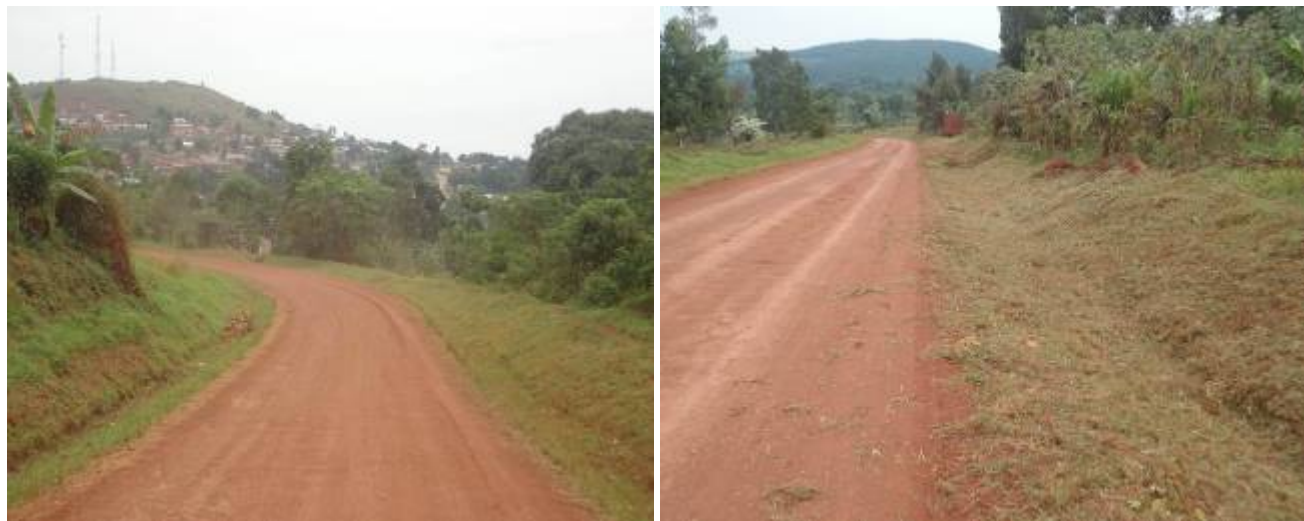
Mpigi loop (2.5km) which is a 6m wide unpaved road forming a loop from Masaka road to Mpigi town council offices and back to Masaka road. The team was informed that the road had undergone periodic maintenance in August 2012 involving full regravelling and drainage improvement works. At the time of the visit, the road was receiving routine manual maintenance by labour based contractors and was still in good condition.

UNRA Mpigi: Sections of Mpigi Loop undergoing routine manual maintenance in Q3, FY 2012/13

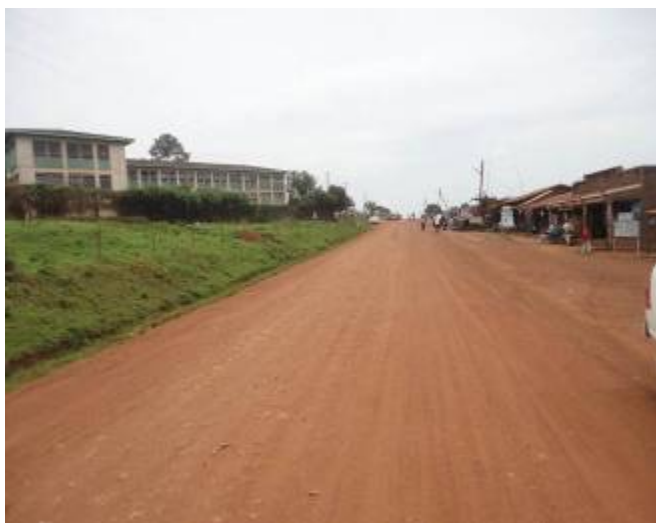
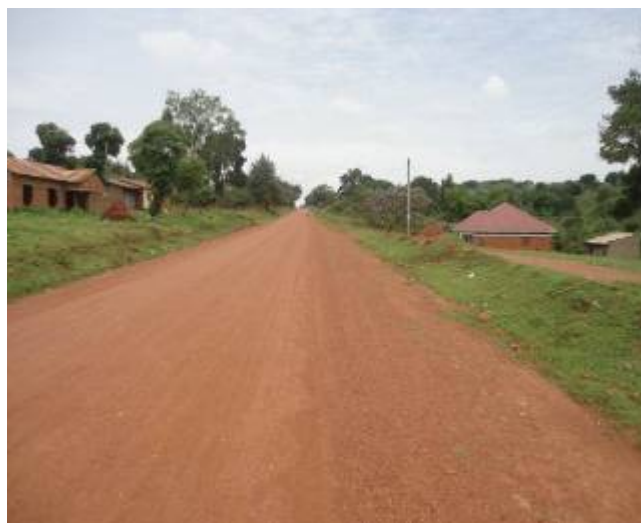
UNRA Mpigi: Sections on Mpigi - Gombe road (30km) graded and shaped in July 2012 using force account.

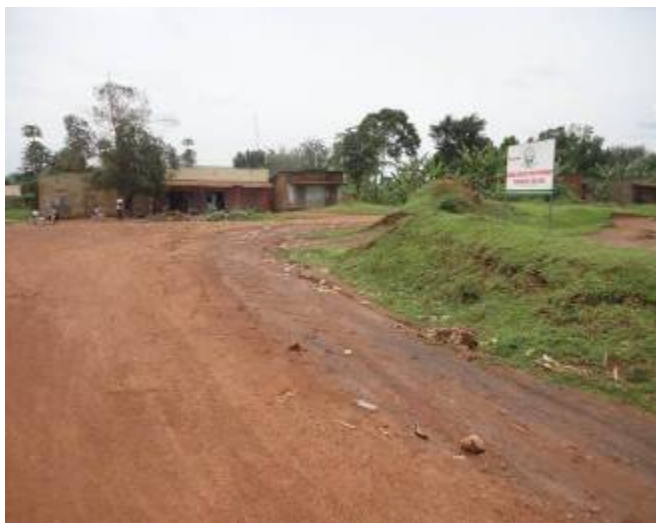
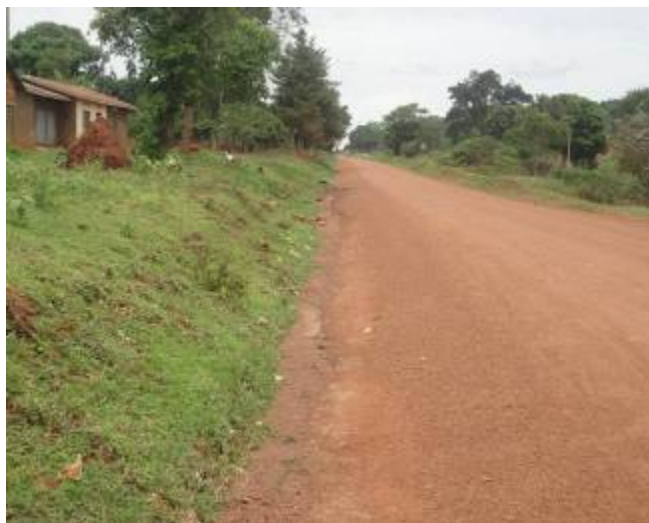
UNRA Mpigi: Sections on Gombe – Kinoni road (30km) requiring side drain protection works.

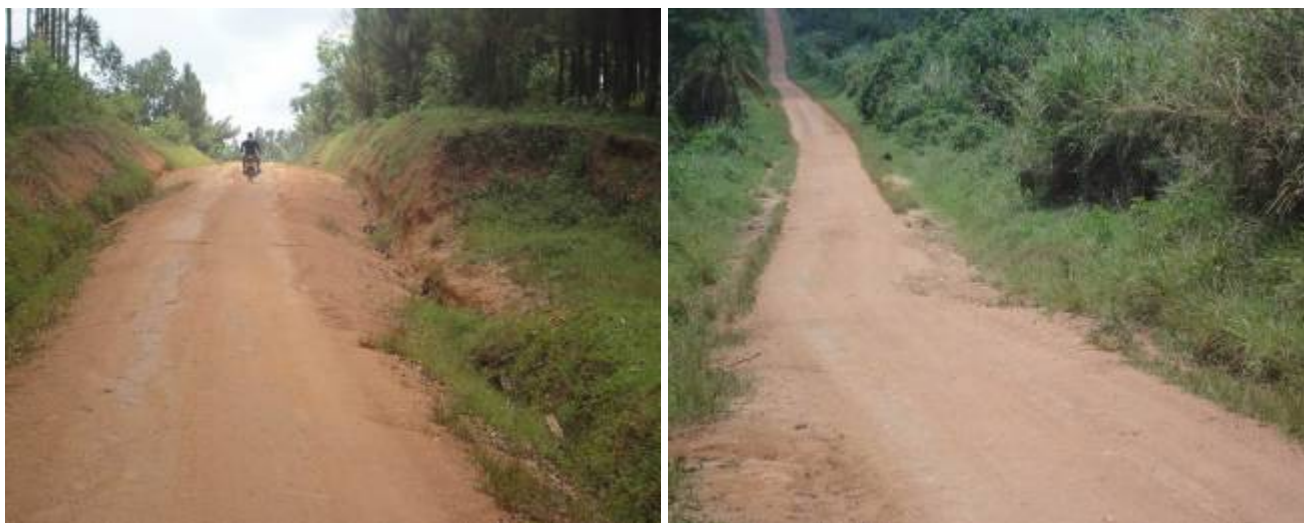
Kanoni – Mitala Maria (30km) is a gravel road that had also been earmarked for periodic maintenance during FY 2012/13. The contract for this road had been awarded to M/S Lambar Enterprises Limited but the contractor was yet to mobilise and commence the works. The road had received routine mechanised maintenance in July 2012 involving grading & shaping and spot gravelling (5.4km) and was still in fair condition. At the time of the visit, the road was undergoing routine manual maintenance using labour based contractors, however some sections required spot improvement to remove potholes and corrugations.

UNRA Mpigi: Sections on Mitala- Maria road (30km) that require spot improvement.

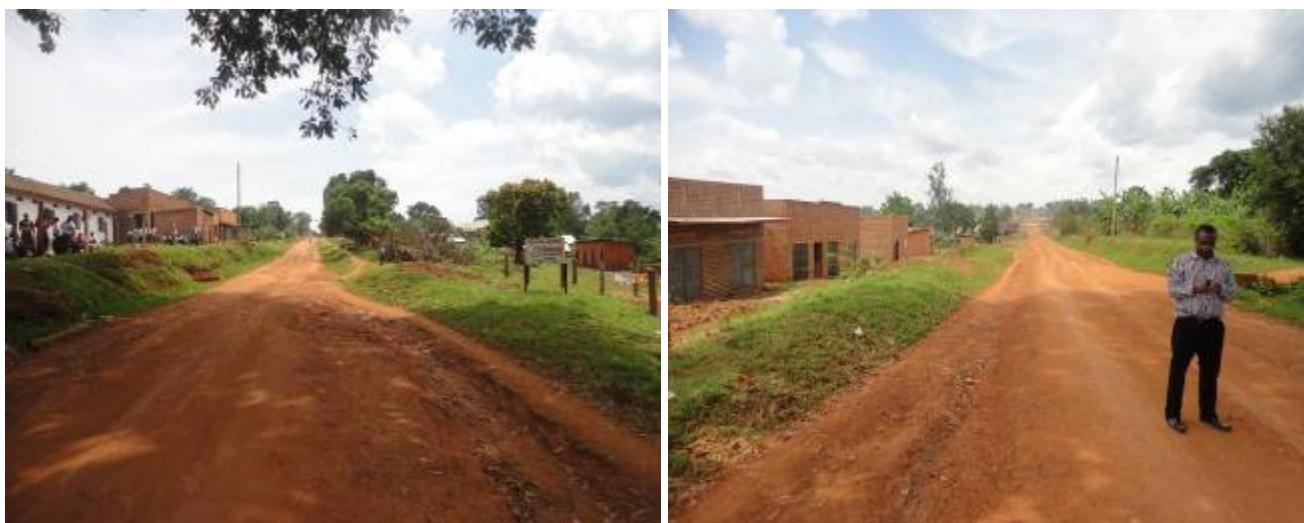
Mitala Maria loop (4.5km) is a gravel road that had also been earmarked for periodic maintenance during FY 2012/13. The contract for this road had been awarded to M/S Lambar Enterprises Limited but the contractor was yet to mobilise and commence the works. The road had also received routine mechanised maintenance in July 2012 involving grading & shaping works and was still in fair condition. At the time of the visit, the road was undergoing routine manual maintenance using labour based contractors, however some sections required spot improvement to remove potholes and scouring in the side drains.

UNRA Mpigi: Sections on Mitala- Maria loop (4.5km) that require spot improvement.

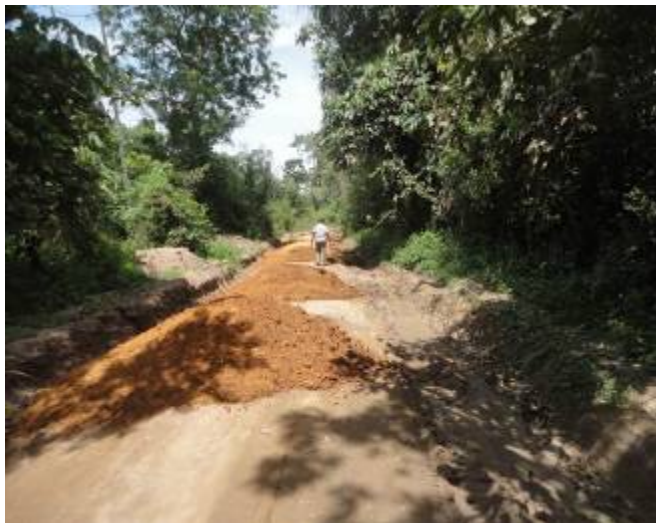
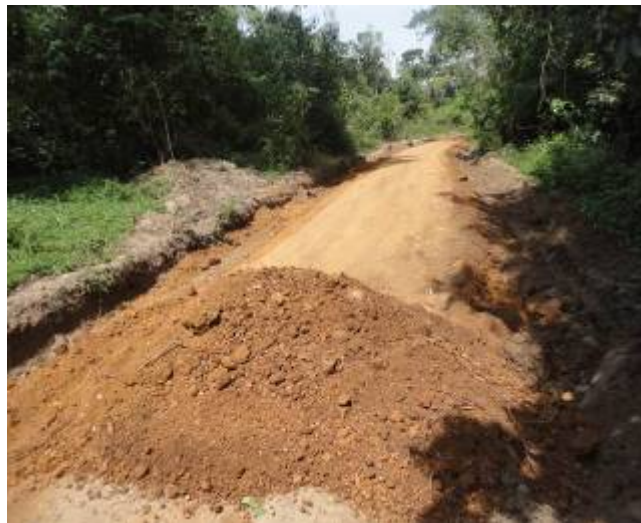
UNRA Mpigi: Gravelling works in progress on Lukolo- Bunjakko (13.5km) Ch 13+500.

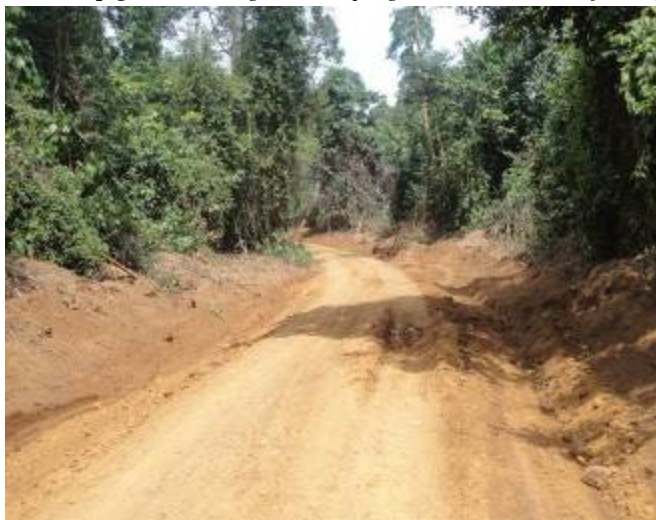
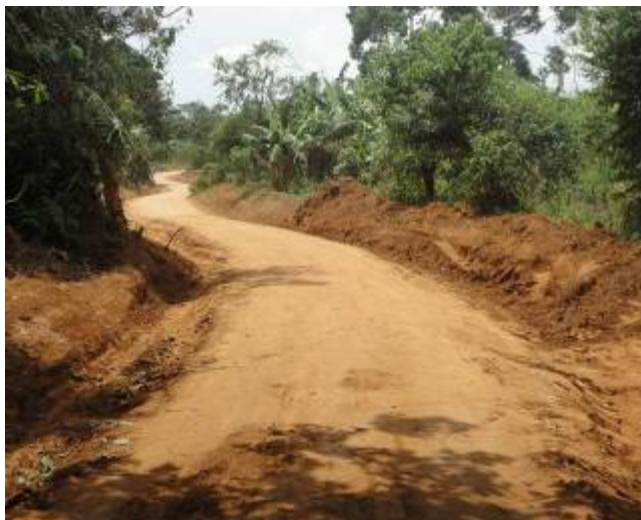
UNRA Mpigi: Some poorly compacted sections on and the very many dangerous corners on Lukolo- Bunjakko road (13.5km)

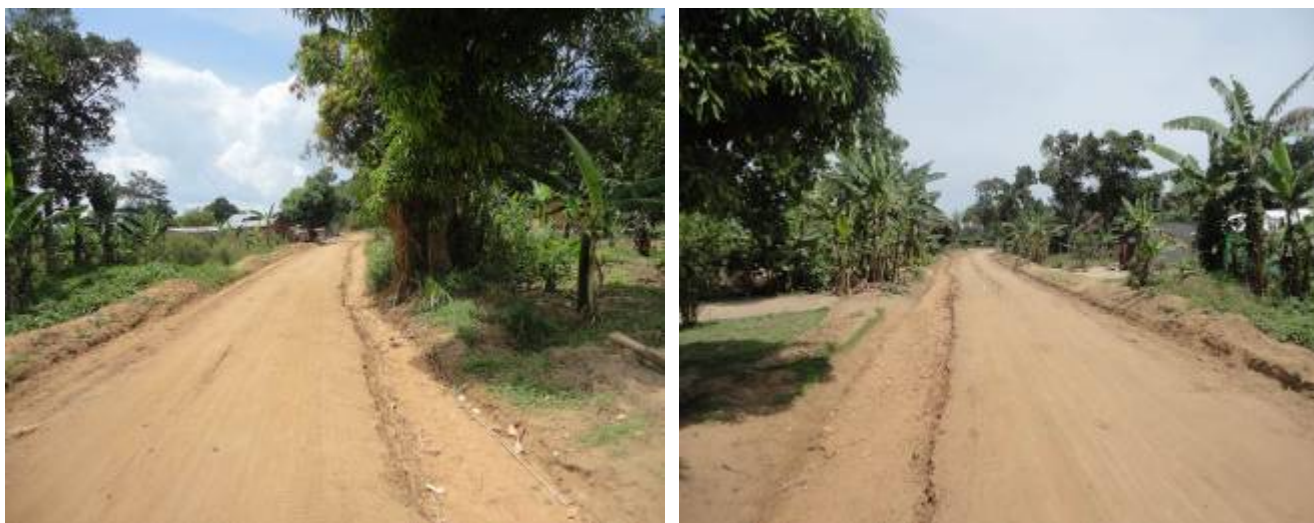
UNRA Mpigi: Sections on Lukolo- Bunjakko road (13.5km) that require side drain protection works.

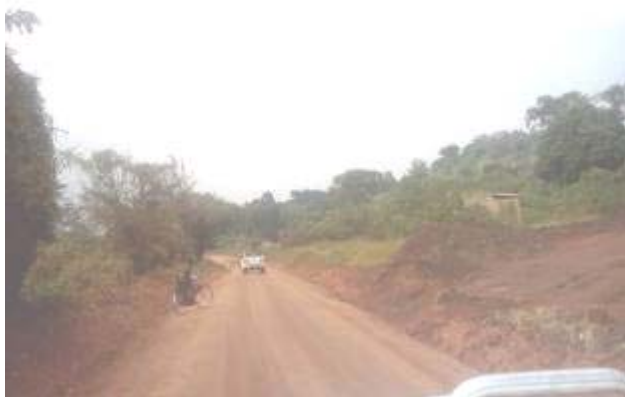
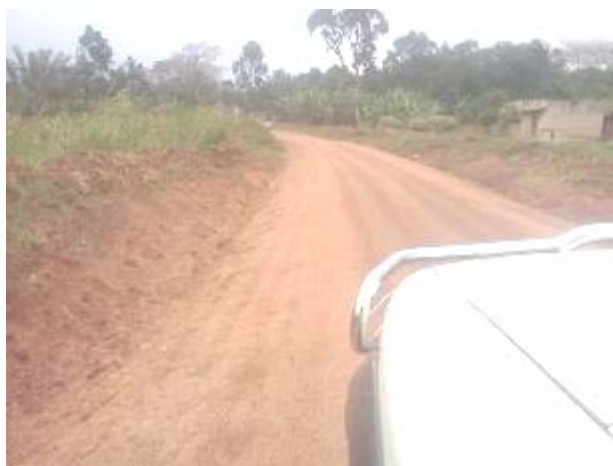
The Contractor had graded and re-gravelled 10km, graded and shaped up to 27km and was still on site progressing with works. The following is a pictorial of the works done and ongoing works as at the time of the monitoring field visit.

UNRA Mubende: Mubende – Kakumiro – Kibaale road – recently graded sections from Ch 1+700 to Ch 27+000

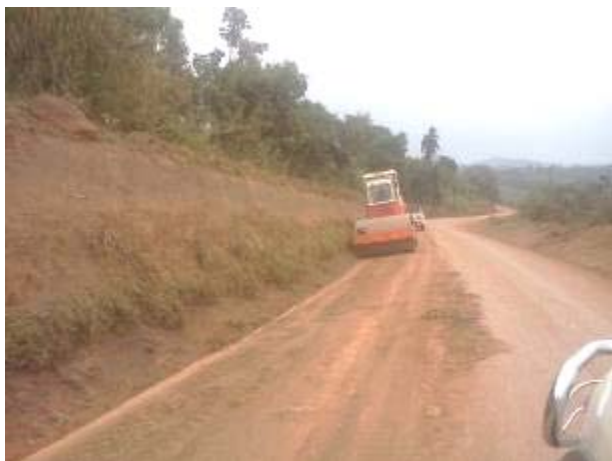
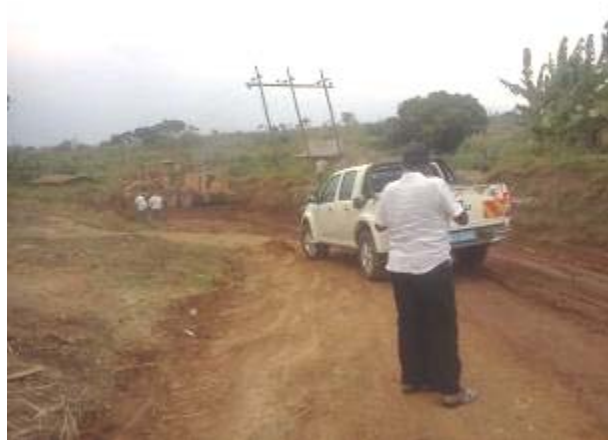
UNRA Mubende: Mubende – Kakumiro – Kibaale road – compaction of recently graded sections (L) and Shaping and grading at Ch 28+000(R)

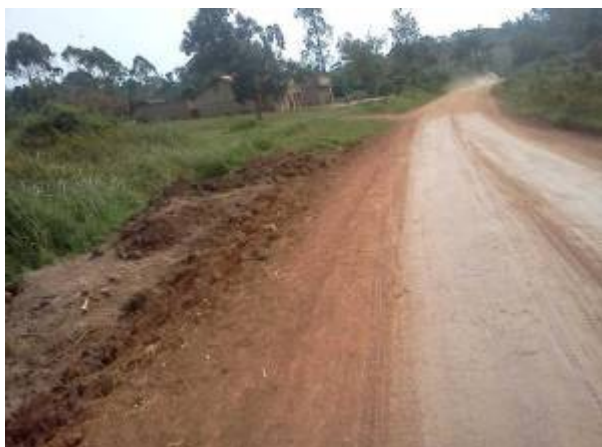
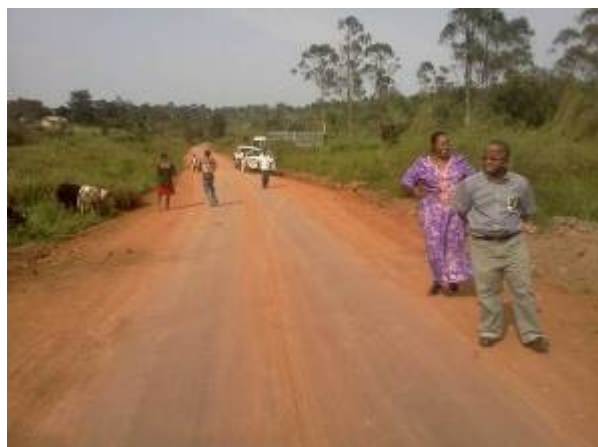
UNRA Mubende: Lusalira - Nkonge road – Section 1 which received emergency intervention (L) and Section 2 at Ch 1+350 which received emergency intervention (R) using FA

The Station had also carried out emergency works at selected sections along Lusalira-Kasambya-Nkongwe (39km) – Grading, spot regravelling, culvert installation and river training using force account, as shown in the following pictures.
