ROAD MAINTENANCE MONITORING REPORT QUARTER 3 (July 2012 – March 2013) – FY 2012/13

APRIL 2013

This is a monitoring report of road maintenance programmes funded by URF in FY 2012/13 covering the period July 2012– March 2013.

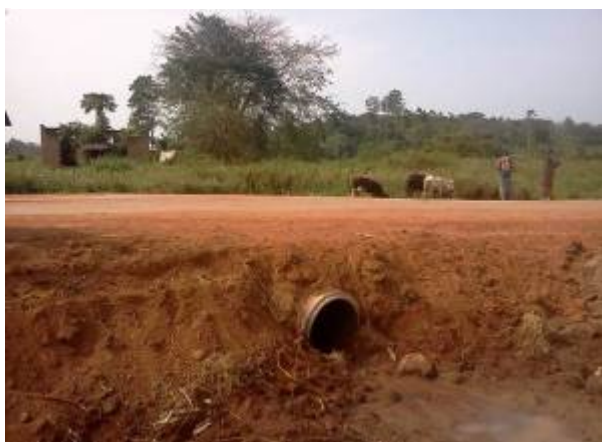
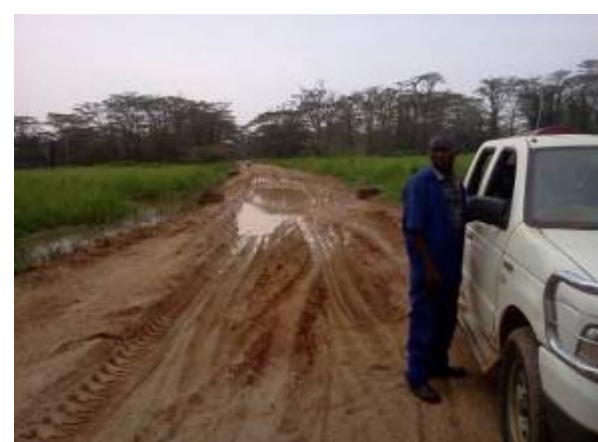
UNRA Mubende: Lusalira - Nkonge road – Section 2 Ch 1+350(L) showing recently installed culvert line as part of the emergency intervention using force account and Section 3 Ch 34+000 (R): Yet to be worked on, the force account team was deployed to the spot but the grader broke down

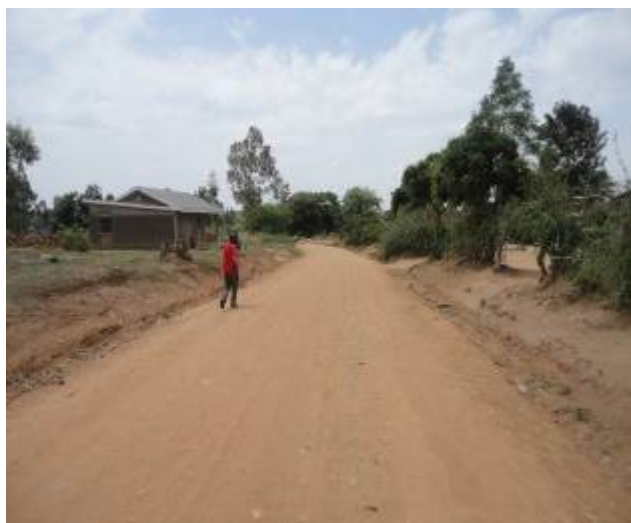
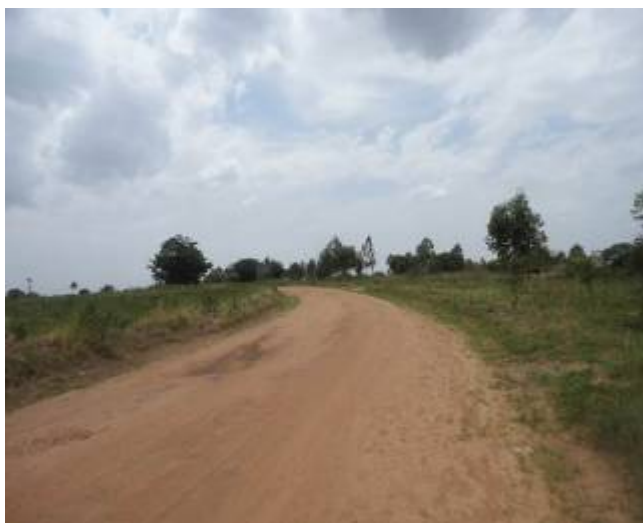
Jiako- Odramachaku (16.54km) is a spot gravelled district road 7m wide road traversing the sub counties of Dadamut and Ayivu in Arua district. Works on this road had been planned for during FY 2011/12 but spilled over into FY 2012/13 and had been executed in December 2012. Planned works included bush clearing, grading and shaping of 12.7km which had all been executed using force account. The road was by the time of the visit receiving routine manual maintenance and was in a in fair condition.

Arua DLG: Completed works on Jiako- Odramachaku road (16.54km) carried over from FY 2011/12.

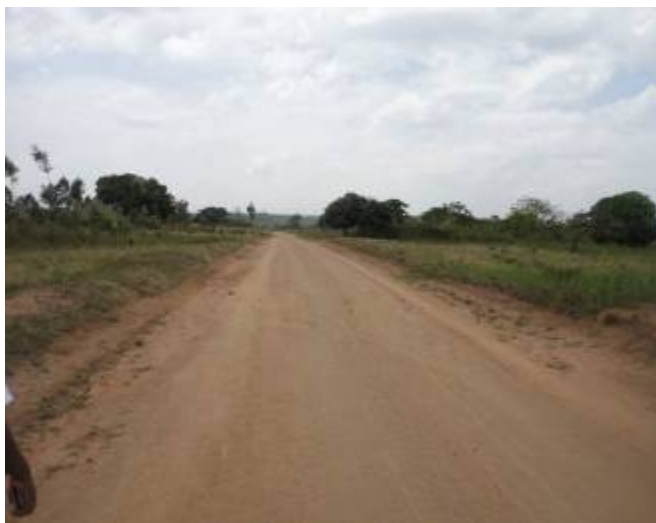
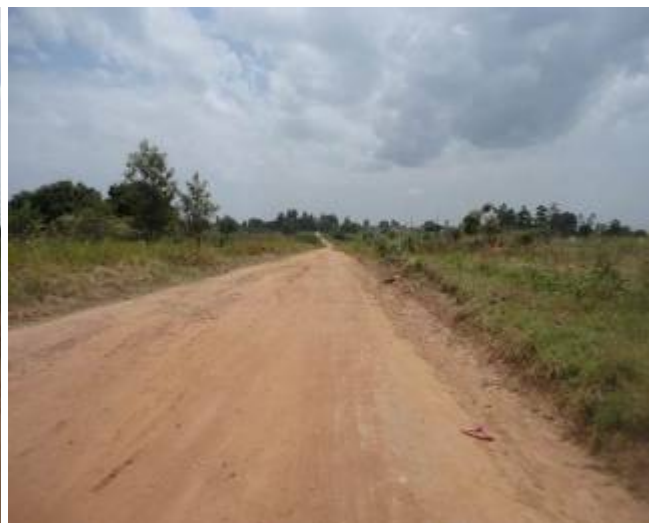
Endru- Fe (3.7 km) is an earth district road which is 7m wide traversing the sub counties of Ayivuni and Adumi in Ayivu County. The road had received routine manual maintenance including grass cutting, grubbing, side drain cleaning, opening offshoots and culvert cleaning and was in good condition.

Arua DLG: Sections of Endru- Fe road (3.7 km) that had received routine manual maintenance in Q2-FY 2012/13

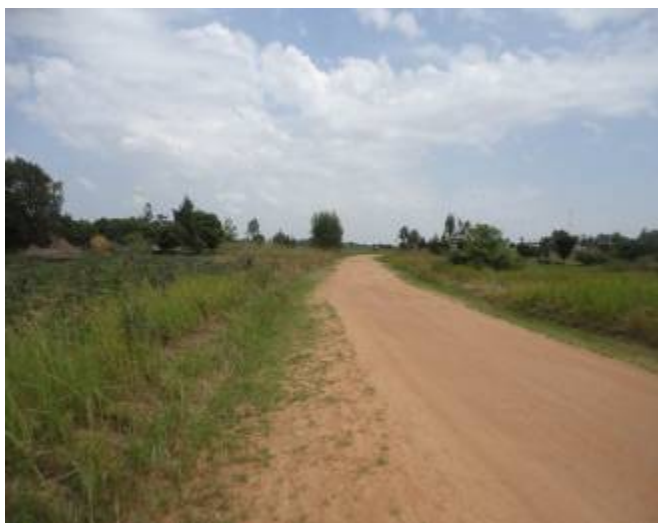
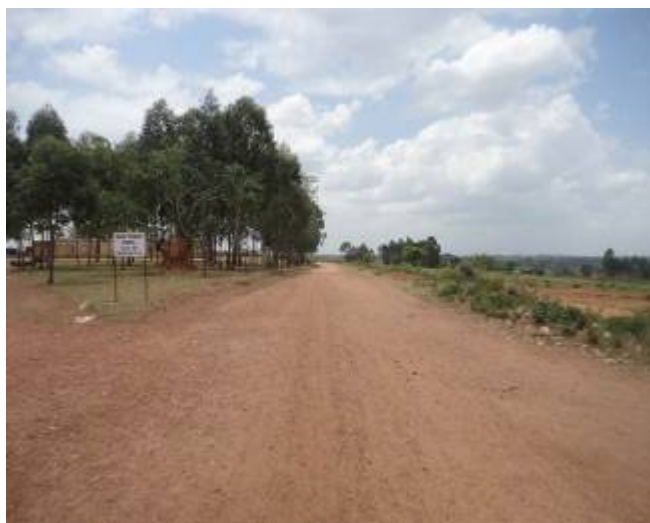
Endru- Nyio road (5.72 km) is an earth district road 7m wide connecting to the sub county of Adumi in Ayivu County. The road had received routine manual maintenance including grass cutting, grubbing, side drain cleaning, opening offshoots and culvert cleaning and was in fair condition.

Arua DLG: Sections of Endru- Nyio road (5.72 km) that had received routine manual maintenance in Q2-FY 2012/13

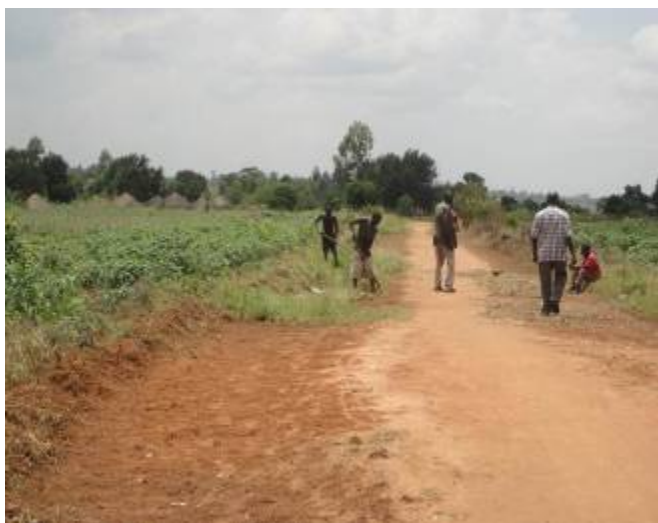
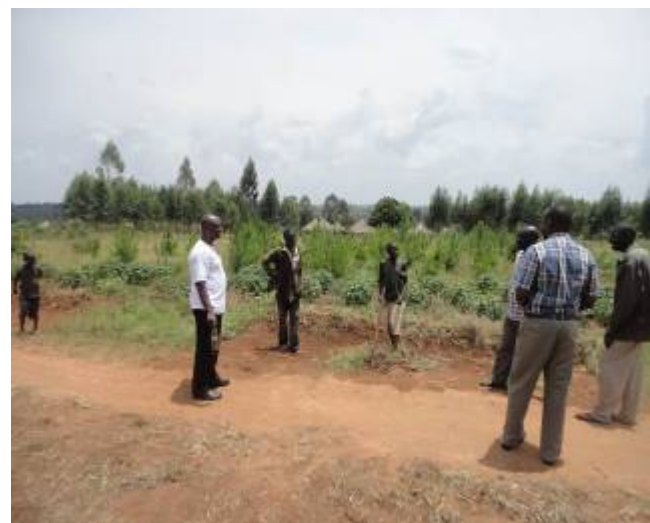
Arua DLG: Sections of Etocbka- Sua road (5.0km) that were receiving routine manual maintenance in Q3-FY 2012/13

Etocbka- Sua (5.0km) is a community access earth road located in Adumi Sub County that was receiving routine manual maintenance using funds carried over from FY 2011/12. Planned activities included grass cutting, grubbing, side drain cleaning and opening offshoots. At the time of the visit, grass cutting and grubbing were ongoing using labour based contractors.

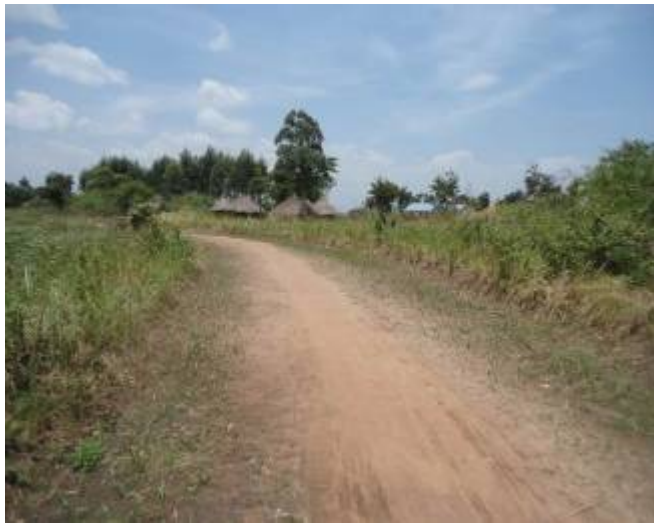
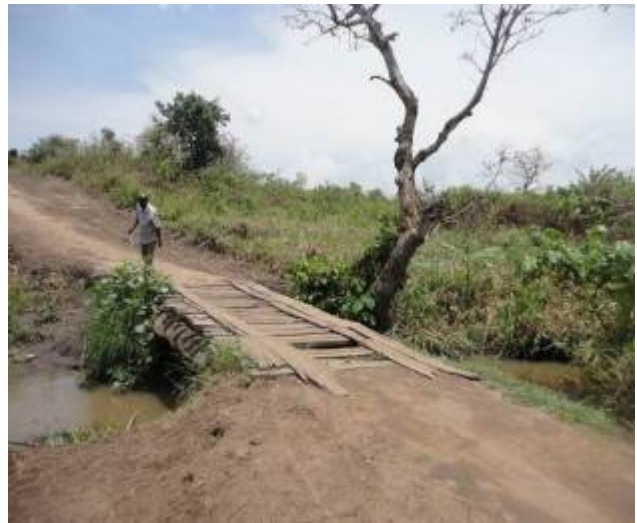
Arua DLG: Section of Etoebka- Sua road that had received routine manual maintenance in Q3-FY 2012/13(L) and Bottleneck on Etoebka- Sua road (5.0km) that needs urgent attention.(R)

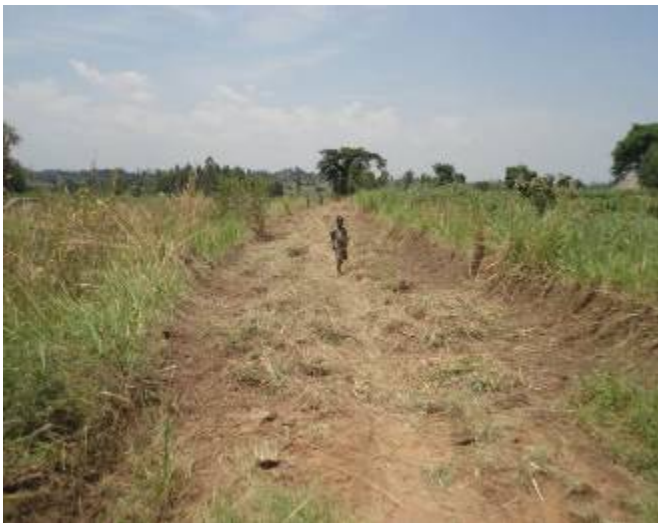
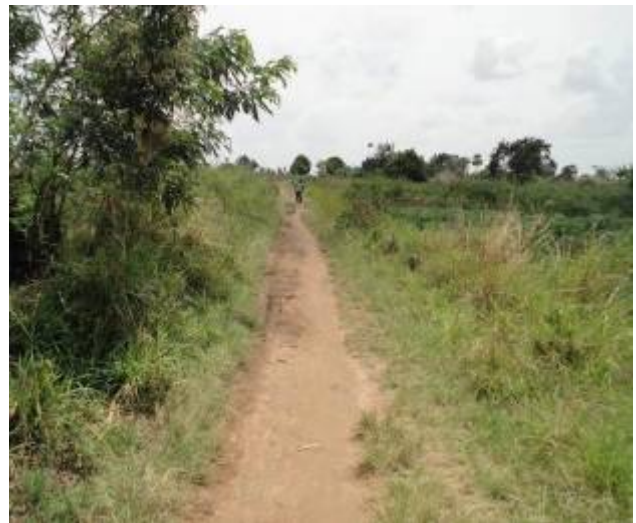
Arua DLG: Section on Andelizu- Oje Mission road (L) (6km that had been bush cleared.) and Section on Andelizu- Oje Mission road (6km) (R) yet to receive any routine maintenance works

Andelizu- Oje Mission (6.0km) is a community access earth road also located in Adumi Sub County that was receiving routine manual maintenance using funds carried over from FY 2011/12. Planned activities included bush clearing, grass cutting, grubbing and opening offshoots. At the time of the visit only bush clearing was on going using labour based contractors.

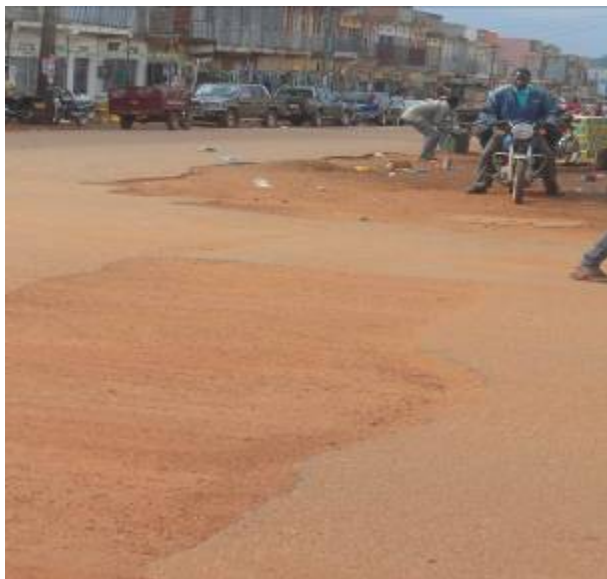
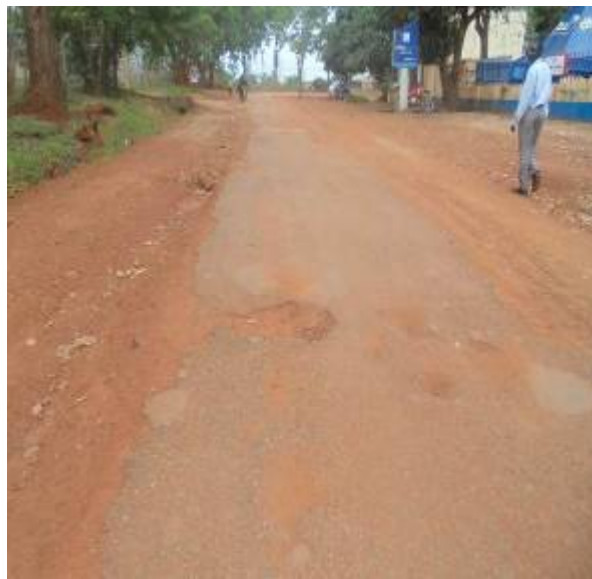
A number of Municipal Council roads were in very bad condition with eaten up tarmac and unmaintained drainage as shown in some of the photos below. The Acting Municipal Engineer informed the team that Gulu Avenue was contracted out but the contractor failed to commence the work.

Gulu MC: Pot holes on Gulu Avenue. One of the many roads in such condition (L) and the road which passes right in front of Gulu Municipal Council offices (R)

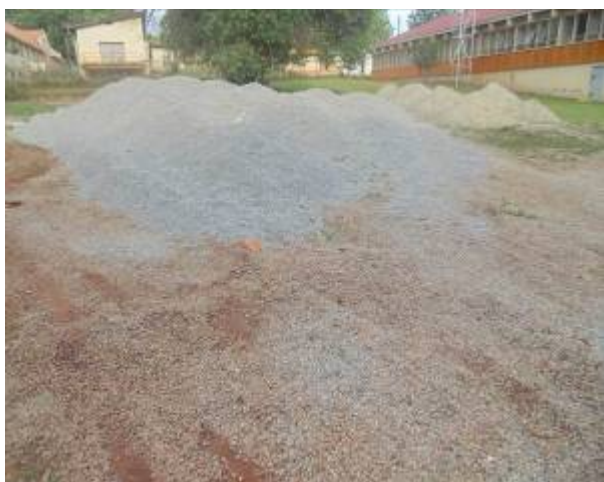
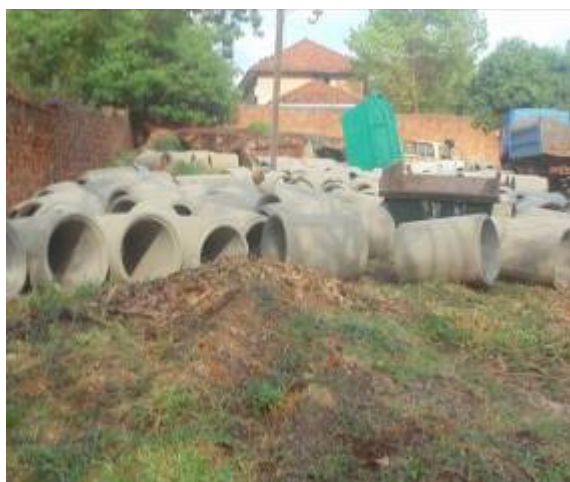
Gulu MC: Stone chippings and dust (L) behind Gulu Municipal council offices and Assorted culverts at Gulu MC Yard (R)

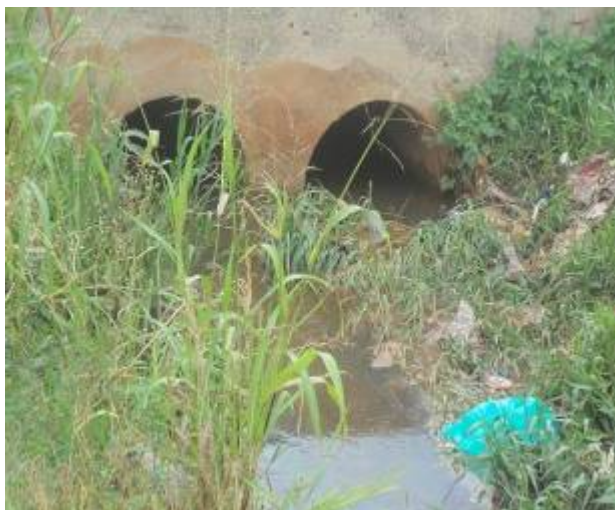
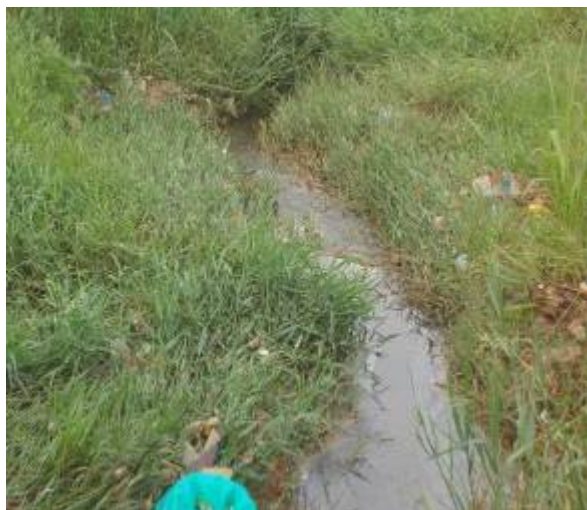
Gulu MC: Unmaintained drainage on Dr. Lucil Corti road

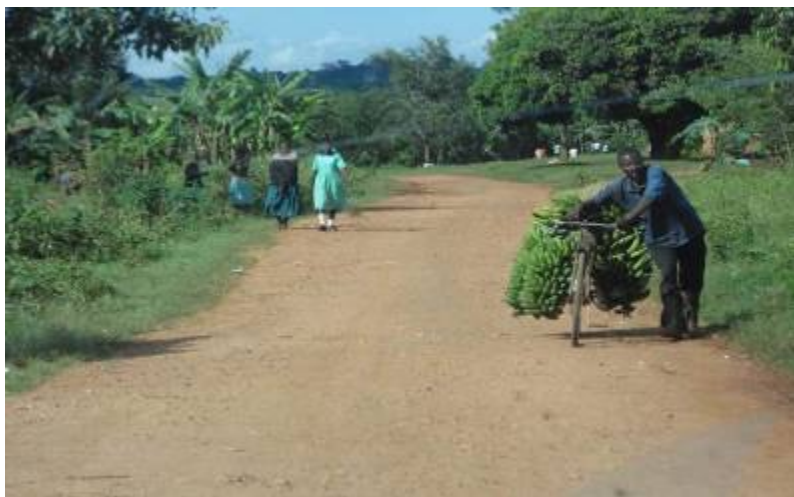
Kalungu DLG: A section of Lukaya – Lusango road

Out of the total road length of 21km road, only 12.85km had been planned for and was complete by the time of the field visit. Works were carried out under routine mechanized maintenance with spot improvement involving grading, installation of eight pieces of culverts and creation of mitre drains;

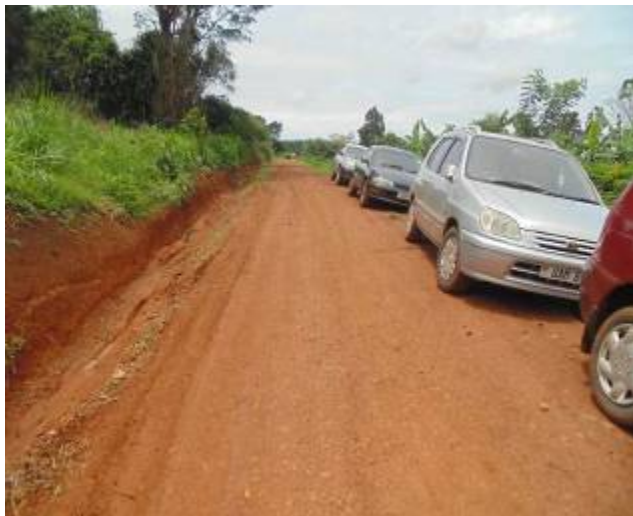
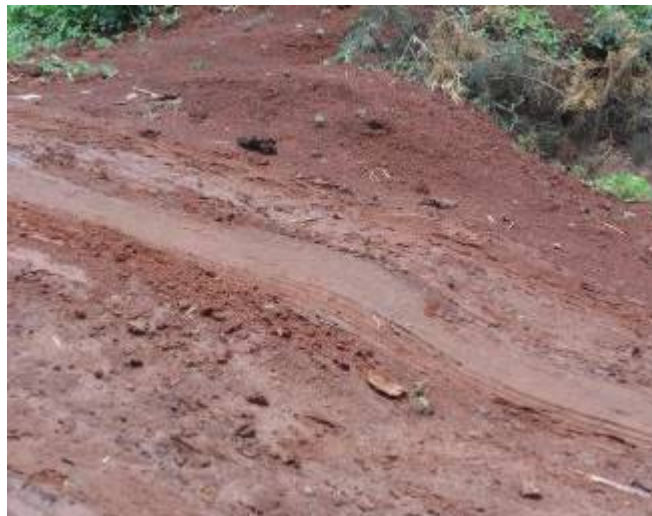
Kalungu DLG: A section of Kalungu- Lusana road graveled without compaction (L) and Culverts laid without headwalls (R)

- Galungu – Lusana road, (3.5 km). A total of UGX 13,965,400 was spent on grading, spot marraming, 3 lines of culverts laid and some volumes of fill material had been delivered on site.
- Luzira by-pass, (2.1 km). A total of UGX 7,870,400 was spent on grading and gravelling of the whole length under periodic maintenance.

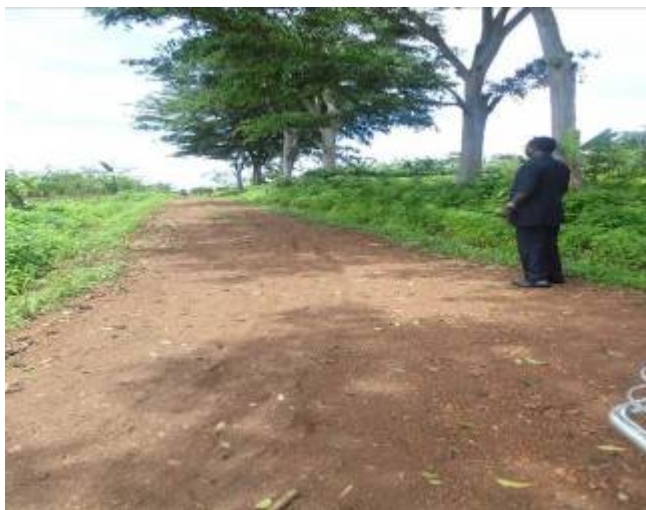
Kalungu DLG: Luzira by-pass where no compaction had carried out and shoulders having overgrown grass requiring maintenance

- A number of planned maintenance roads had not done been due to lack of equipment. The district had only one grader and no roller and for all the roads worked on, no compaction had been done rendering roads loose and at risk of being washed away by rain.

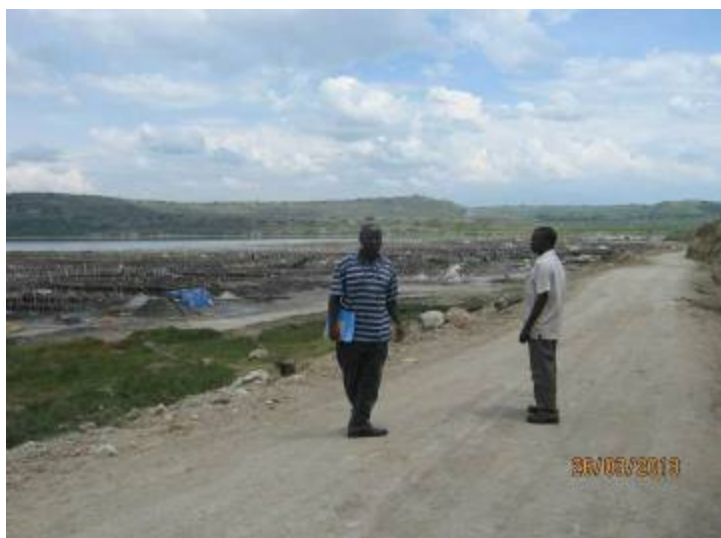
Kasese DLG: Lake Katwe Salt Road under periodic Maintenance

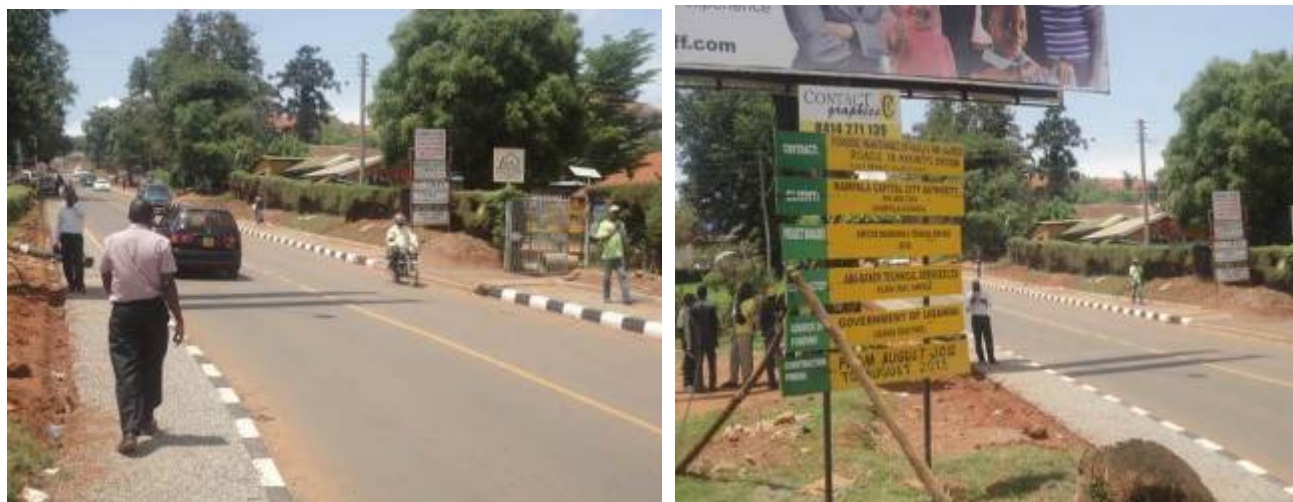
KCCA: Completed sections of Nsambya (0.3km) (L) and Hanlon road (1.6km) (R)partly funded by URF in FY 2012/13.

Nsambya (0.3km) and Hanlon (1.6km) roads were part of the roads in Makindye division earmarked for periodic maintenance. The works costing UGX 3.3bn being carried out by M/S Abubaker Technical Services Ltd had commenced in August 2012 and was expected to end by August 2013. Uganda Road Fund had funded the project to the tune of UGX 1.1bn and the balance of UGX 2.2bn was directly from the Treasury. The planned scope of works included reconstruction of the base, laying a 50mm thick layer of asphalt, construction of walkways, drainage improvement works and road marking. A variation of UGX 0.3bn had been awarded to place gabions and guard rails at Nkere swamp. At the time of the visit, 95% of the works had been completed and the contractor was handling finishing works in preparation of handing over the works to KCCA. The quality of works conformed to technical specifications and the road was in very good condition.

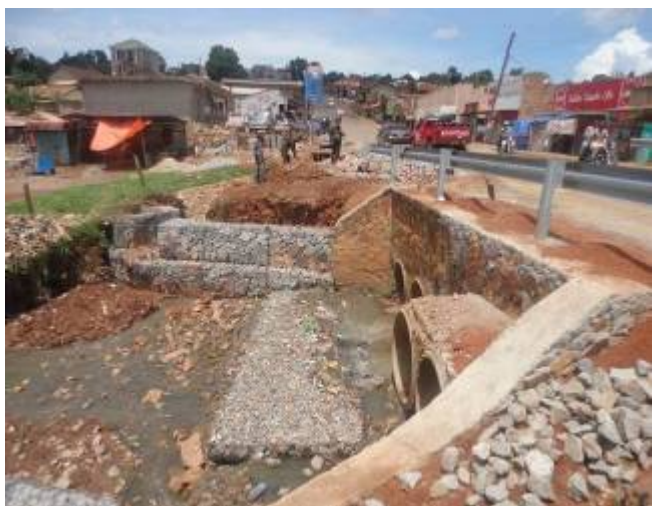
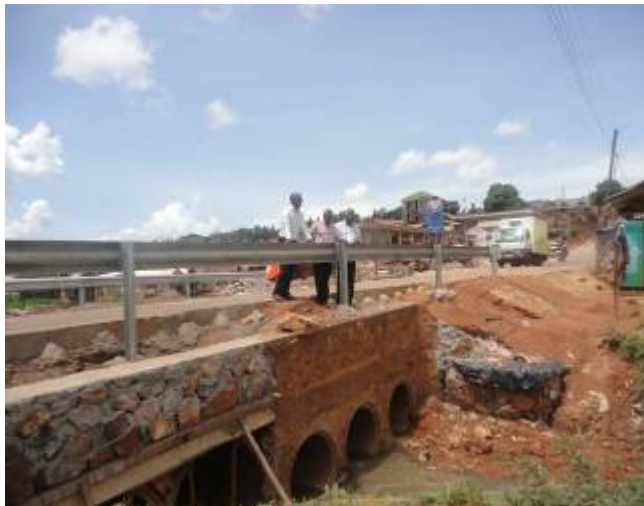
KCCA: Gabion works and guard rails at Nkere swamp on Hanlon road (1.6km) constructed using a variation of the contract.

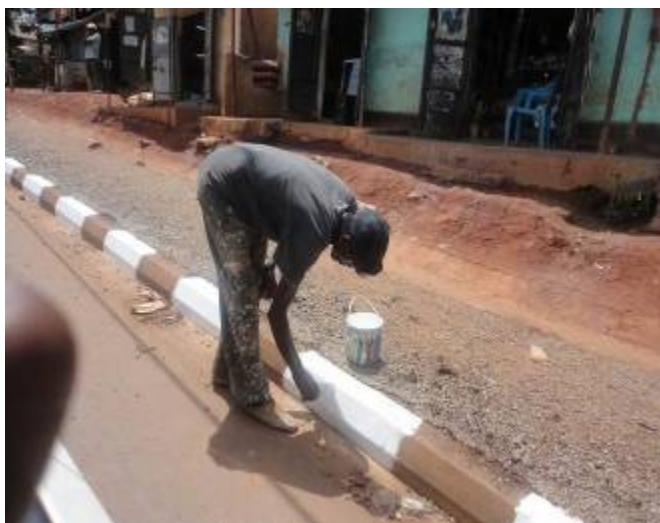
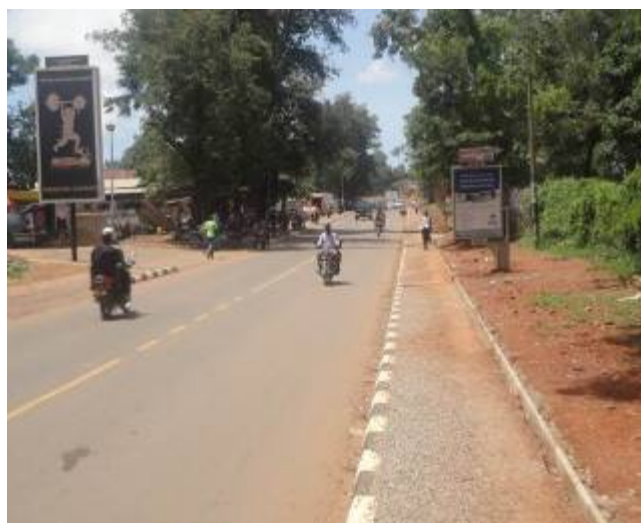
KCCA: Road marking on Hanlon road (1.6km) in progress (L) and Walkway for pedestrians constructed on Nsambya road (R)

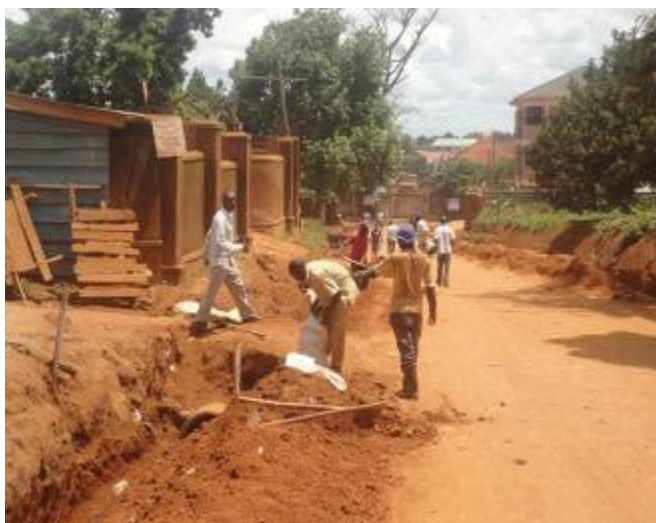
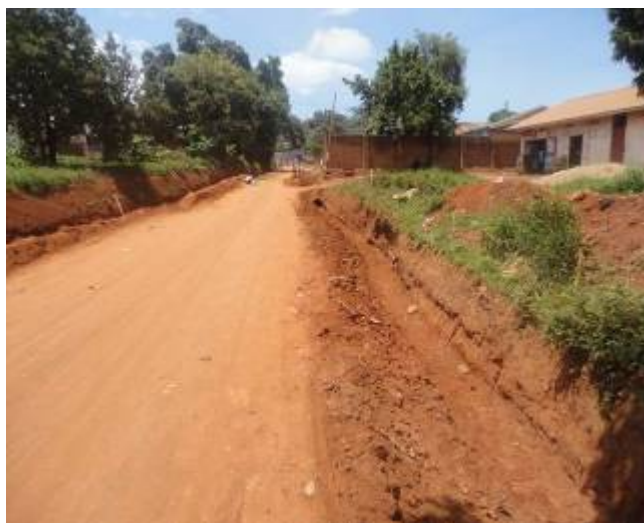
KCCA: Excavation of side drains on Kyabugga road (0.5km) in Lubaga division.

Kyabugga road (0.5km) is an earth road which is 6m wide in Lubaga division that was earmarked for periodic maintenance. The works costing UGX 3.3bn (cost includes old Mubende road- 2.45km) being carried out by M/S Neat Construction Company Ltd had commenced in mid February 2013 and were expected to last a period of six months. The planned scope of works included widening the road, earthworks, full gravelling and drainage improvement works. At the time of the visit, the road bed had been prepared ready to receive gravel and excavation of side drains was ongoing. The works were generally progressing slowly and the contractor had been instructed not to proceed with the gravel works until he had provided KCCA with both survey data and gravel test results.

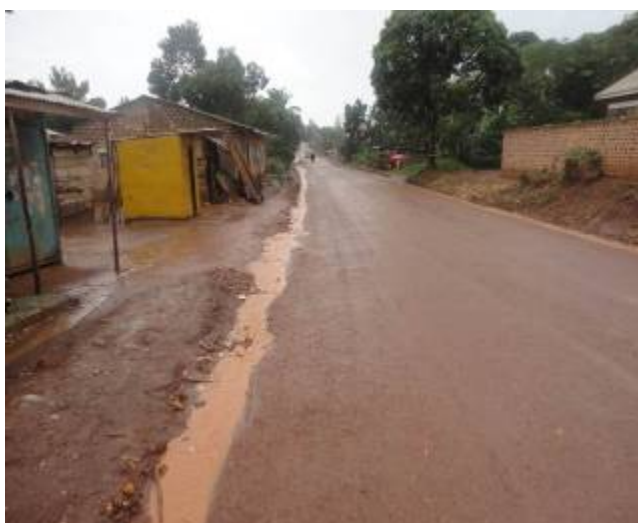
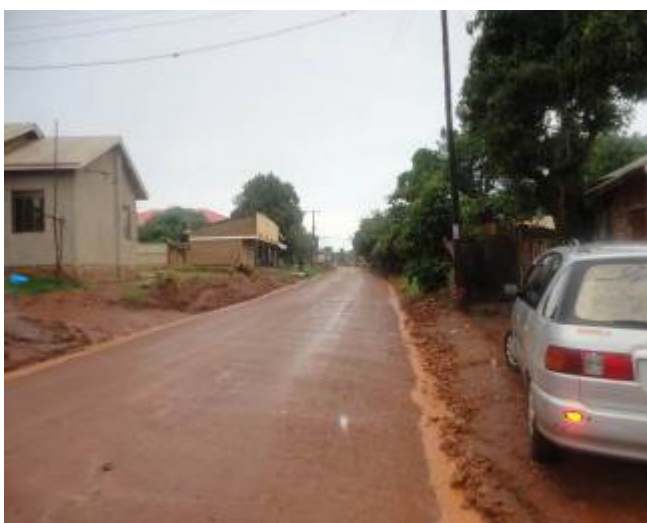
KCCA: Sections of Kisasi road (2.3km) that had been shaped and gravelled but requiring drainage protection works

Kisasi road (2.3km) is an earth road which is 7m wide in Kawempe division that was earmarked for periodic maintenance. The works costing UGX 0.84bn (cost includes Church Kisowera, Sheikh Kulumba, Lumas and Hajji Mumyuka roads- 2.36km) being carried out by M/S Wiyeda General Construction Ltd had commenced in February 2013 and were expected to last a period of six months. The planned scope of works included widening the road, earthworks, full gravelling, stone pitching and drainage improvement works. At the time of the visit, grading, shaping and compaction of the entire road had been completed and gravel works were in progress. Completed sections required urgent side drain protection works as rain water was travelling long distances leading to erosion in the side drains.

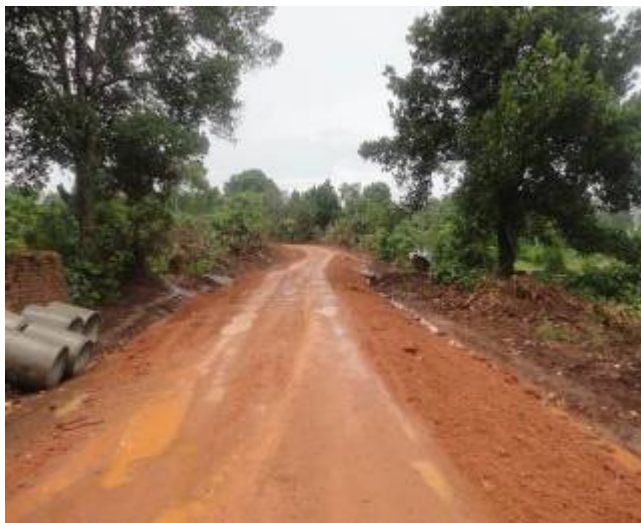
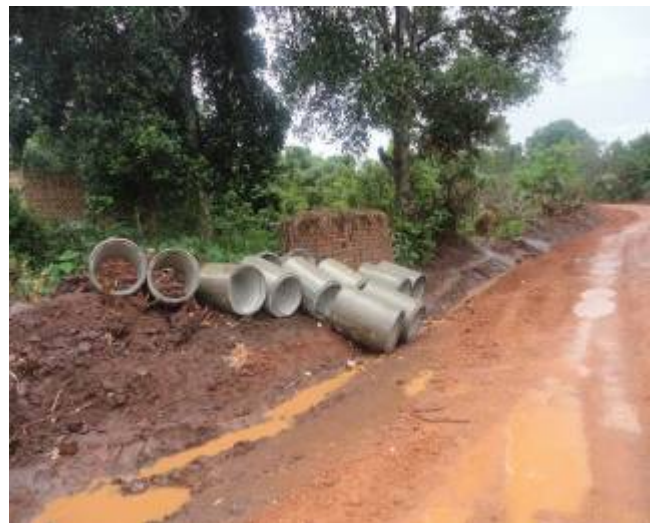
KCCA: Gravel works in progress and culverts to be installed on Kisasi road (2.3km)

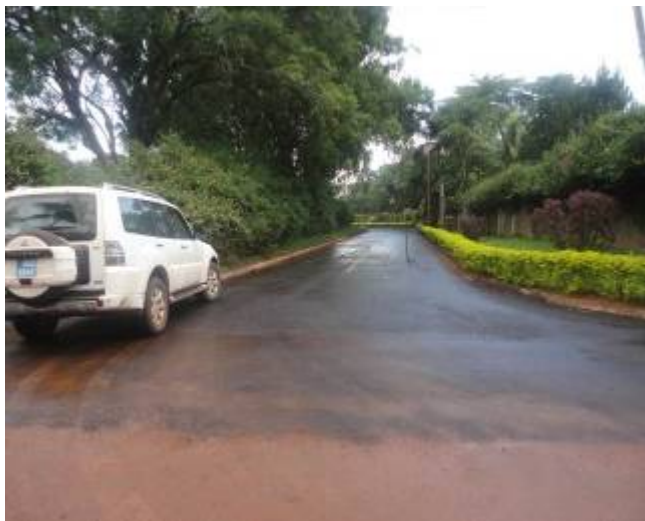
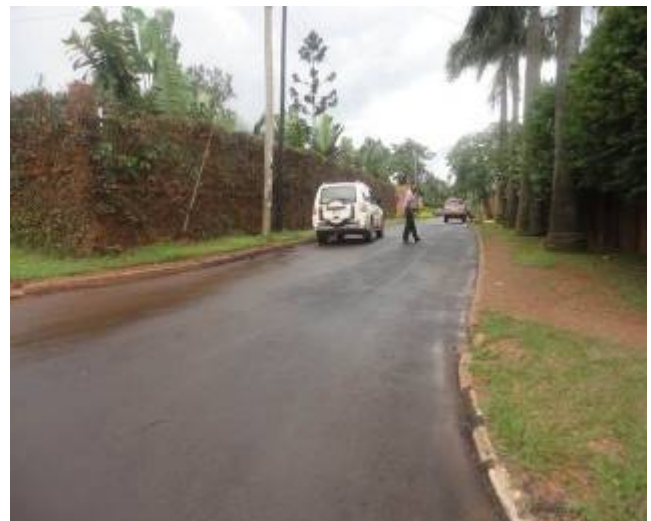
KCCA had undertaken patching of potholes and sectional repairs on a number of roads including Nyonyi gradens, KAR drive, Spring (Bugolobi) and Luzira port bell roads in Nakawa division. During the visit, the monitoring team was informed that sectional repairs involving base reconstruction and an asphalt overlay of 30mm had proved effective in handling the very many potholes on the city roads.

KCCA: Sectional repairs on KAR road and Nyonyi gardens road repaired in Q3-FY 2012/13

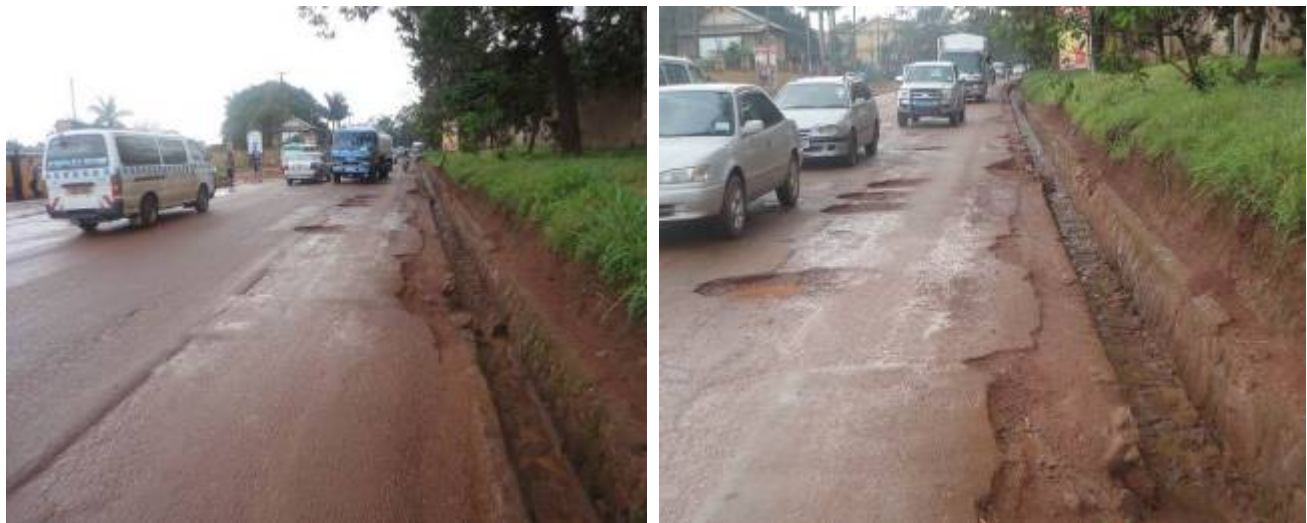
KCCA: Heavily potholed section of Luzira - Port Bell road recently returned to KCCA by UNRA requiring sectional repairs

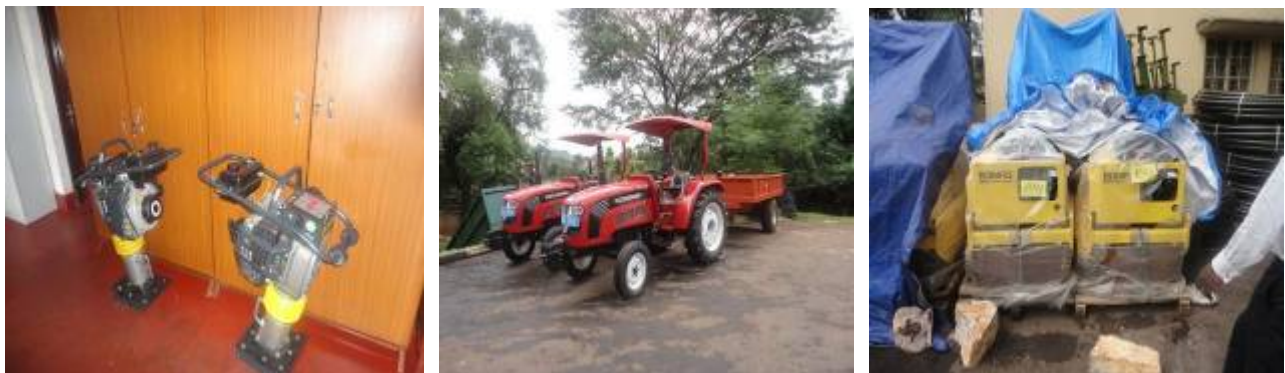
KCCA: Part of the light equipment purchased for routine mechanised works.

During FY 2012/13, KCCA planned to purchase a number of light equipment at a cost of UGX 0.68obn to assist the agency increase its capacity to undertake routine mechanised works. KCCA had planned to purchase Tractors and Trailers (5no), double drum rollers (5nos), Shear cutters (5nos) and Jumper compactors (5nos). At the time of the visit, all the equipment had been purchased and awaited handing over to the various divisions.

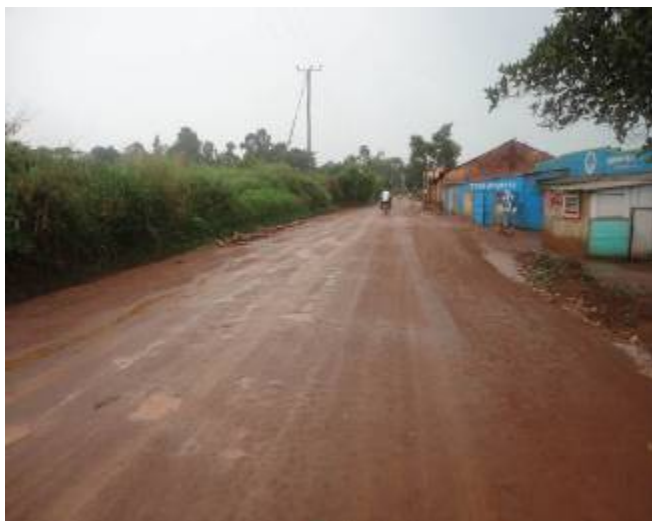
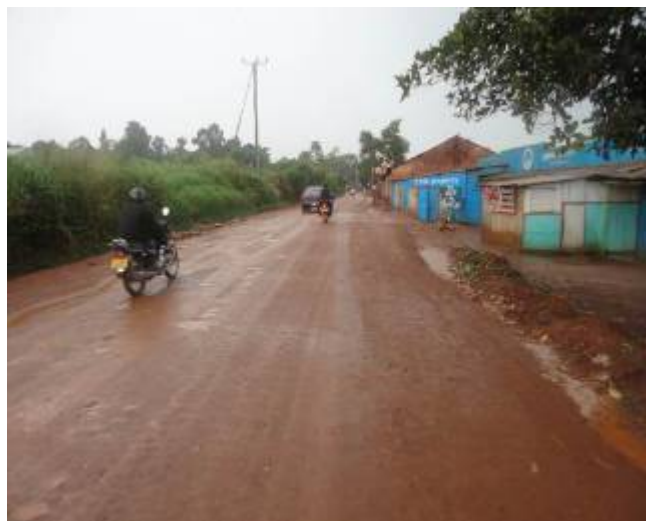
KCCA: Prepared road surface ready to receive gravel on Banda Circular road (2.4km) funded by GOU.

Banda Circular road (2.4km) is a spot gravelled road which is 7m wide in Nakawa division that was being upgraded to tarmac with funding from GOU. The works costing UGX 2.3bn and being carried out by M/S Abubaker Technical Services Ltd had commenced in April 2013 and were expected to last a period of eight months. The planned scope of works included laying a 150mm gravel base, 40mm asphalt surfacing, single surface dressing of shoulders, stone pitching and drainage improvement works. At the time of the visit, the road bed had been prepared ready to receive gravel and installation of culverts was ongoing.

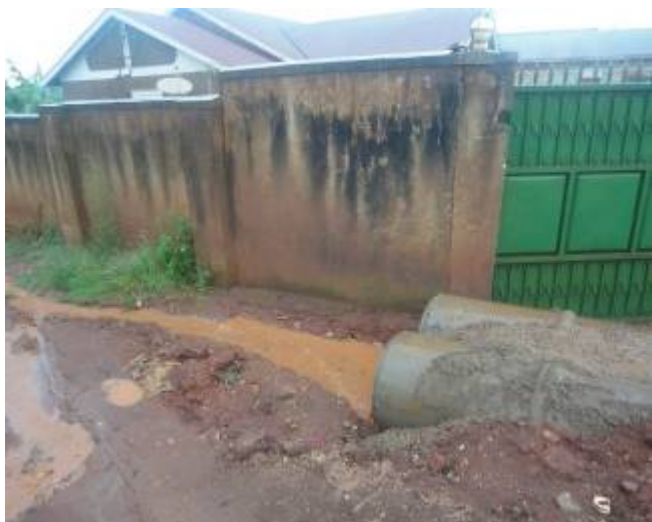
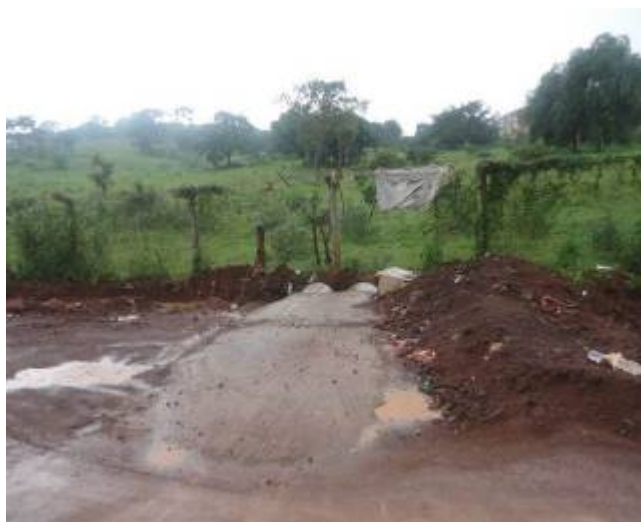
KCCA: Culverts installation on a section of Banda Circular road (2.4km) funded by GOU

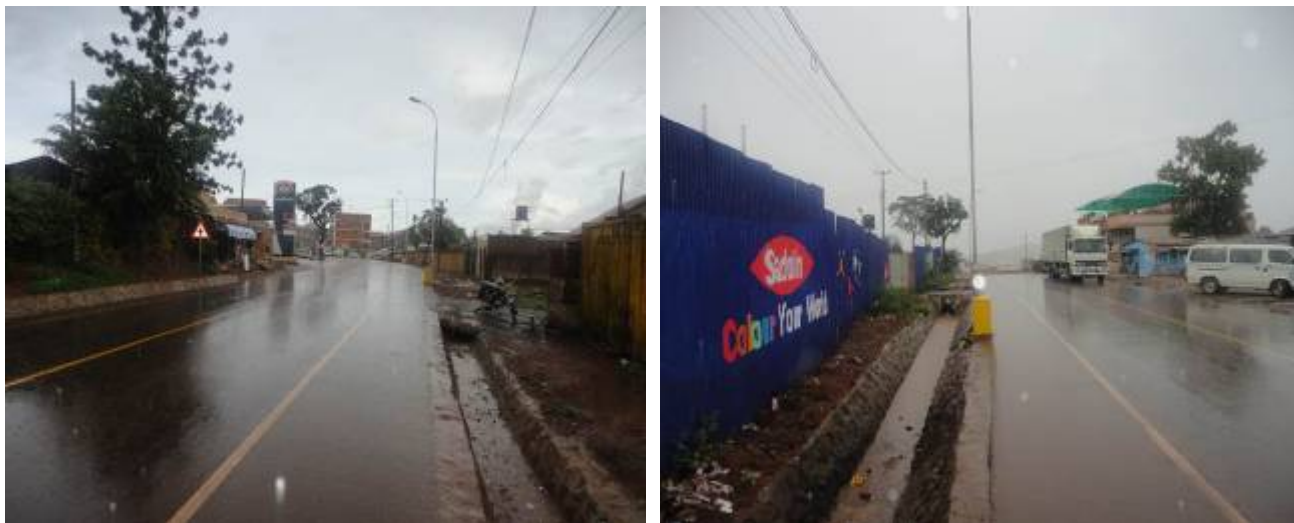
KCCA: Completed Bukoto- Kisaasi road (10.0km) road funded by the World Bank

Bukoto- Kisaasi road (10.0km) is a paved road in Kawempe division and had undergone rehabilitation with funding from the World Bank under the KIIDP project. The rehabilitation works costing USD 8m were carried out by M/S Energo Project Ltd and the scope of works included recycling the existing base, placing of asphalt surfacing, drainage improvement works, stone pitching, road marking and installation of street lights. At the time of the visit, the works had been completed and handed over to KCCA on 23/04/2013.

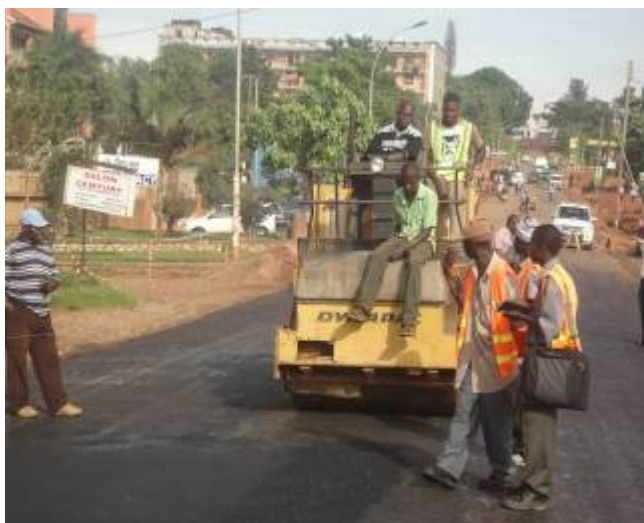
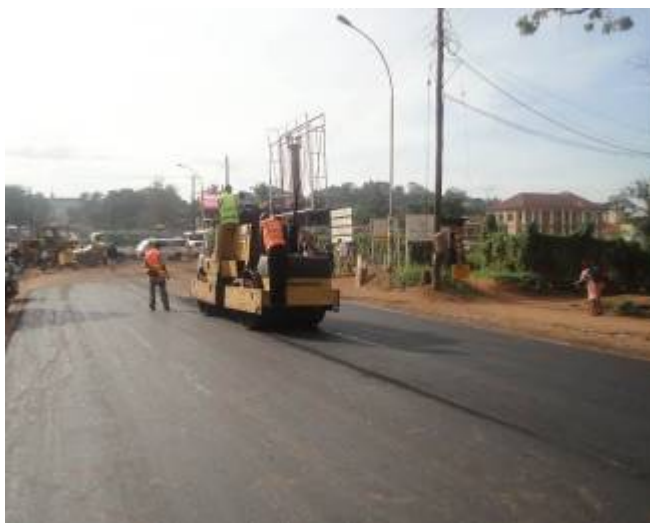
KCCA: Laying of the asphalt layer on Kabakanjagala road (1.0km) funded by GOU in progress

Kabakanjagala road (1.0km) is a single carriageway paved road in Lubaga division that was being rehabilitated with funding from GOU. The works costing UGX 4.2bn (including upgrading of Nabunya- 0.3km, Kabuusu- 1.1km, Ssekabaka Kintu- 1km and Kalinda- 0.3km roads to tarmac), were being executed by M/S Sterling and the road was to be turned into a dual carriageway. The planned scope of works included reworking the existing base into the sub grade, laying of the base, laying an asphalt layer of 50mm, construction of walkways, drainage improvement and beautification works. At the time of the visit, laying of the asphalt and compaction of the base layer was in progress.

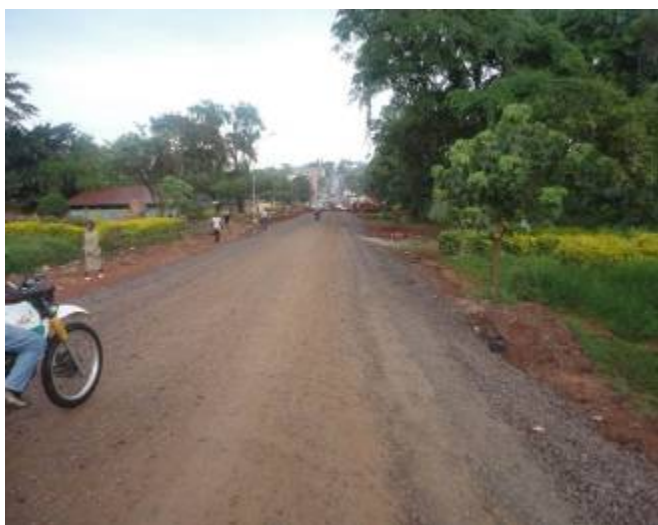
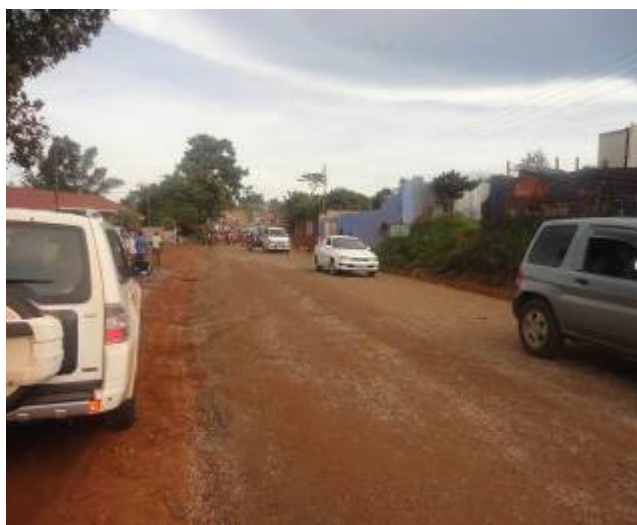
KCCA: Compacted base on Kabakanjagala road (1.0km) funded by GOU.

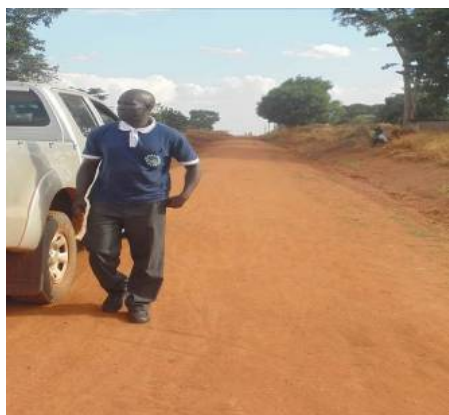
Lamwo DLG: Lukung- Palabek kal road 13Km being upgraded

The UGX 30million recovered from PRDP was applied in upgrading Lukung – Palabekkal road 13Km by force account. See photo below.

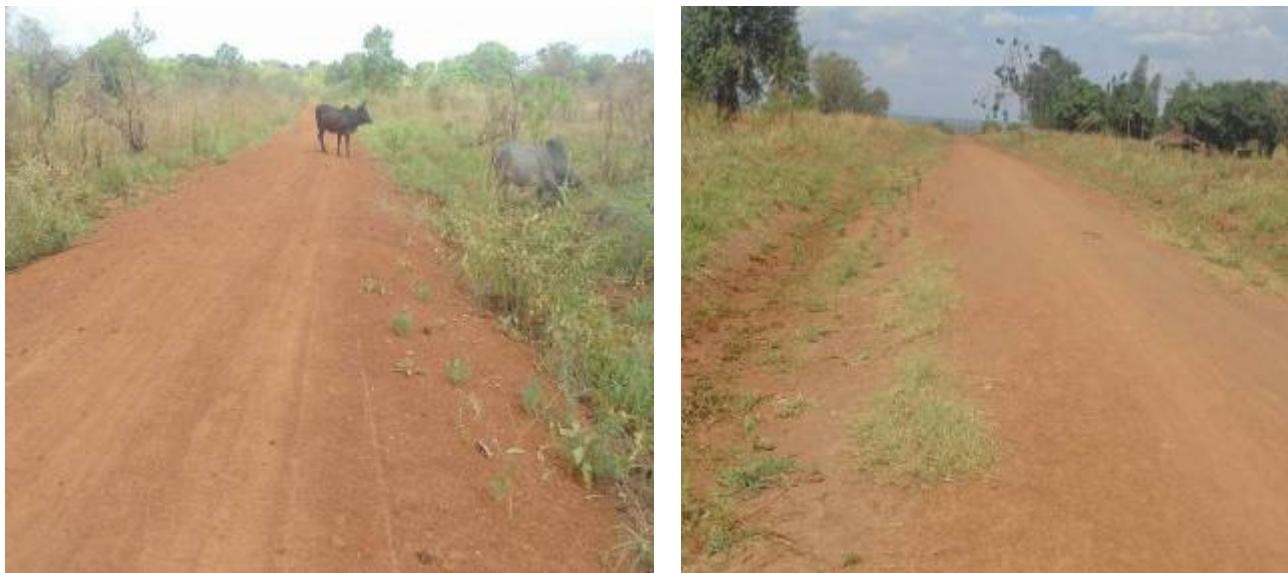
Because of lack of routine maintenance, the shoulder had over grown grass but the general road condition was still good. See photos below:

Lamwo DLG: Padibe- Mucwini road 14km contracted under periodic maintenance

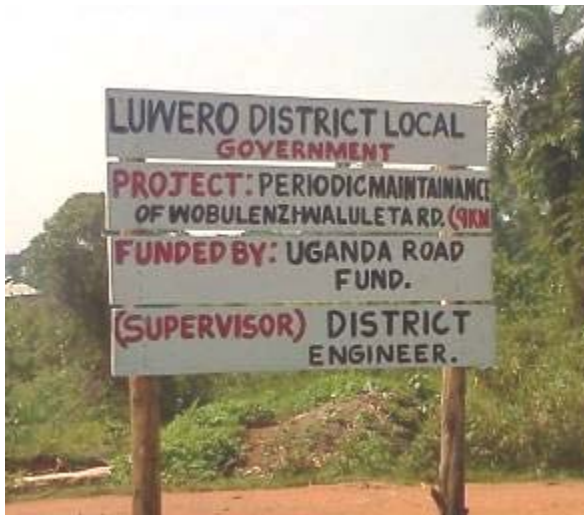
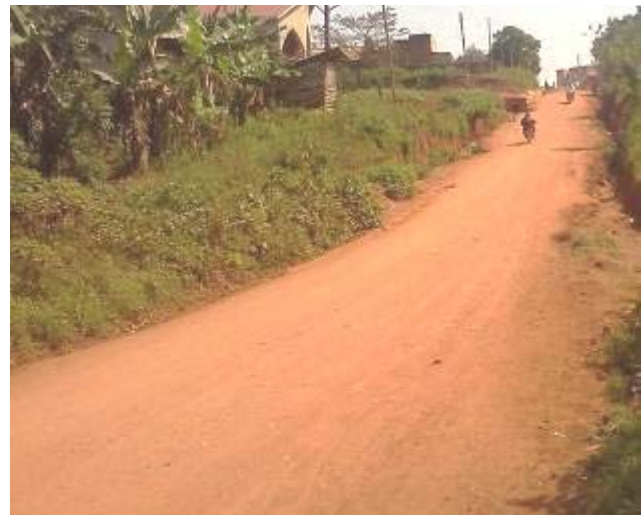
Luwero District: Sign post (L) showing the PM works of Wobulenzi – Waluleta Road (9km) and a section of the road (R)

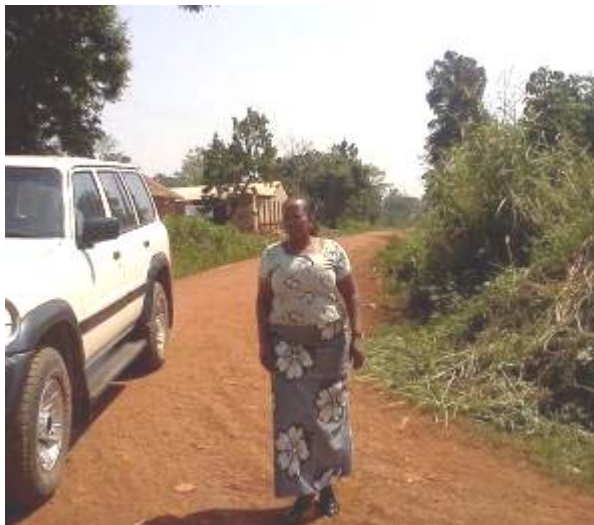
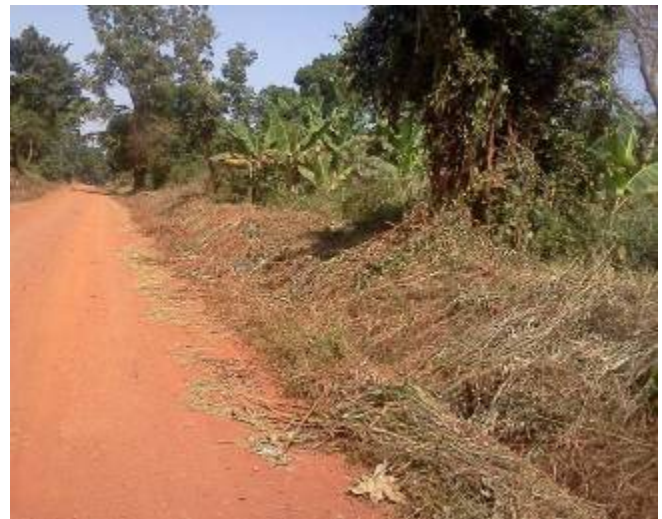
Luwero District: Appreciation and inspection of routine manual maintenance works executed by road gangs.
