ROAD MAINTENANCE MONITORING REPORT QUARTER 3 (July 2012 – March 2013) – FY 2012/13

APRIL 2013

This is a monitoring report of road maintenance programmes funded by URF in FY 2012/13 covering the period July 2012– March 2013.

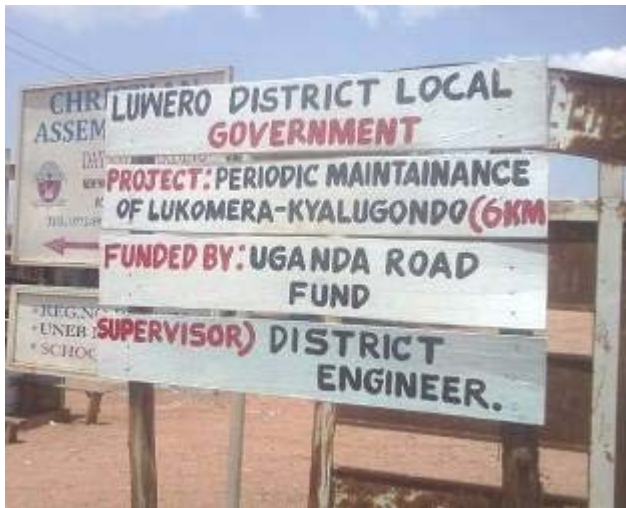
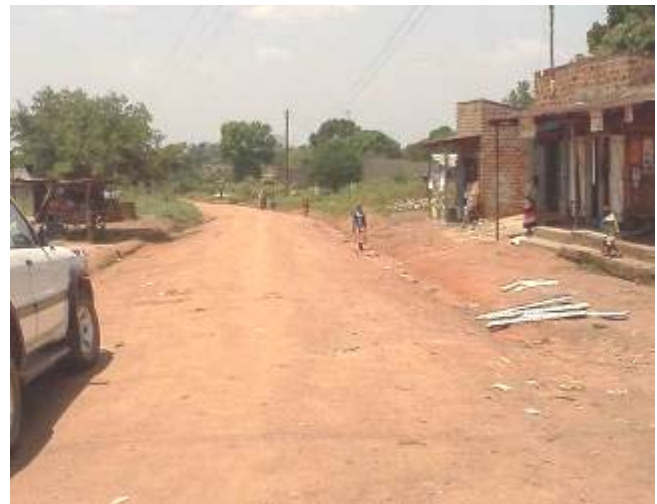
Luwero District: Sign post (L) showing the PM works of Lukomera – Kyalugondo Road (6km) and a section of the road (R)

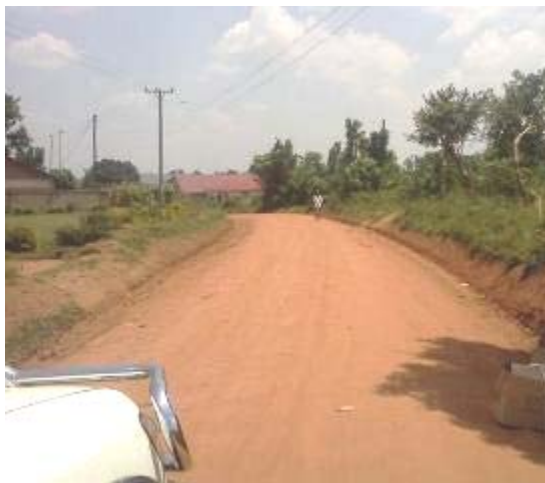
Luwero District: Tweyanze – Sekamuli (12km) received grading and shaping.

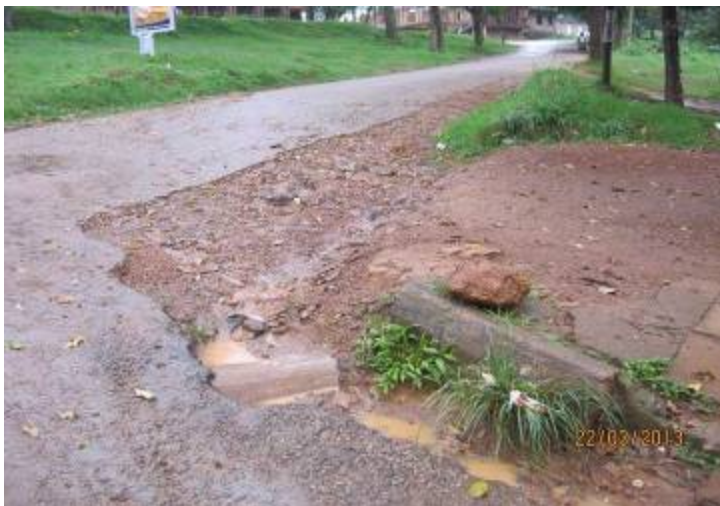
Masaka MC: An example of Road drainage problem on one road in Masaka MC

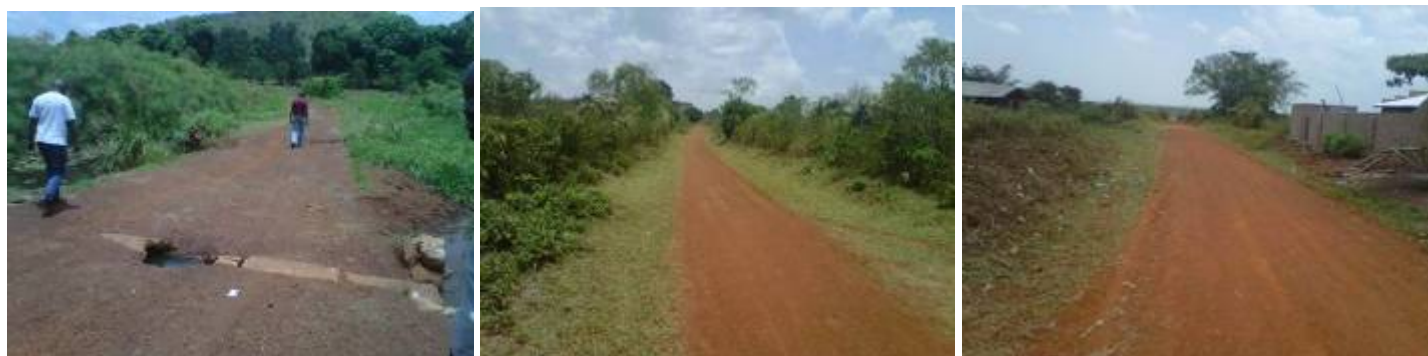
Masindi District: Katugurukwa – Kinumi road – Broken culvert crossing (L) and Section where slashing was done (C); and (R) a section of Kasindizi – Kinumi road where routine manual maintenance had been done.

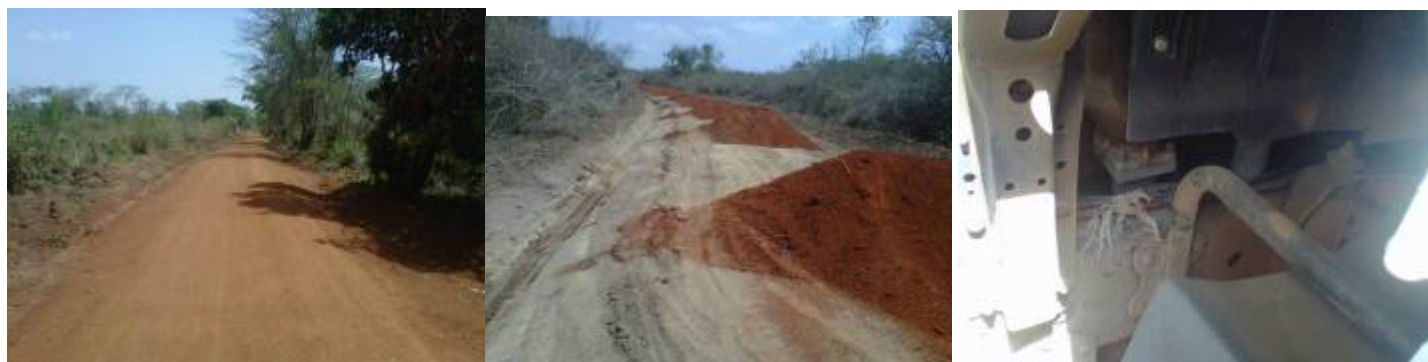
Masindi District: Kimengo – Masindi Port road – graveled section (L); gravel damped on dry dusty surface (C); and compressor pipes of tipper truck from China, which was delivered with the tubes bound with sole tape and super glue (R)

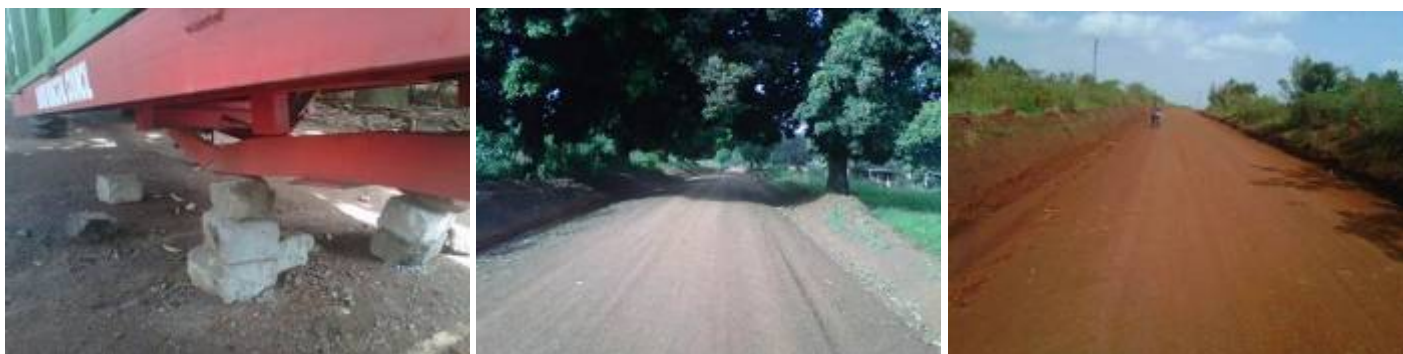
Masindi MC: Warped frame of tractor trailer from China (L); Graded section of Bulyasoja road (C); and Graded section of Katasenya – Butoobe road (R)

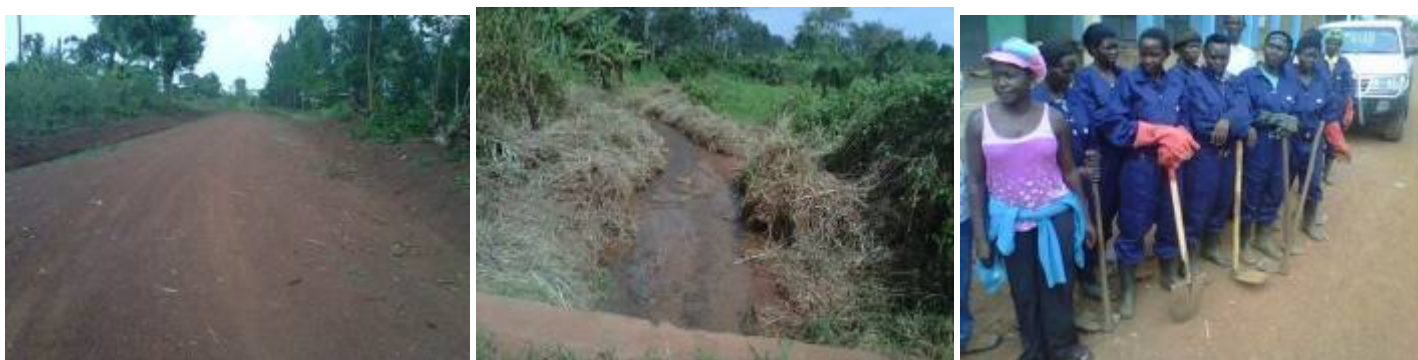
Masindi MC: Graded section of Kategeta – Buborogota road (L); River training at culvert crossing on Kijunjubwa road (C); and A road gang with several female workers, equipped with protective gear on Sebagala Street(R)

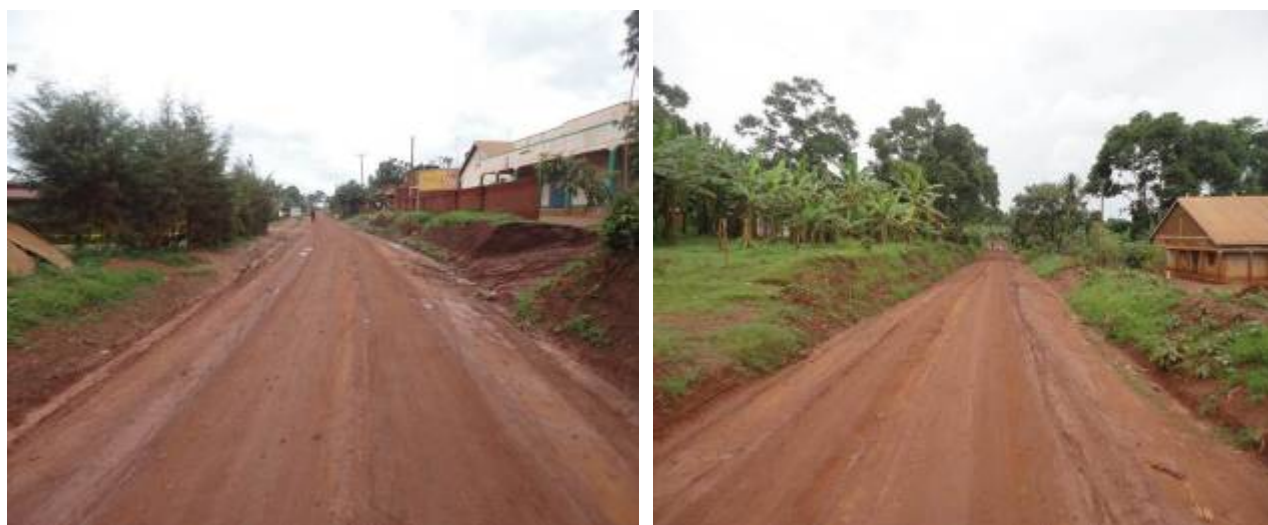
Mpigi DLG: Graded and shaped sections on Kamengo – Butoolo- Buvumbo road (11.37km) completed in Q3- 12/13 .

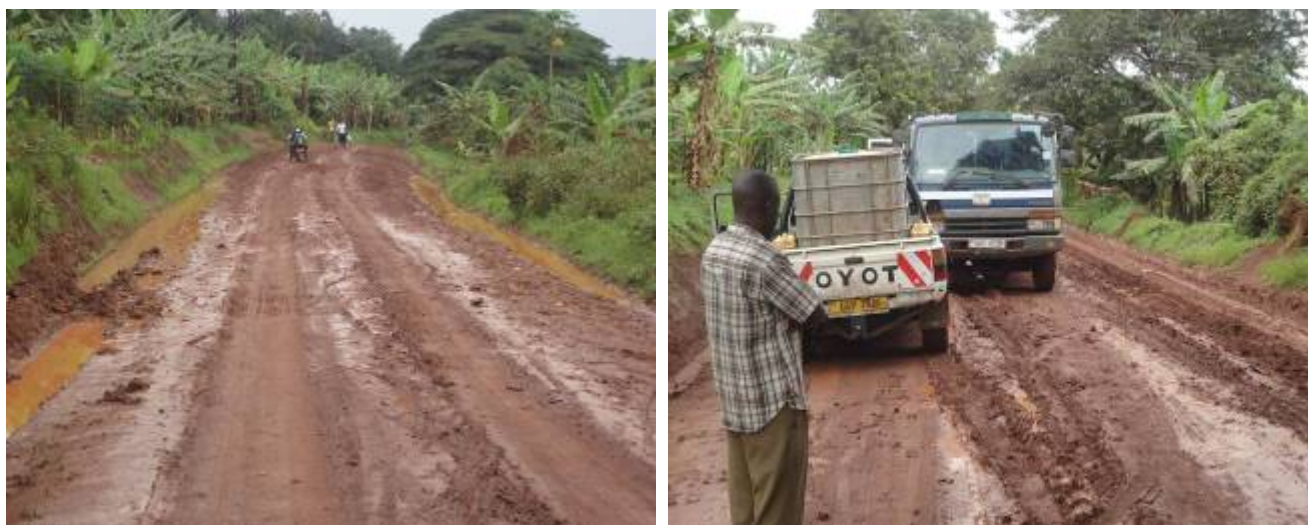
only 4.6km had been graded and shaped but not compacted. Works had stopped due to the heavy rains in the area and some completed sections which had been damaged by the heavy rains required reshaping and compaction.

Mpigi DLG: Shaped sections on Kamengo – Butoolo- Buvumbo road (11.37km) damaged by the heavy rains requiring reshaping.

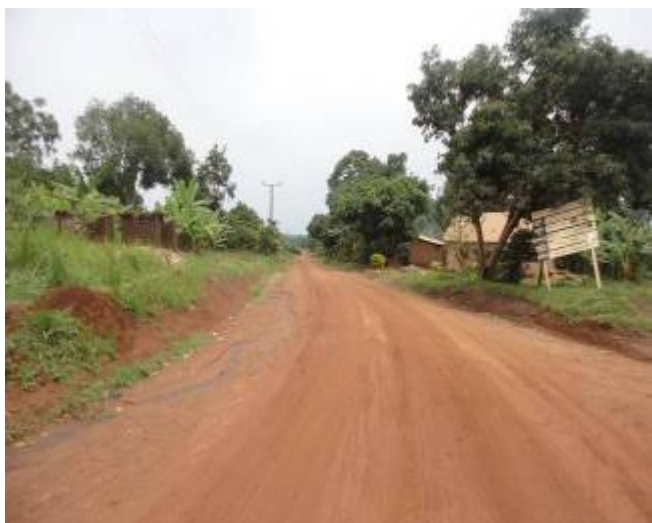
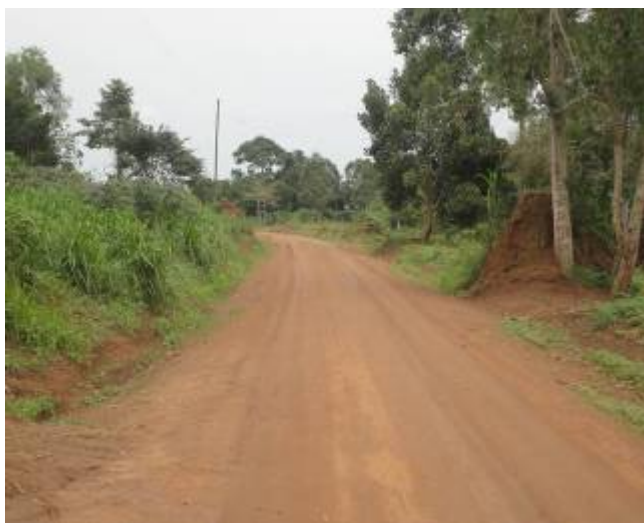
Butoolo- Sanya- Namugobo (9.3km) is an earth/spot gravelled district road, 7m wide that was undergoing routine mechanised maintenance using force account. Planned works on this road included grading and shaping, spot gravelling and drainage improvement works. At the time of the visit, only 9.3km had been graded but not compacted and the road was in fair condition.

Mpigi DLG: Graded and shaped sections on Butoolo- Sanya- Namugobo road (9.3km) road completed in Q2- 12/13.

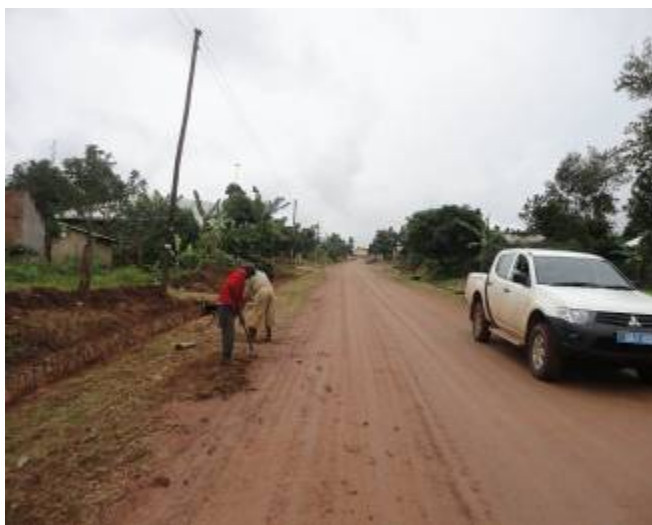
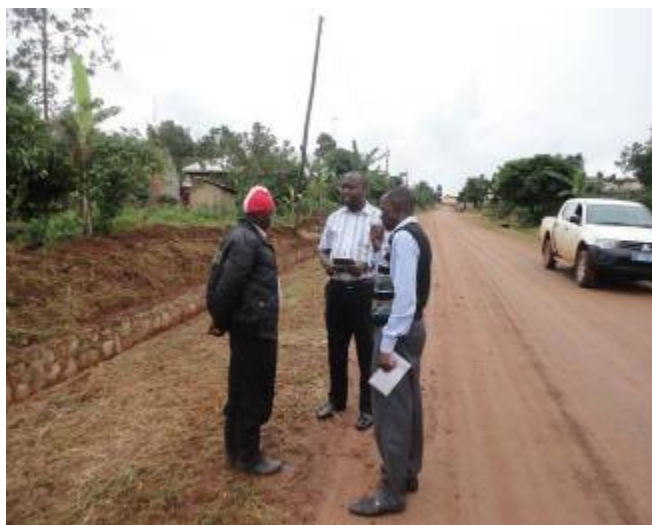
Amdan – Mpanga road (2.0km) is a gravel urban (town council) road that was undergoing routine manual maintenance using road gangs. Planned activities on the road included grass cutting, grubbing, side drain cleaning, opening offshoots and culvert cleaning. At the time of the visit, a gang of 8 workers was undergoing training on this road before being deployed to their respective sections. The road was in a good condition.

Mpigi DLG: Trial works on Amdan – Mpanga road Monitoring team interviewing gang headman

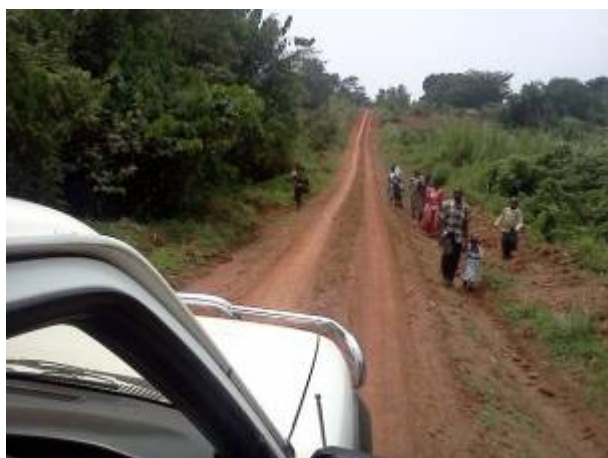
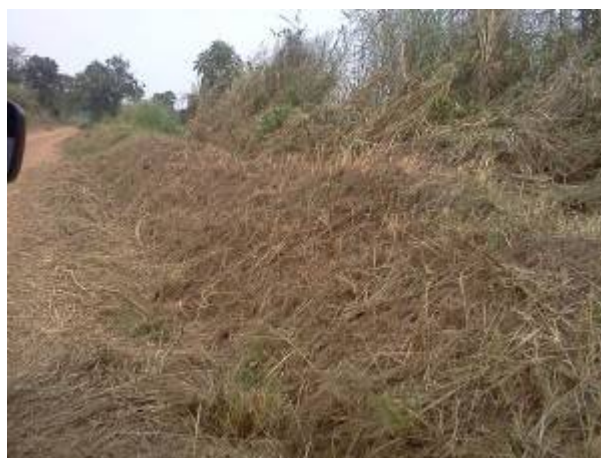
Mubende DLG: Recently graded and spot re-graveled Kiyuya- Kamondo road (L) and Routine Manual Maintenance along Kiyuya - Kamondo road using Road Gangs(R)

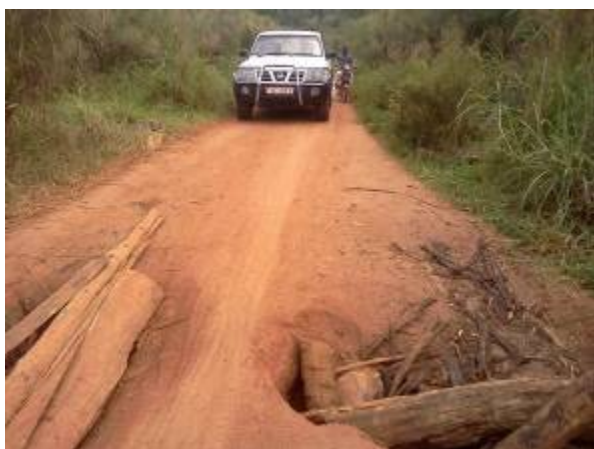
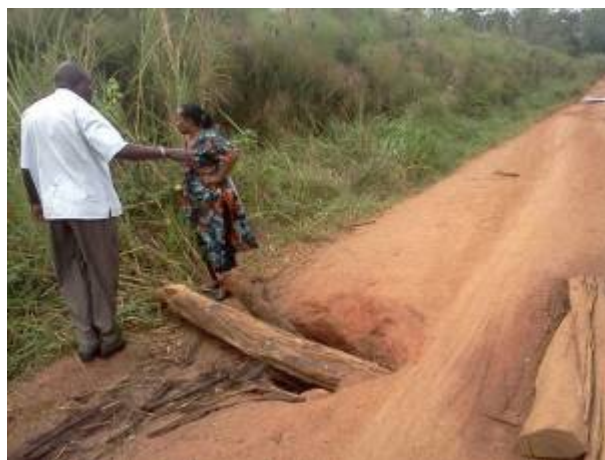
Mubende DLG: Damaged Culvert along Kiyuya – Kamondo Road - heavily loaded trucks ferrying maize and timber continue to damage such crossing

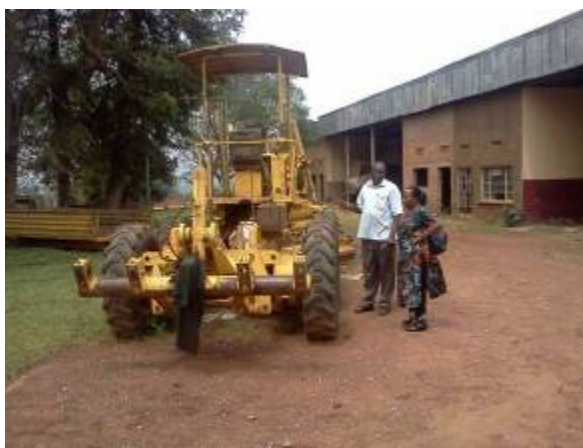
Mubende DLG: Old Grader (L) and Dozer (R) at Mubende DLG Works Department – the equipment require repairs

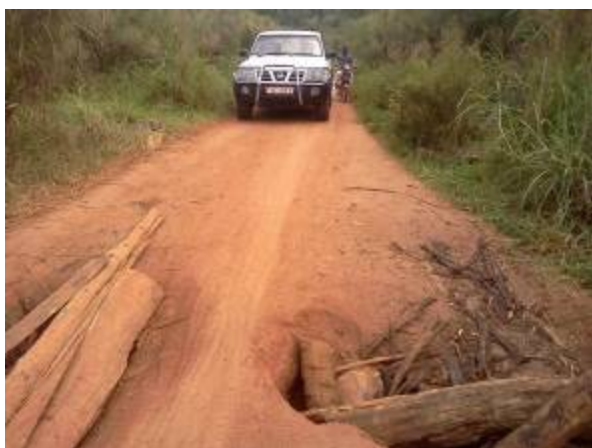
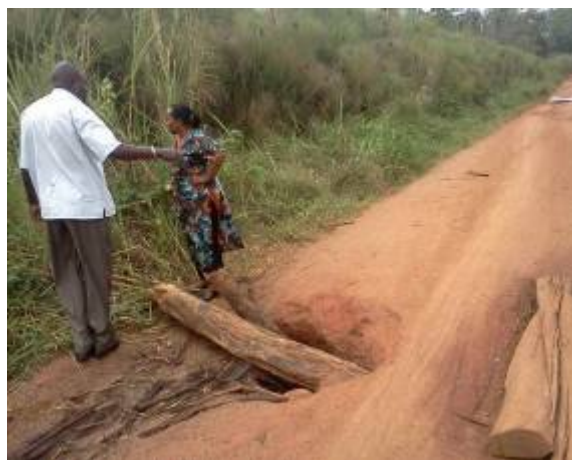
Mubende DLG: Damaged Culvert along Kiyuya – Kamondo Road road, heavily loaded trucks ferrying maize and timber continue to damage such crossing

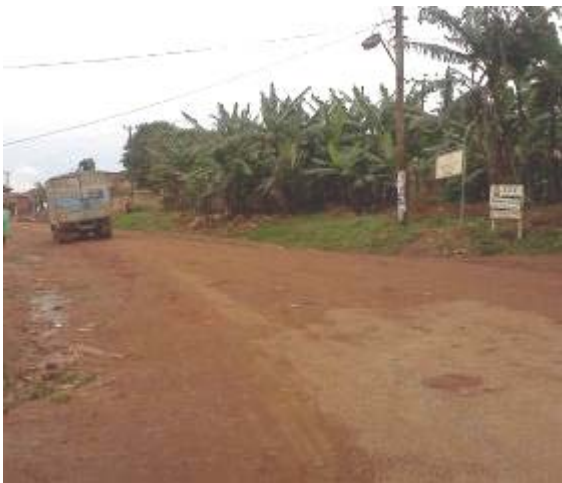
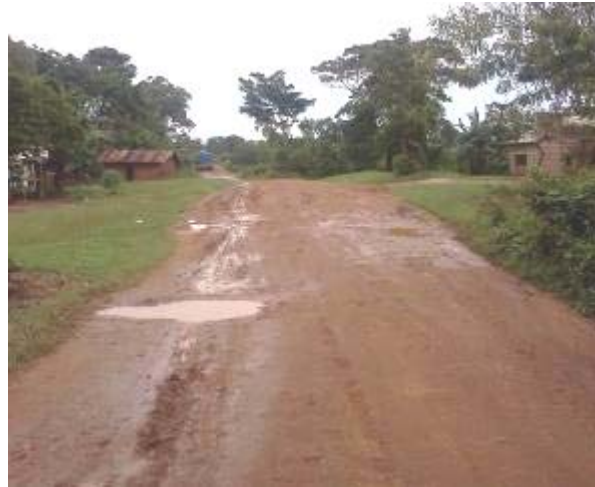
Mukono MC: Sections of Nsubi – Nabuti Road (4.5km) that was graded in Q1 FY 2012/13

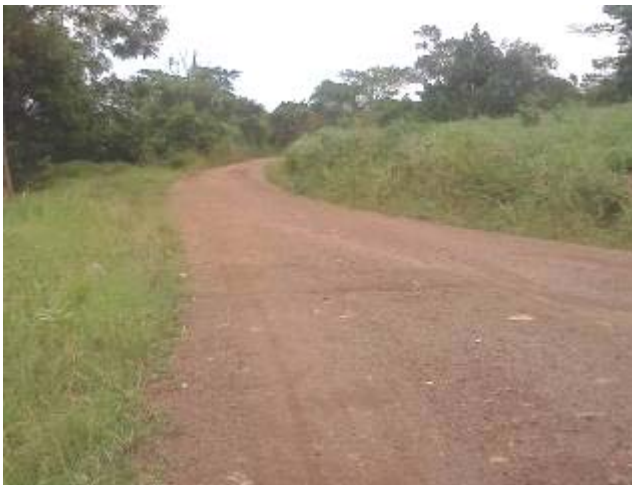
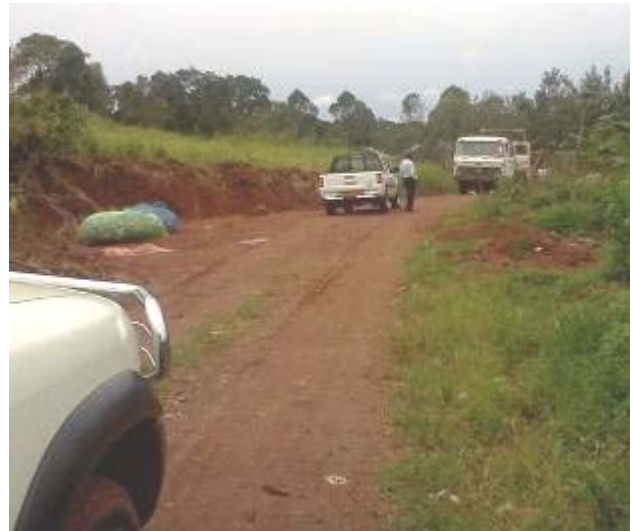
Mukono MC: Sections of Katikolo (L) and Kyungu (R) Roads that were graded in Q1 FY 2012/13

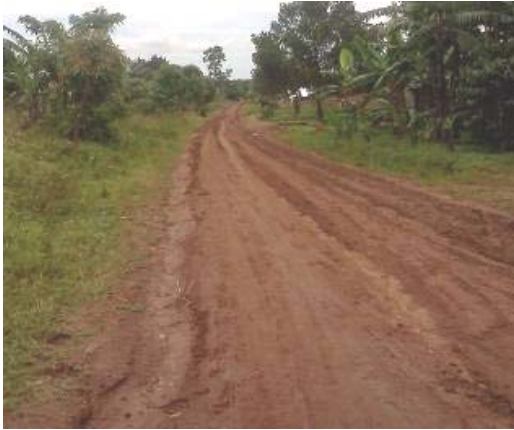
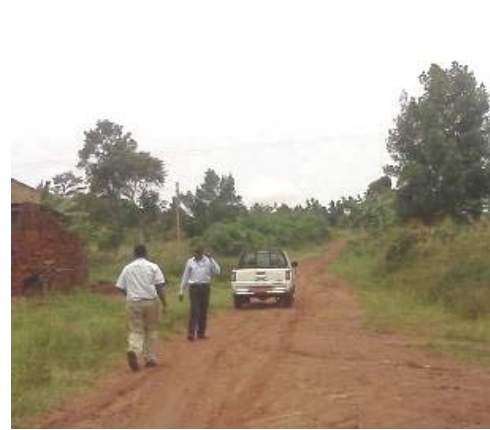
Mukono MC: Sections of Kyungu Road which has not received routine manual maintenance in the Quarter

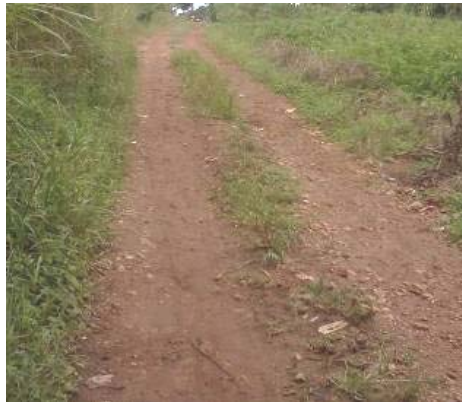
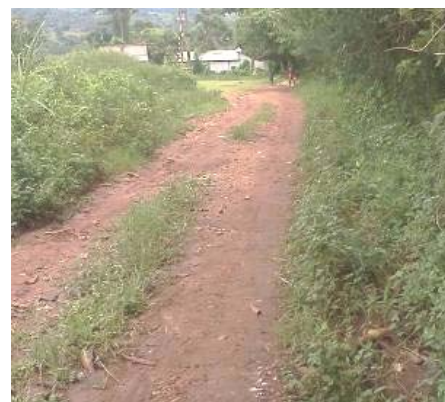
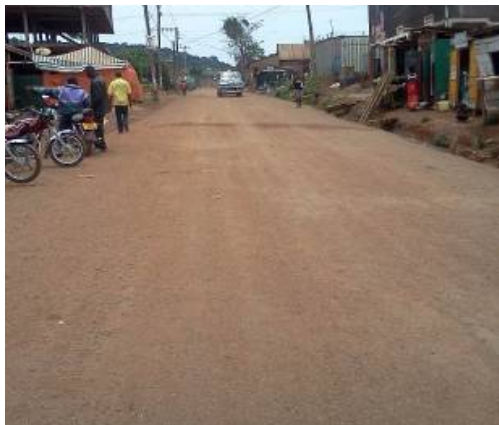
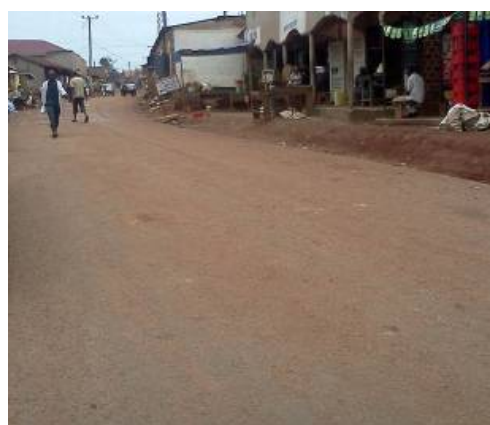
Mukono MC: Sections of Kame – Atoni Road (1km) which was the major project in FY 2012/13 which received single surface dressing. The Contractor still on site rectifying failures during the DLP

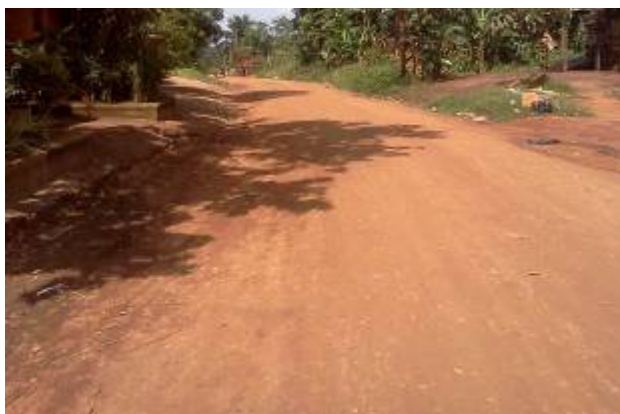
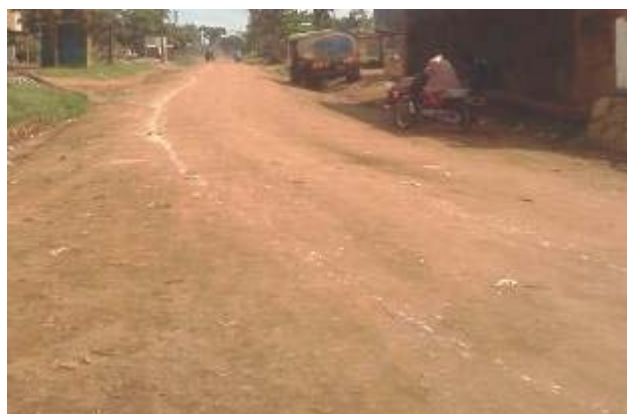
Mukono MC: Sections of Kobo - Musisi and Kiwanga – Sonde Roads which were graded and shaped in Q2 FY 2012/13

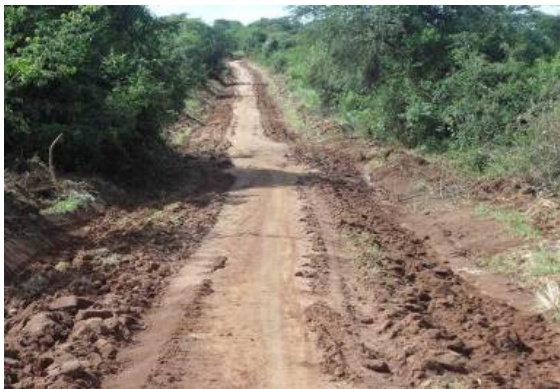
This road is about 45km away from Sembabule District headquarters. The work on this road was commendable with bush clearing done on the whole road length and grading in progress. The major challenge that was observed along this road is that the soil is very fine requiring more gravel to improve on its plasticity, as observed that the road was very slippery during rains.

Sembabule DLG: Ntuusi- Kabugongote road (12km) being graded and scarified

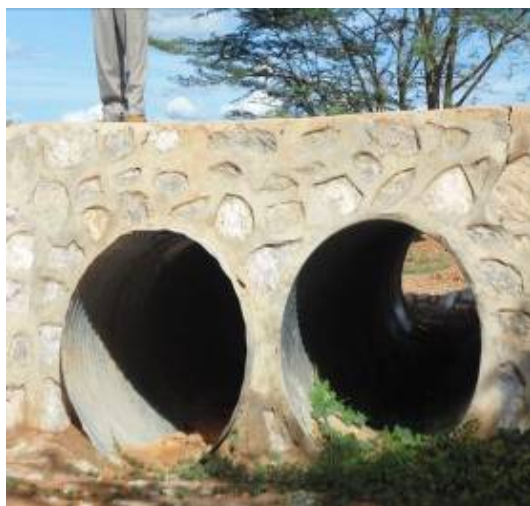
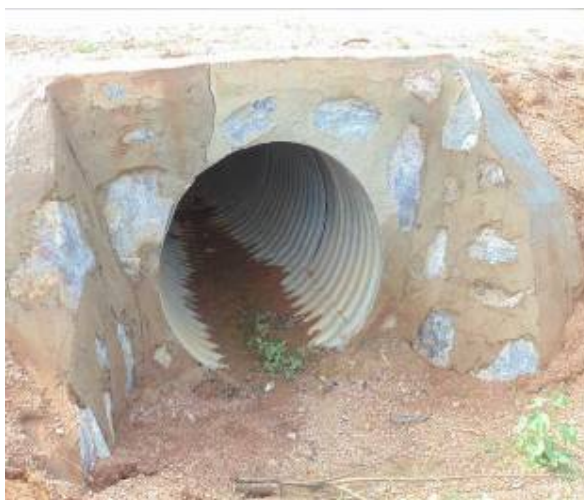
Kitahire Bridge, which is 40 meters long had collapsed cutting off interconnection in parts of Sembabule district. The construction work begun in Quarter one and completed in Quarter three with 16 meters of 1200mm dia and 19 meters of 900mm dia amco culverts installed, gabion built and gravel fill done. See photos below:

Sembabule DLG: First section of Kitahire bridge (L) and second section of Kitahire bridge (R)

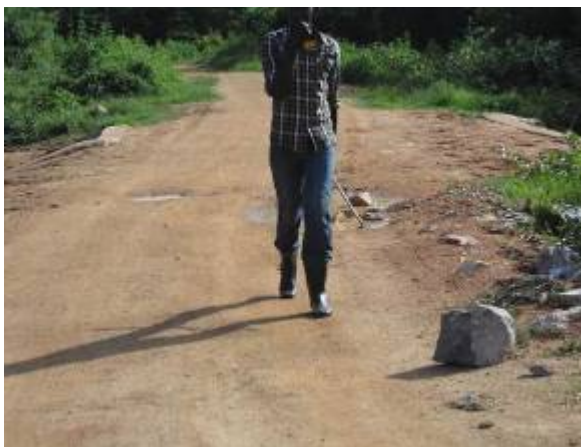
Sembabule DLG: Kitahire road section covering the second culvert of the bridge.
