# ROAD MAINTENANCE MONITORING REPORT

QUARTER 1-3 FY 2016/17 (July 2016 – March 2017)

*Executive Director  
Uganda Road Fund  
5th Floor Twed Towers  
Plot 10, Kafu Road, Nakasero  
P.O.Box 7501, Kampala*

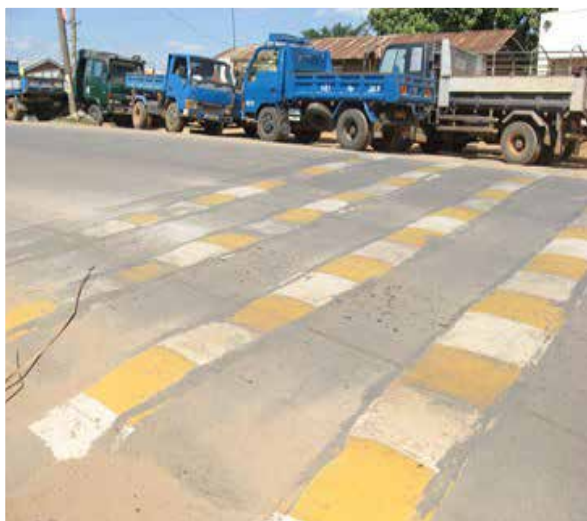
**UNRA Mbarara:** Newly repaired and painted rumble strips on Mbarara-Ntungamo road (60km) under routine mechanised maintenance

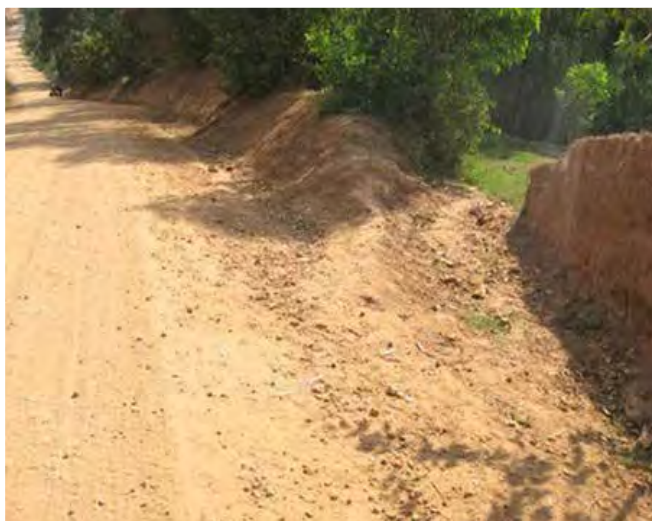
**UNRA Mbarara:** Heavy grading done on Kabwohe-Kitagata-Rukungiri road (66km) under term maintenance

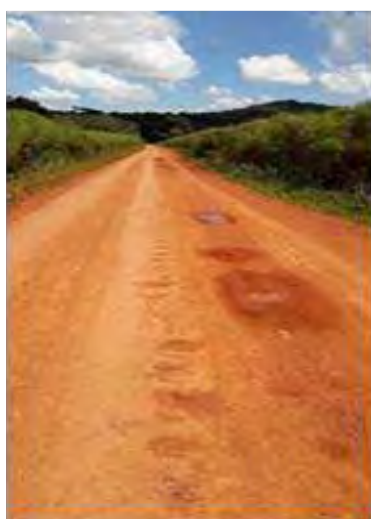
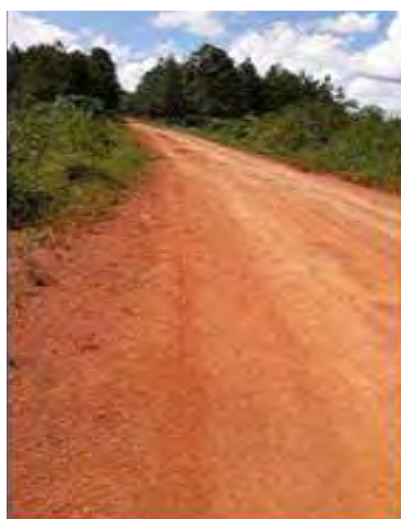
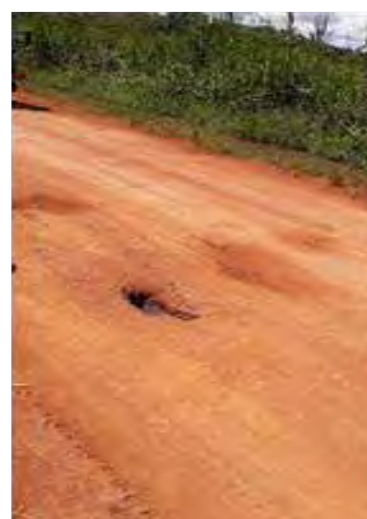
2.	Mitala Maria – Bulu - Kanoni (30Km)	<p>Routine Manual/Mechanised Maintenance using Term Maintenance contracting on Mitala Maria – Bulu - Kanoni (30Km) and Mityana – Busunju (30Km)</p> <p>Contractor: Rodo Contractors Ltd Contract sum: UGX 4,145,933,000 Commencement: 2 Feb 2015 Completion: 2 Feb 2018 Cycle: 5 of 6</p>	<p>The road had been graded to shape and gravelled in 4 cycles and works covering the 5<sup>th</sup> cycle were still underway.</p> <p>The road was still generally in fair condition but was due for regrading as some sections of the road had developed potholes, galleys on slopes, water crossing the surface at swamp between Km 6+400 and 6+600 and some culvert crossings were broken, therefore requiring replacement. Vehicle measurement of road length was 30.2Km.</p>
----	-------------------------------------	---	--

*UNRA Mpigi: Sections of Mitala Maria – Bulu – Kanoni road which was undergoing routine mechanized maintenance under Term Maintenance contracting*

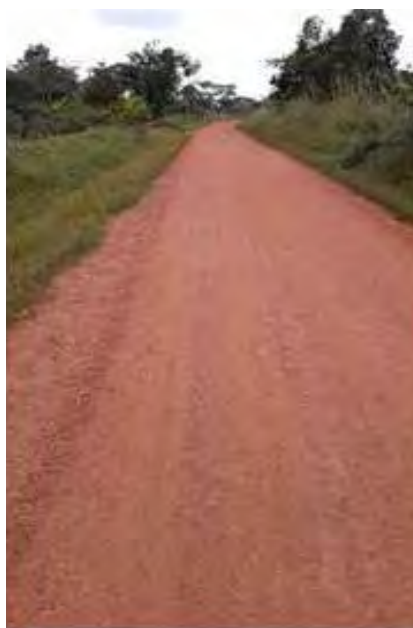
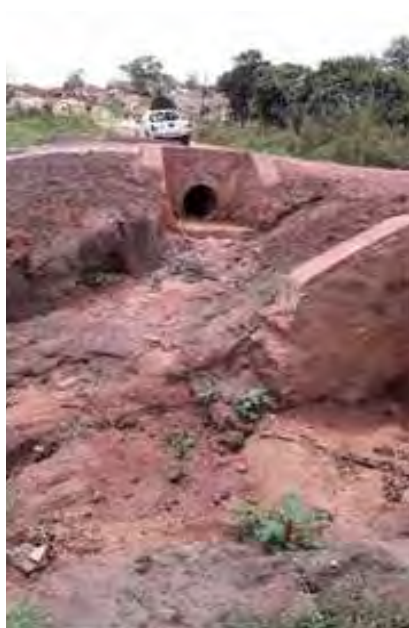
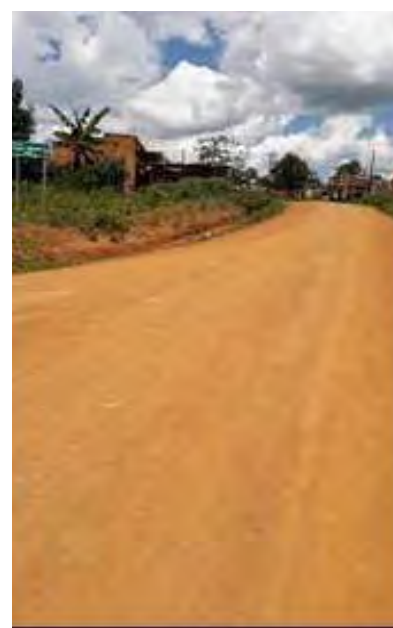
**UNRA Mpigi:** Sections of Maddu – Musozi road, which was worked on using force account

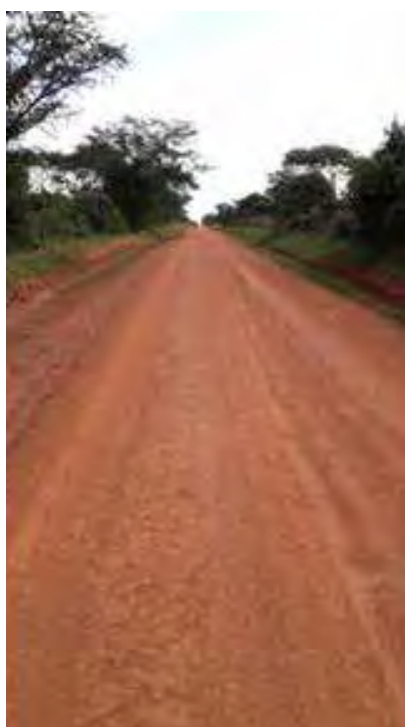
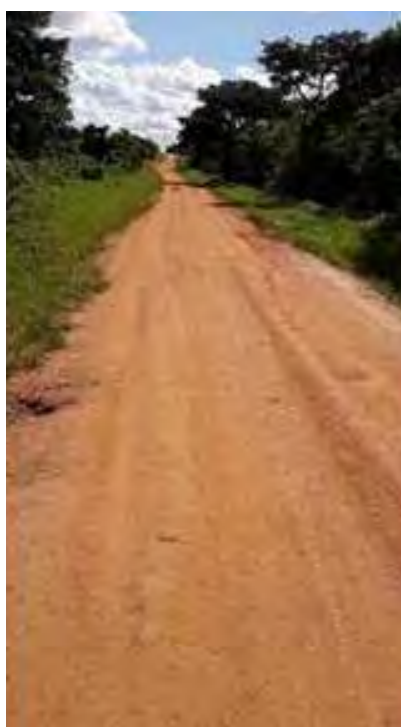
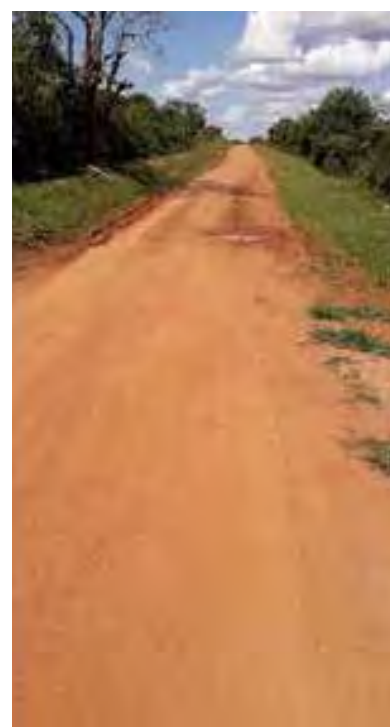
2.	Maddu – Kyayi - Nabakazi road (40Km)	Routine mechanised maintenance using force account	<p>The road had been graded and spot gravelled in selected sections. A total of nine 900mm dia. Culverts had been installed but required more backfill along the approaches. Routine manual maintenance was evident along most of the road.</p> <p>The road was generally in fair condition but with potholes in some sections and overgrown grass on the shoulders in some sections. Vehicle measurement of road length was 40 Km.</p>

**UNRA Mpigi:** Sections of Maddu – Kyayi – R. Nabakazi road, which received routine manual and mechanized maintenance .

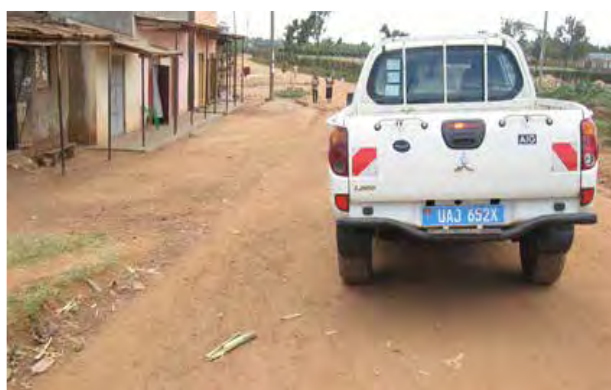
**Mbarara MC:** Karugangama road (6.0km) that had received RMeM involving bush clearing and reshaping

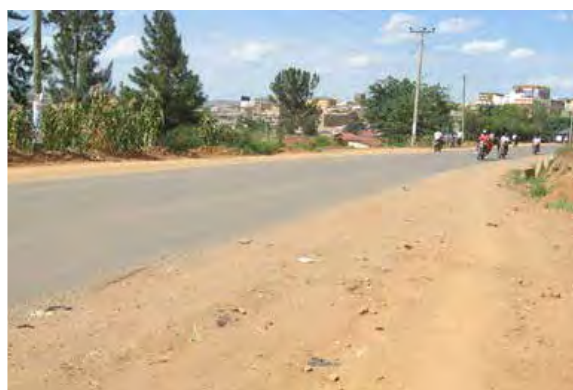
**Mbarara MC:** Ntare road (3.2km) that had received RMeM involving shoulder repair, pothole patching, and desilting culverts

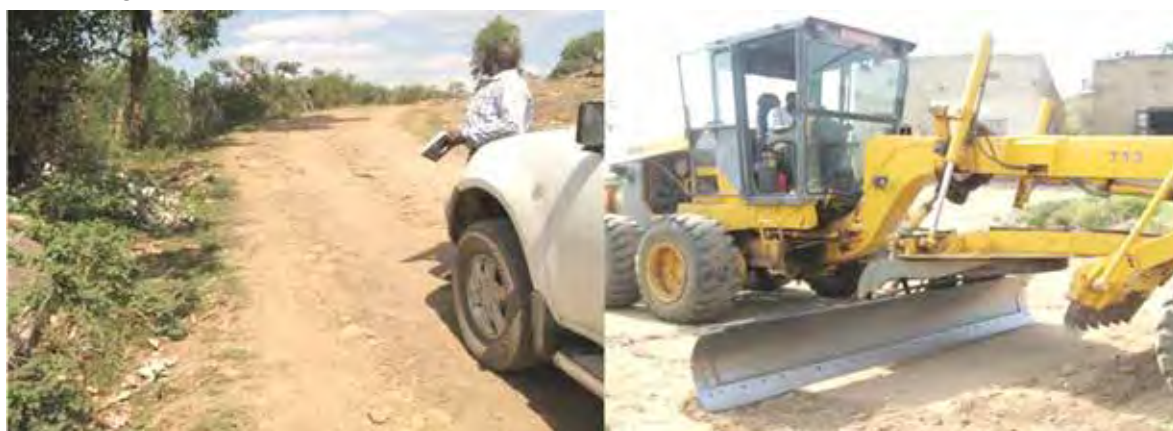
**Mitooma district:** A section on Bukuba-Bitereko-Rwempunga road (9.0km) that was riddled with rock outcrops.

**Mitooma district:** A grader on Bitereko-Kiyanga-Rutookye road (23.5km) being used for restoration of camber

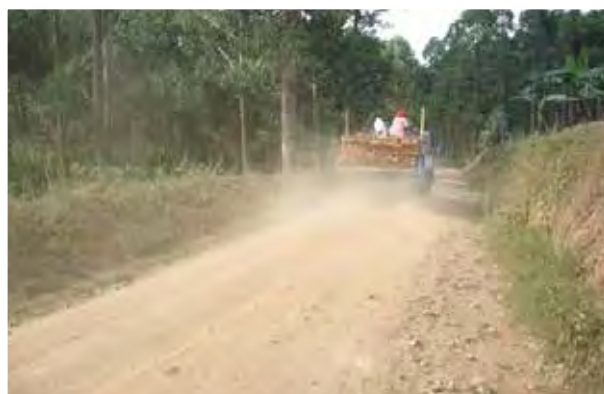
*Rukungiri district: A section on Rukungiri-Rubabo-Nyarushanje road (27.8km) that was fully graded under RMeM.*

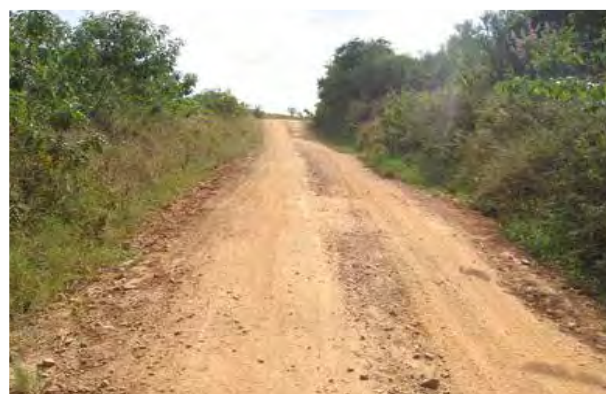
*Rukungiri district: A section on Rukungiri-Rubabo-Nyarushanje road (27.8km) that was spot gravelled under RMeM.*

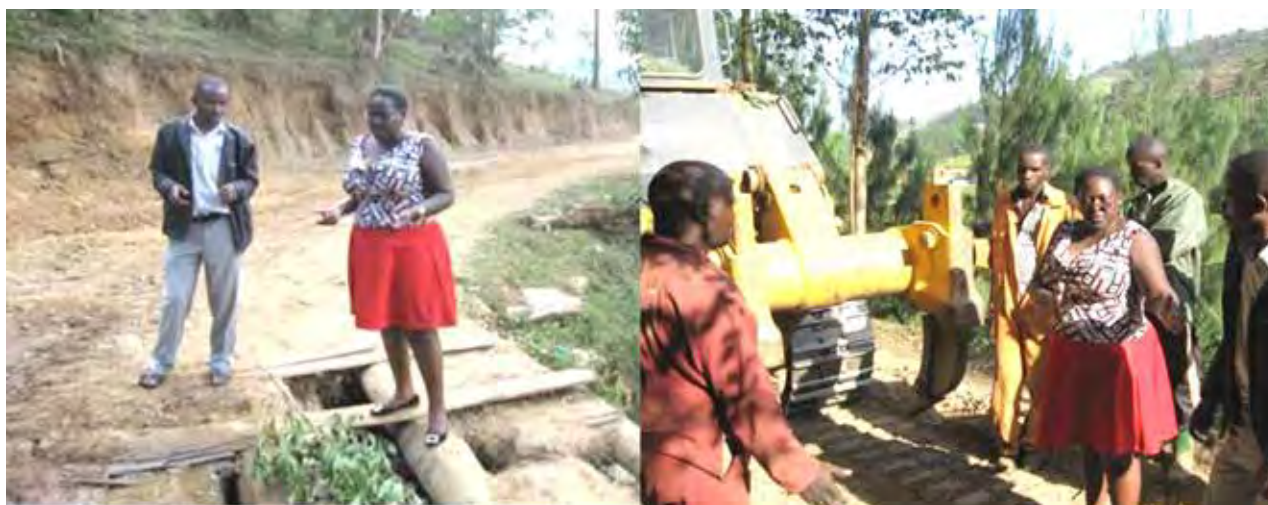
**Rubanda district:** A bottleneck created by a stream crossing on Muko-Kara-Mengo-Iyamuriro-Nshanjare road (22.1km) with temporary timber logs for crossing.

**Rubanda district:** Bottleneck removal involving cutting through the hillside to widen narrow sections on Kashasha-Ihunga road (13.2km).

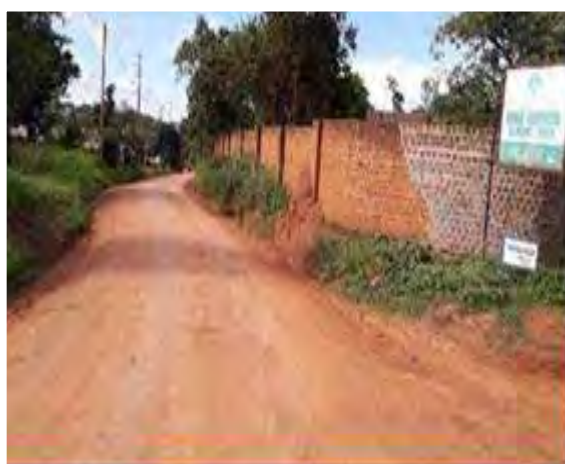
Sn	Road Name	Site Observations
1.	Kito - Nsasa (1.6Km) – Planned for routine mechanised maintenance	The road had been graded to shape and spot gravelled in selected sections of about 300m. However the road had not been compacted and gravel had been left in the side drains in some sections. The road was measured to be 1.6Km.

**Kira MC:** Sections of Kito - Nsasa road, which had been graded and spot graveled in selected sections

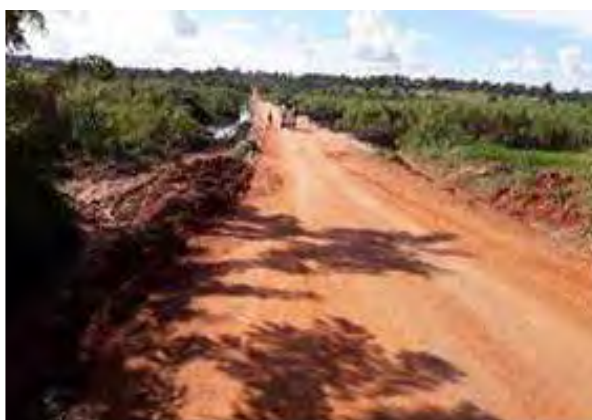
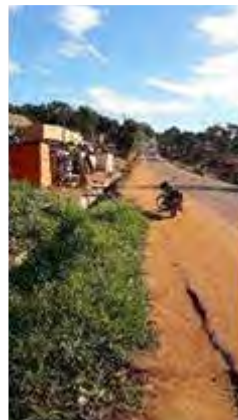
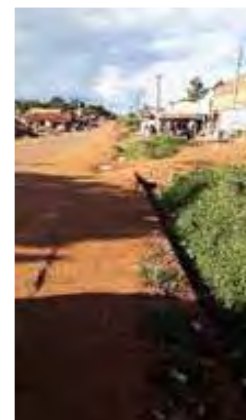
3.	Kiwologoma - Kijjabijjo (4.5Km) – Planned for routine mechanised maintenance	Works undertaken on the road included pothole patching, installation of access culverts, stone lining of side drains along a distance of about 200m both sides and emergency works on a swampy section of about 300m.

**Kira MC:** A section on Kiwologoma – Kijjabijjo with Emergency repairs (L); and sections of Kira – Kijjabijjo with Stone Lining works

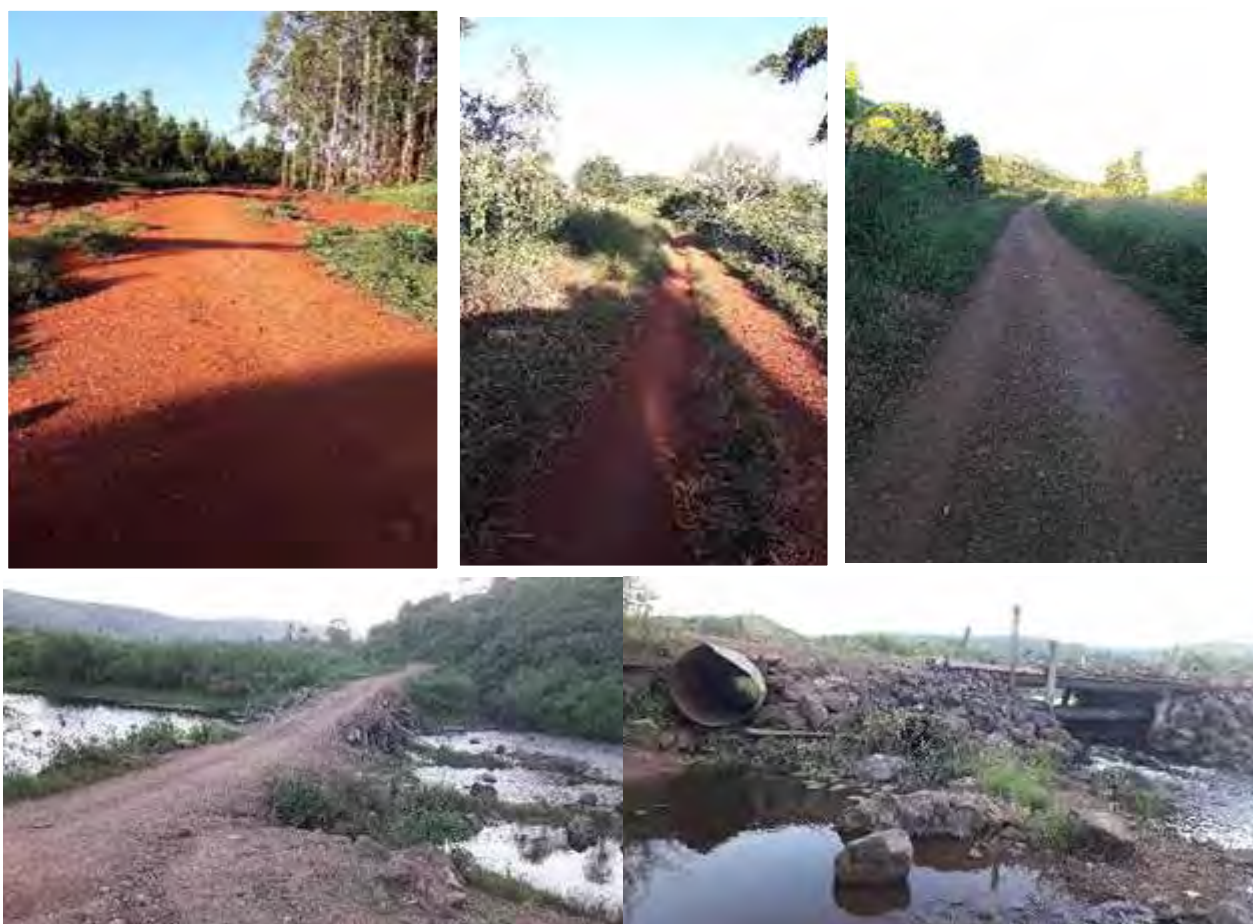
**Figure 3.6: Photographs in Kyankwanzi district**

Sn	Road Name	Site Observations
1.	Nzoo - Bambala (12.5Km)	Works done on the road included bush clearing and grading, and spot gravelling in selected sections. The road was however overgrown with grass across the side drains and shoulders and had a critically distressed bridge at the end of the road. The riding surface was still fair however the road had not received routine manual maintenance. Vehicle measured length of the road was 12.5Km.

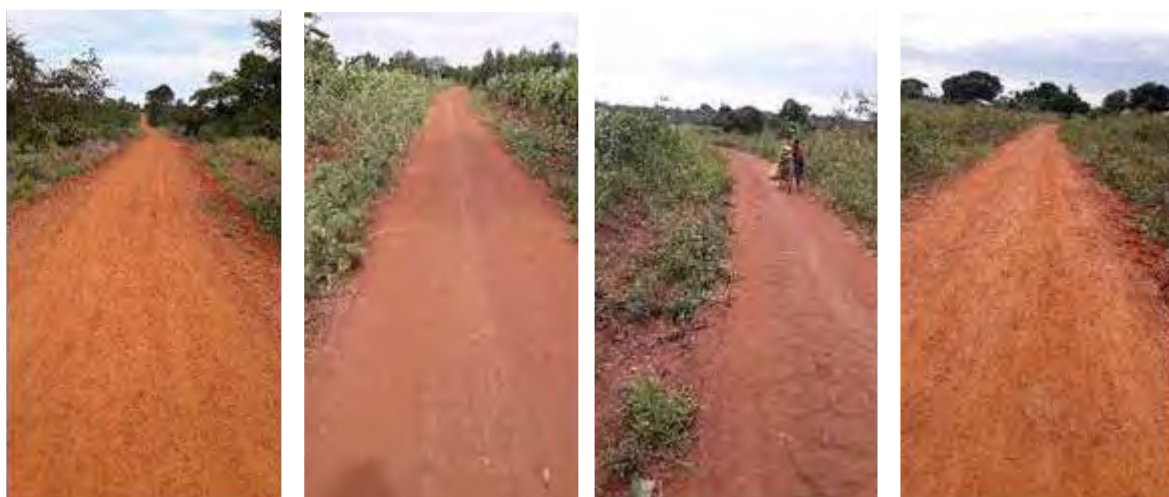
Sn	Road Name	Site Observations
1.	Butemba College – Kayunga road (1.6Km)	Works done on the road included bush clearing, grading and spot gravelling in selected sections. 3no. 600mm diameter cross culverts had been installed however they had insufficient gravel cover on the approaches. Both the gravelled and graded sections had not been compacted and the shoulders along the graded sections were overgrown with grass.

*Butemba TC: Sections of Butemba College – Kayunga road*

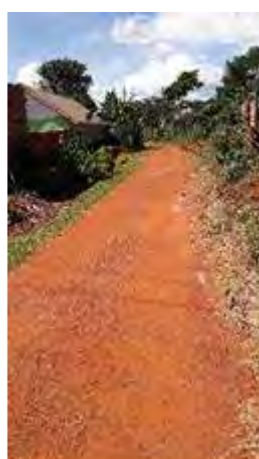
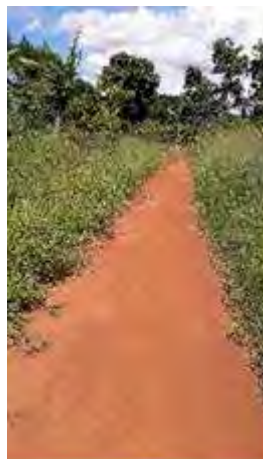
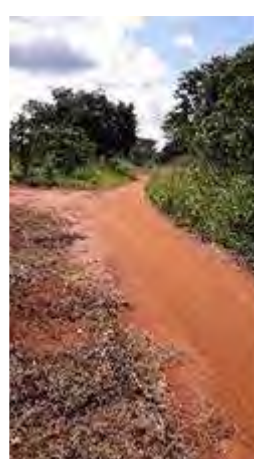
Sn	Road Name	Site Observations
1.	Kaleem – Byasali road (2.0Km)	Works done on the road included opening, bush clearing, and grading to a width of about 4.5m. However no offshoots had been provided and the road had not been compacted and was overgrown with grass across the shoulders in some sections.

**Ntvetwe TC: Sections of Kaleem – Byasali road**

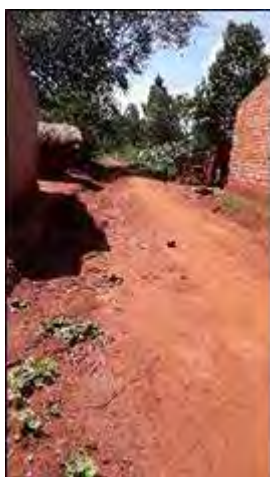
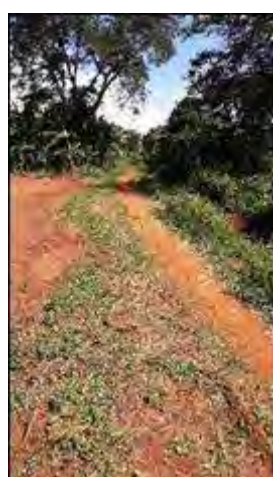
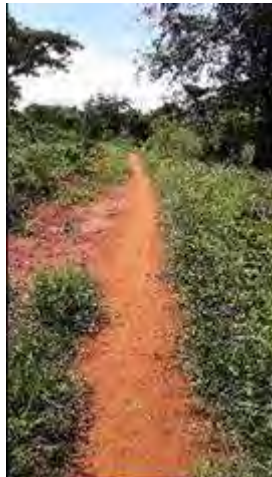
Sn	Road Name	Site Observations
2.	Nalumbuye - Masembe road (1.5Km)	Works done on the road included opening, bush clearing, and grading to a width of about 4.5m. However no offshoots had been provided and the road had not been compacted and was overgrown with grass across the shoulders/carriageway in some sections.

*Ntwetwe TC: Sections of Nalumbuye - Masembe road*

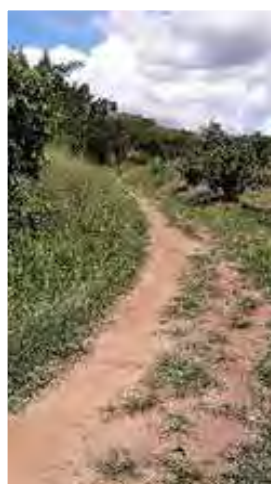
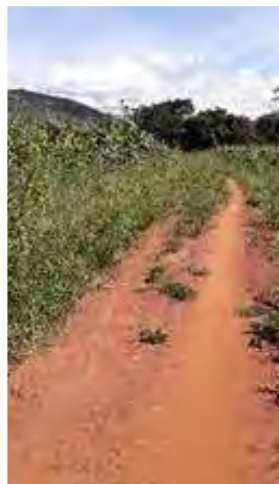
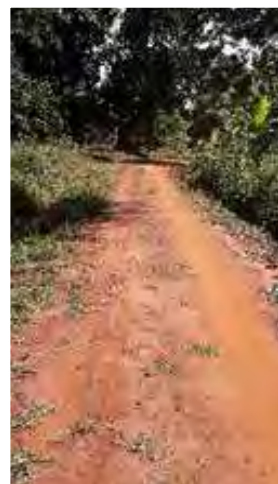
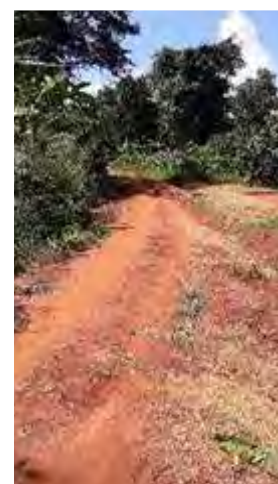
3.	Sekidde - Ensieribetya road (2.0Km)	Works done on the road included opening, bush clearing, tree removal, and grading to a width of about 5.0m. However no offshoots had been provided and the road had not been compacted and was overgrown with grass across the shoulders/carriageway in some sections.
----	-------------------------------------	--

*Ntwetwe TC: Sections of Sekidde - Ensieribetya road*

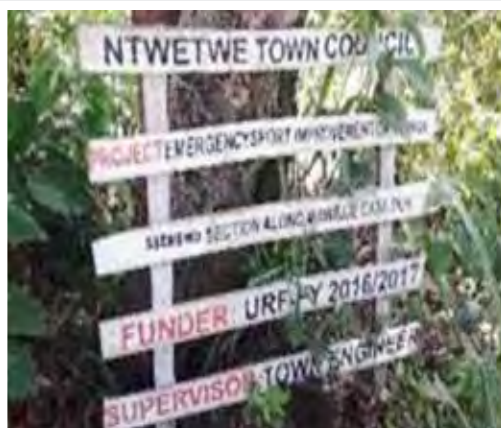
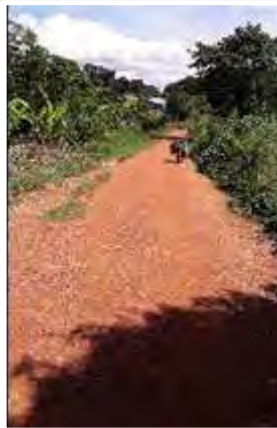
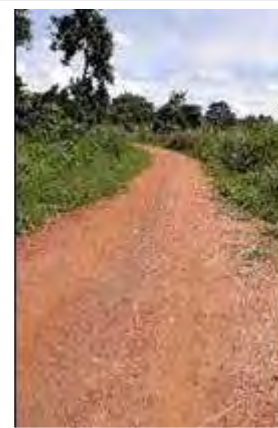
Sn	Road Name	Site Observations
1.	Church Semeo road (1.0Km) – the road was providing alternative access to Ntwetwe town after a section of the main access, Ntwetwe – Kiboga road, which is under UNRA had been cut-off by floods and had a slippery surface.	Works that had been done on the road included grading to formation and spot gravelling in selected sections measuring 350m. Vehicle measured length of the road was 1Km.

**Ntwetwe TC: Sections of Emergency works on Church Semewo Road**

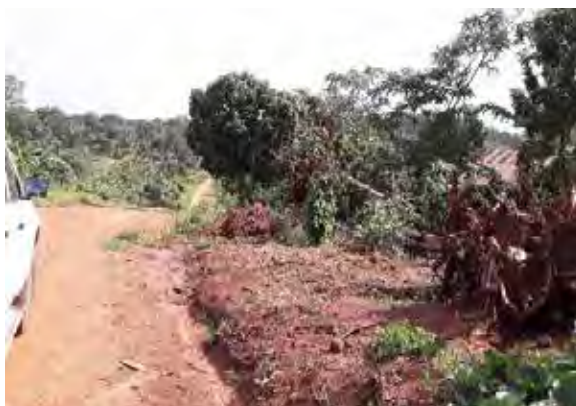
***Luwero DLG: Sections of Luwube –Nakyewa road (Community Access Road in Katikamu Sub-county)***

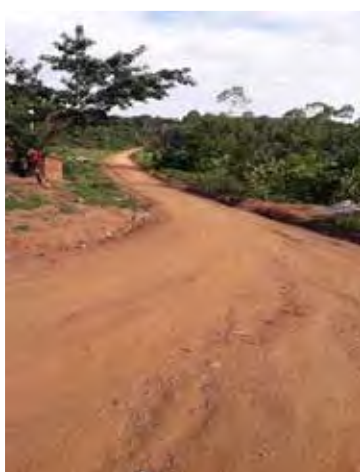
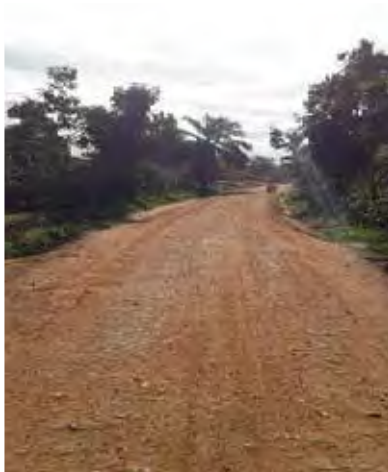
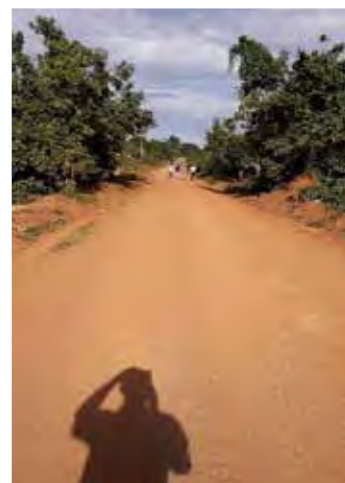
***Luwero DLG: Sections of Koko – Kiziri road***

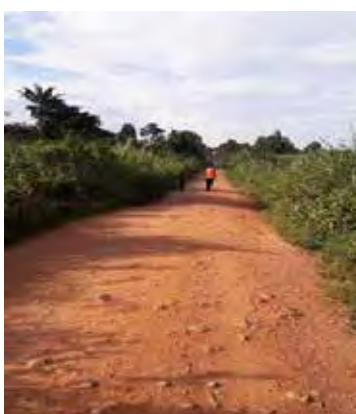
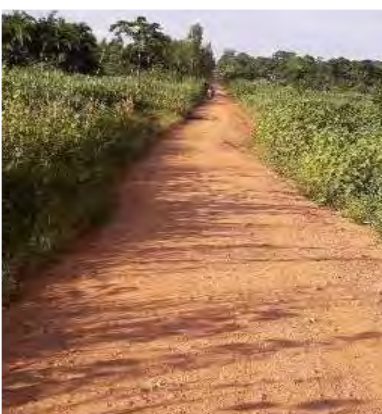
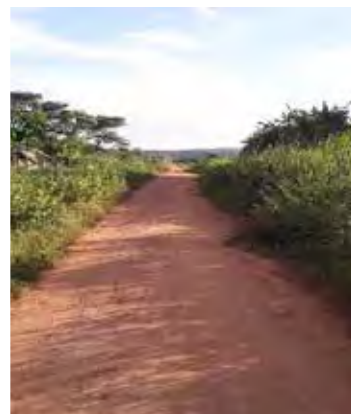
***Luwero DLG: Sections of Kalagala – Namawojja road***

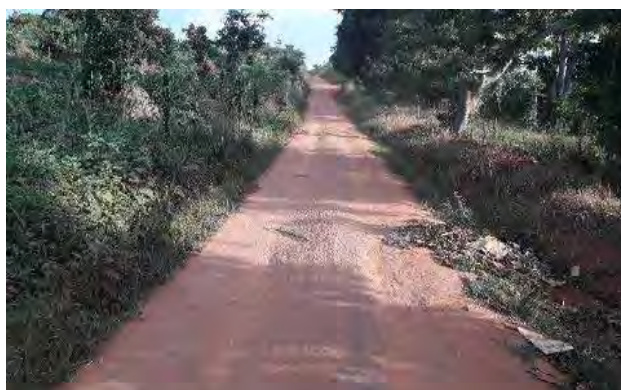
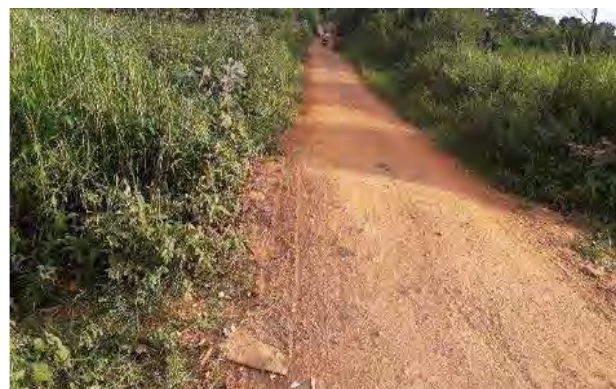
*Luwero DLG: Sections of Kalagala – Lutete road*

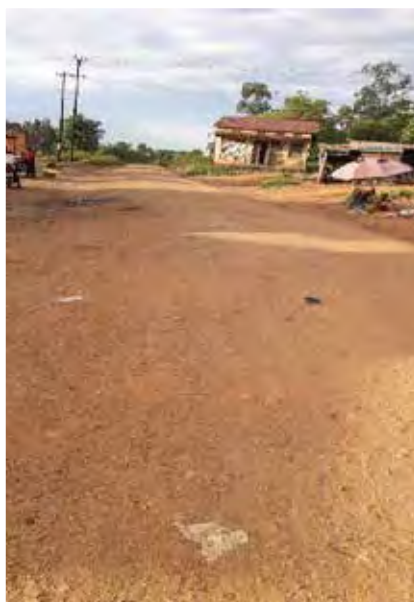
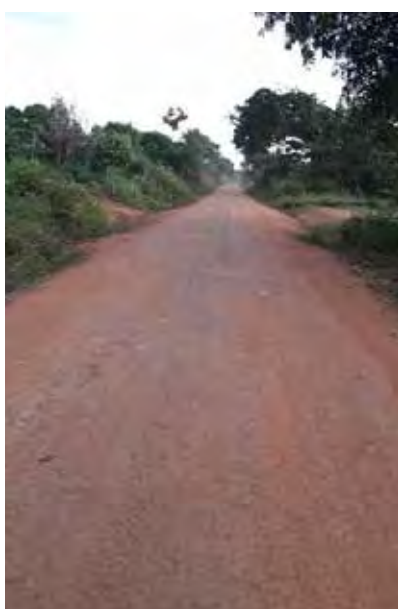
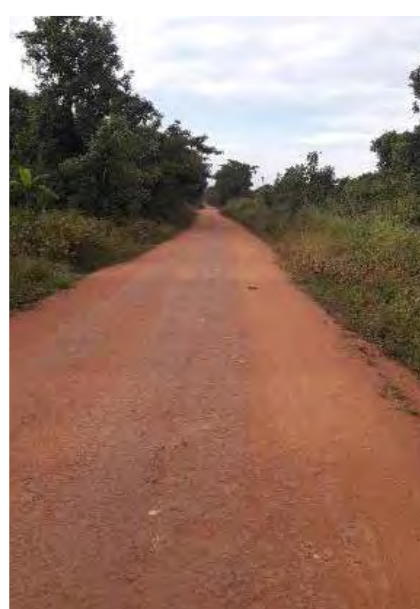
5.	Bamunanika – Kikusa (16.0Km), <i>planned for periodic maintenance but received routine mechanised maintenance</i>	The road had been graded and compacted, and selected spots of about 1.0Km had been gravelled. The road was however overgrown with grass across the side drains. Vehicle measurement of road length was 15.5Km.

*Luwero DLG: Sections of Bamunanika – Kikyusa road*

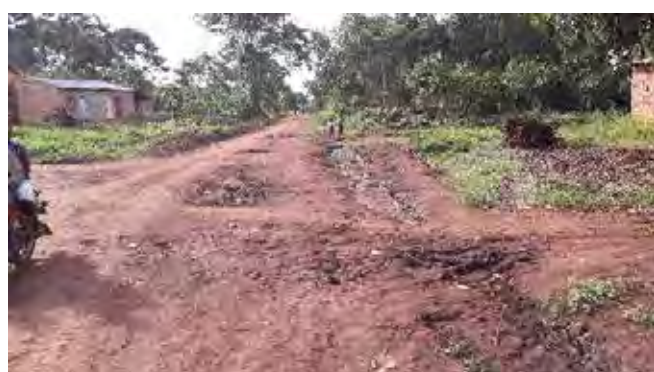
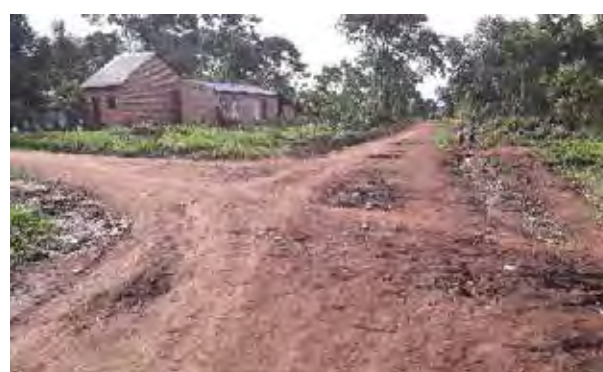
***Luwero TC: Sections of Eng. Jemba road***

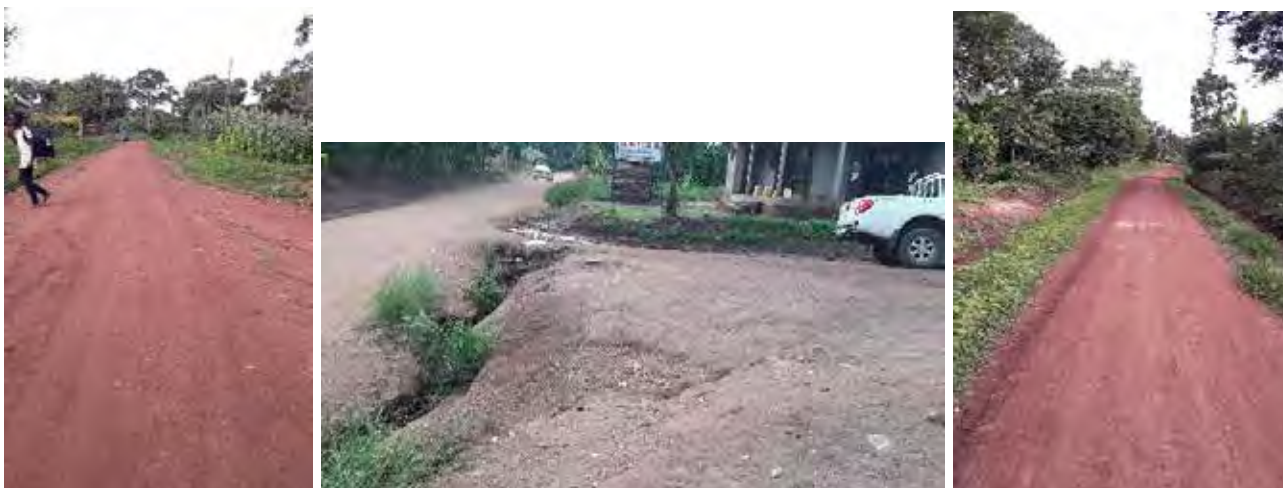
*Luwero TC: Sections of Kizito - Nsubuga road*

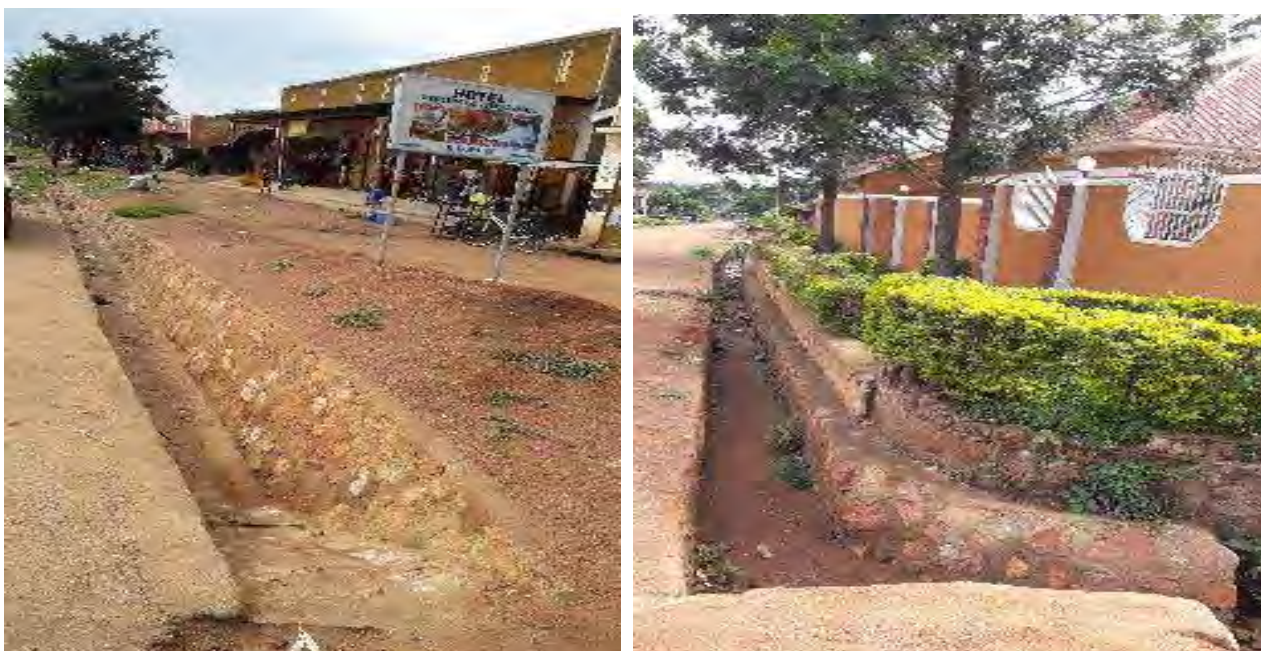
Sn	Road Name	Site Observations
1.	Kyebakutika road	Stone pitching of the side drains had been done in 4 sections totalling about 250m. The road had been previously paved but with the lining of the side drains left outstanding.
2.	Kizito – Nsubuga road (1.2Km)	The road had been graded and compacted, however it had no access culvert at the beginning and therefore could hardly be accessed by motorised traffic. The road was overgrown with grass across the shoulders and had no offshoots provided. Vehicle measurement of road length was 1.1Km.
3.	Eng. Jemba road (0.7Km)	The roads had been opened, and shaped to formation. Trees removed from the roadway were observed, however no offshoots or culverts had been provided.
4.	Ivan road (0.4Km)	
5.	Eng. Jemba – Ivan road	
6.	Road no.2 –Kalibbala (0.2Km)

*Luwero TC: Sections of Kyebakutika road*

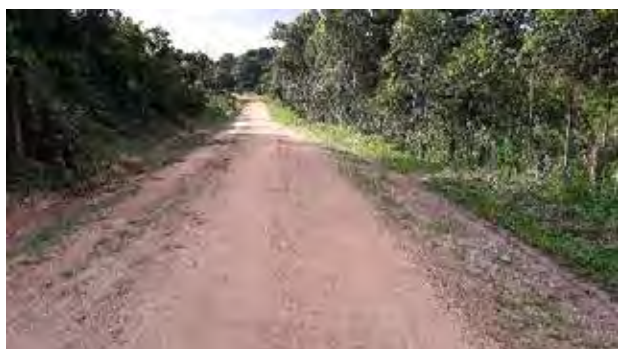
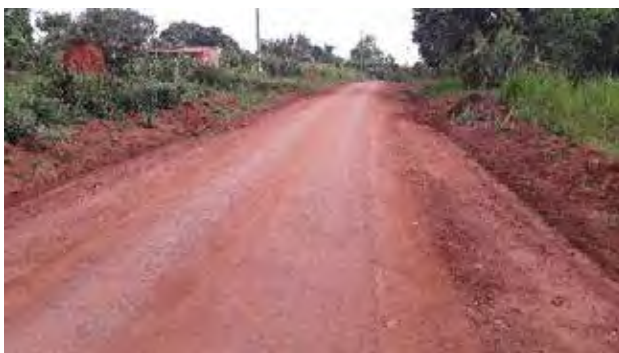
**Wakiso DLG:** Sections of Gobero – Magogo - Mwera road

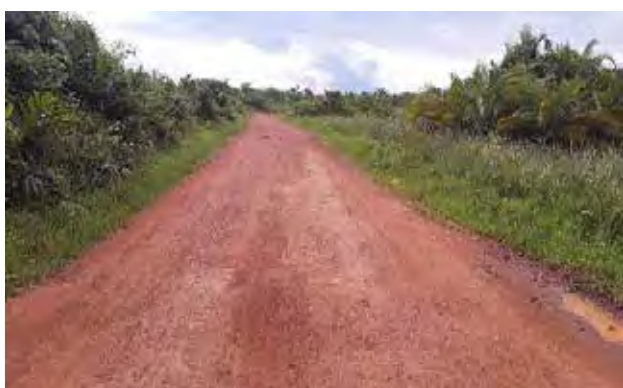
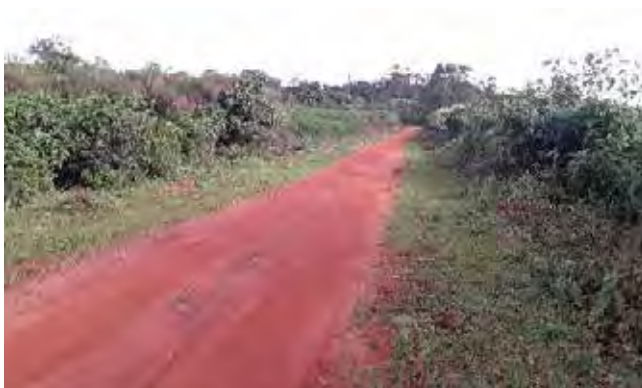
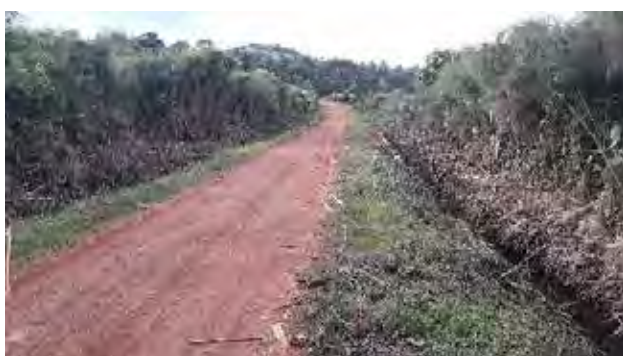
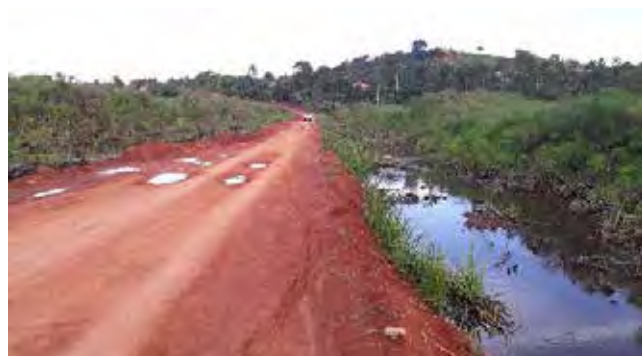
3.	Nansana – Bira – Kireka road (6.7Km)	The road had been graded to formation and spot gravelled in selected sections of about 1.6Km including a section of 1Km which was planned for lime stabilisation and sealing. Heavy scouring of the side drains was observed in several sections of the road partly due to the fact that no mitre drains/ relief culverts had been provided along the entire road. The riding surface was however still in fair condition with the exception of the first 300m, which was rough. Vehicle measurement of length was 6.1Km.

**Wakiso DLG: Sections of Nansana – Bira - Kireka road**

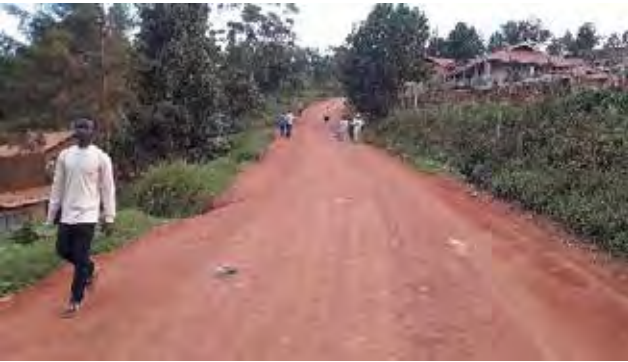
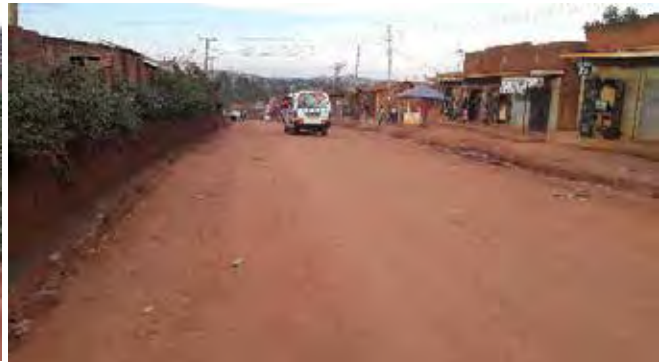
**Wakiso DLG: Sections of Nansana – Bira - Kireka road**

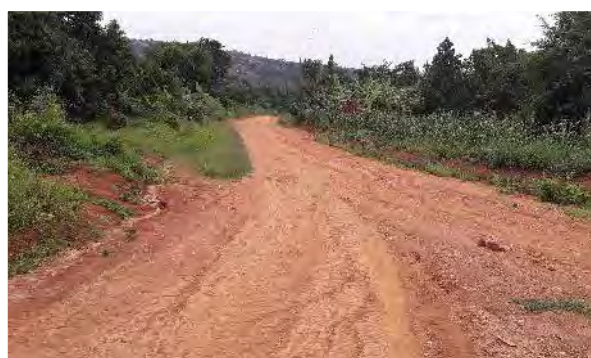
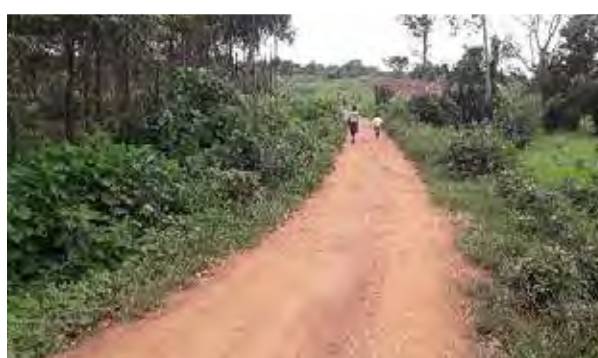
**Wakiso TC: Sections of Kimomongole road**

Sn	Road Name	Site Observations
1.	Kimomongole road (1.5Km)	Works done on the road included road opening and widening to about 9m width, grading of the road to shape, removal of trees and installation of 2no. 900mm diameter culverts lines. The road was however overgrown with grass across the shoulders in some sections. Vehicle measurement of road length was 0.8Km.

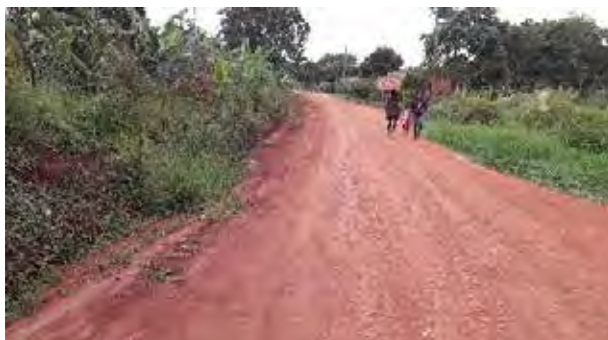
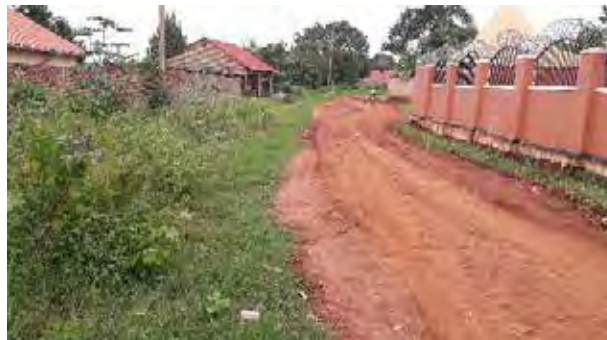
**Wakiso TC: Sections of Mukabwe road**

2.	Mukabwe road (3.1Km)	Works done on the road included road opening and widening to about 9m width, grading of the road to shape, removal of trees and installation of 2no. 600mm diameter culverts lines. The riding surface along the road was however still rough and the road was overgrown with grass across the shoulders in some sections. Vehicle measurement of road length was 1.2Km.
----	----------------------	--

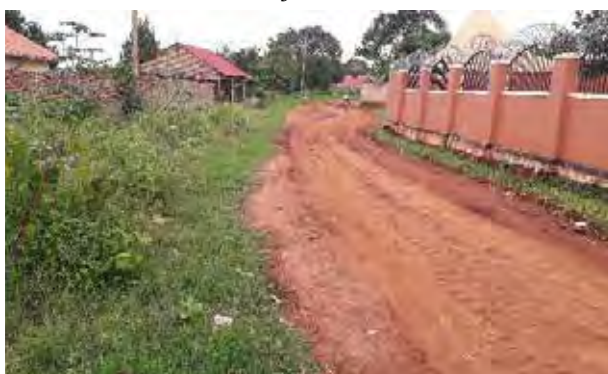
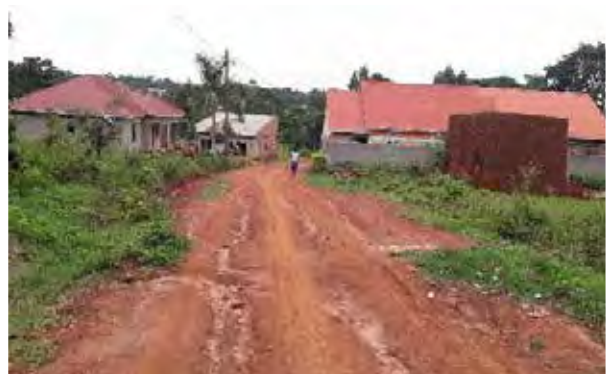
**Wakiso TC: Sections of Mukabwe road**

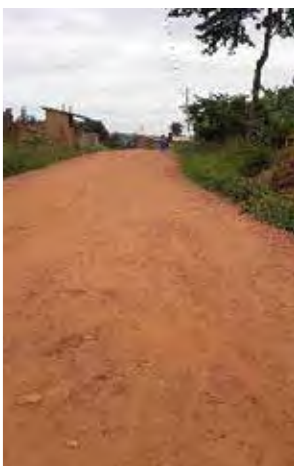
**Wakiso TC: Sections of Nakasuga road**

3.	Nakasuga road in Kasengeje ward	Works done on the road included road opening and widening to about 10m width, grading of the road to shape and removal of trees. Vehicle measurement of road length was 1.1Km.
----	---------------------------------	--

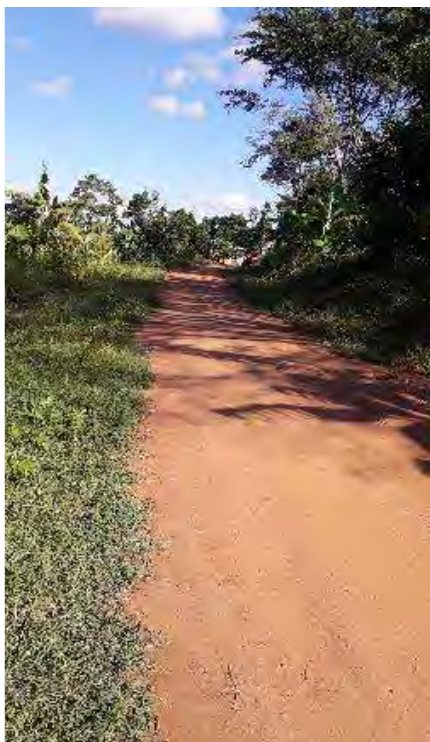
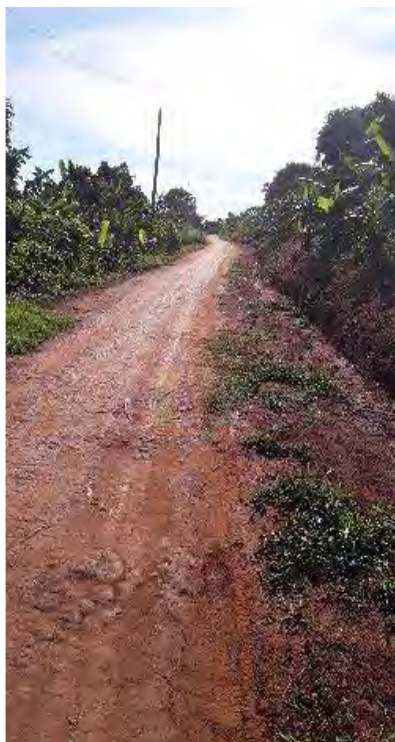
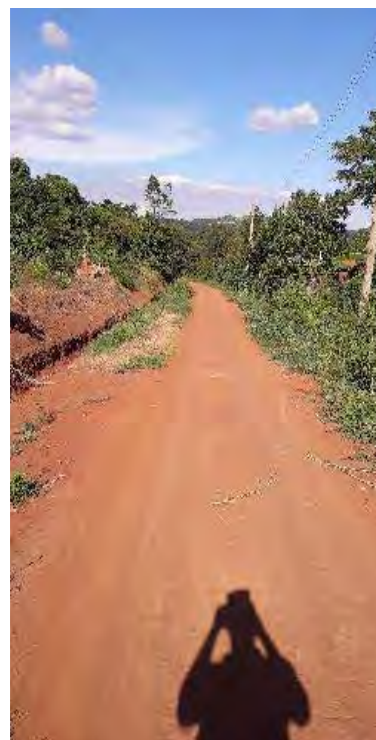
***Kakiri TC: Sections of Lutakome road***

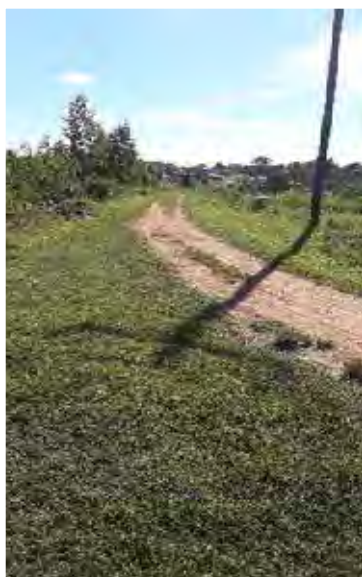
*Kakiri TC: Sections of Southern Bypass road*

<p>2. Southern Bypass II (1.5Km), planned for periodic maintenance</p>	<p>Works that had been done on the road included road opening, shaping and culverts installation. Grass had however grown across the entire carriage was though it had been cut short by routine manual maintenance interventions. The road had a bottleneck at 0.1Km, which was impassable.</p>
--	--

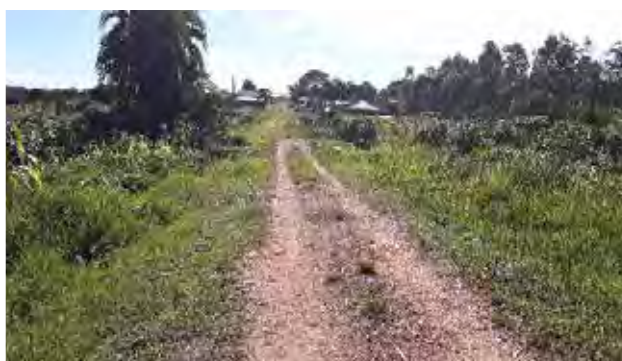
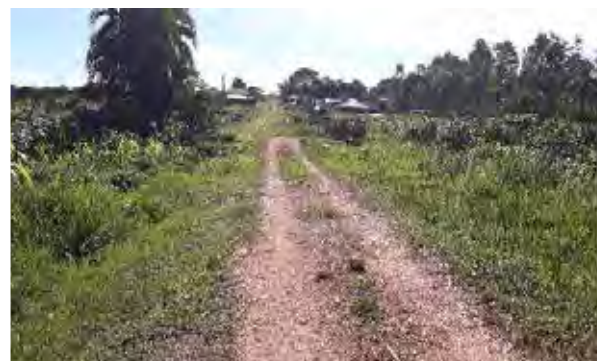
*Kakiri TC: Sections of Southern Bypass road*

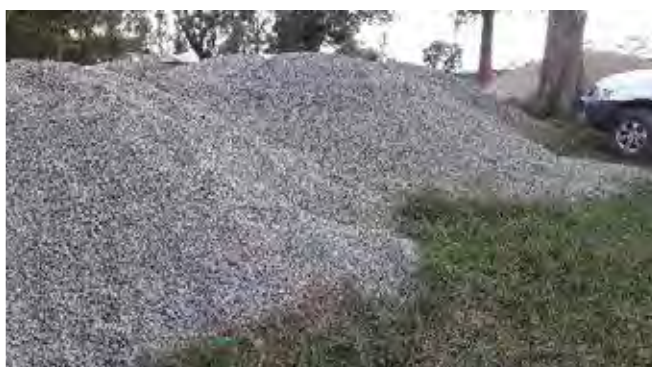
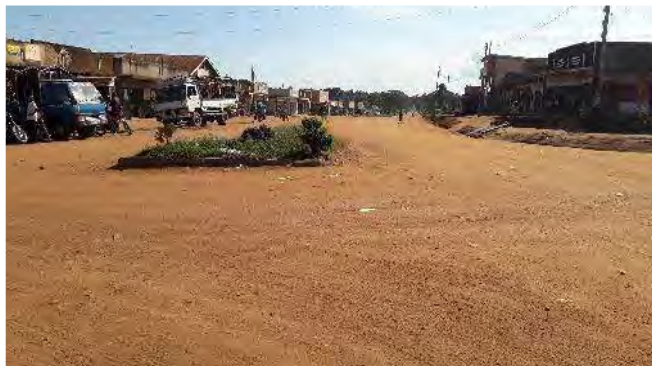
Sn	Road Name	Site Observations
1.	Masulita Street (1.0Km) undergoing tarmacking under the URF Board Special Project	Works that had been done on the road included clearing, widening to about 12m width, removal of trees, cut to spoil and shaping. Materials for surfacing of the road including stone chippings, cut-back and penetration grade bitumen had been procured and stocked. The works had however stalled pending release of additional funds for the works.

**Masulita TC:** Sections of the Tarmacking Project Road and Stocks of Materials Procured.
