ROAD MAINTENANCE MONITORING REPORT

QUARTER 1-4 FY 2018/19 (July 2018– June 2019)

AUGUST 2019

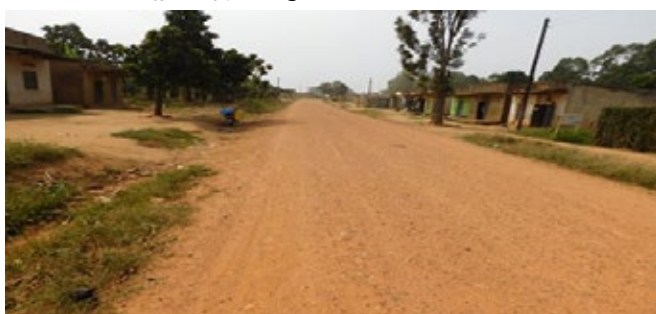
Bihaarwe-Bwizibwera (22km) received medium grading, spot gravelling of 5km, and installation of 8 lines of culverts in Q3 & Q4 using Force Account

One of the graveled sections at CH 16+000, The roads was generally in good condition

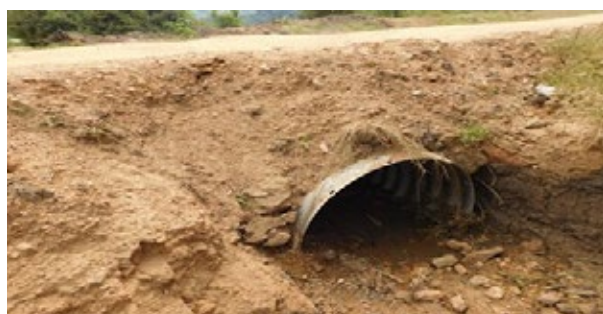
One of the culvert lines at CH 02+000 in need of end structures

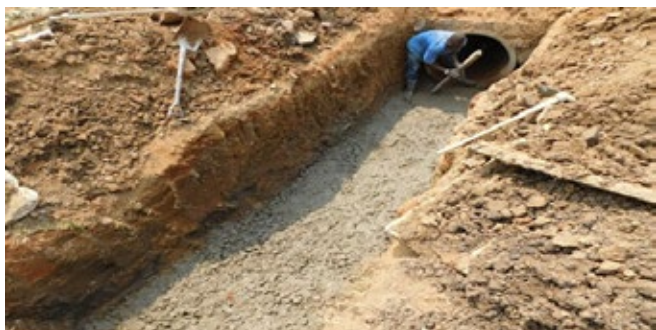
Ntare-Mutonto-Kacwangobe rd. under Framework contract by Efra Limited. Works were ongoing including grading, spot gravelling and drainage improvement

Construction of encasement for a concrete culvert at CH01+500

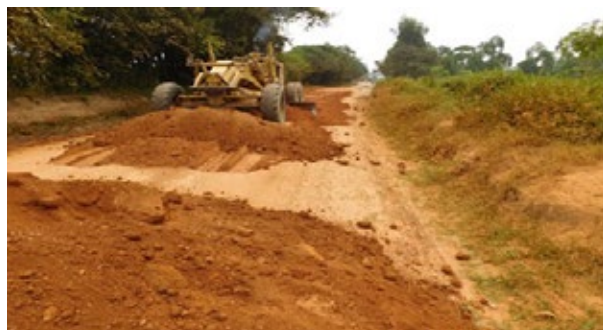
Ongoing gravel works at CH07+500 of Mutonto-Kacwangobe Rd

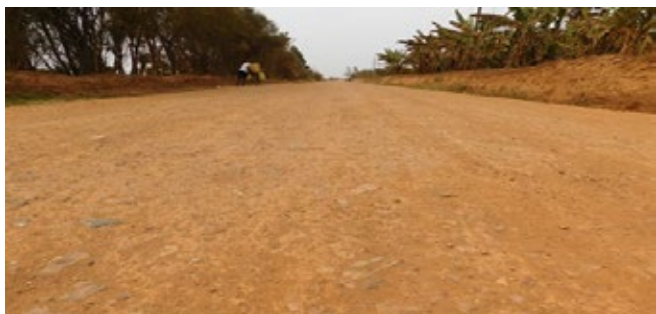
Kikagati – Kafunjo rd. (34km) under framework contract by Wanaik Construction Company Ltd. Works undertaken include heavy grading, filling low lying areas, full graveling and drainage improvement.

The road is heavily trafficked leading to fast gravel loss and should be considered for upgrade to paved standard

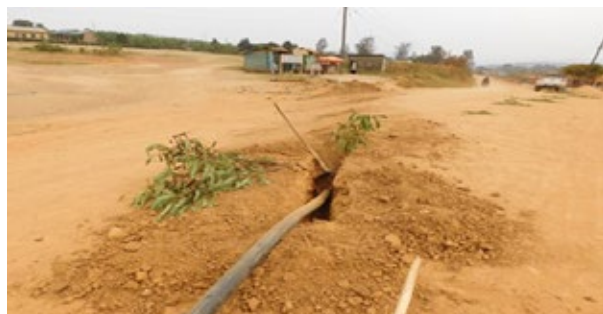
Installation of utility cables by utility companies needs to be undertaken in a coordinated manner to avoid damage to roads.

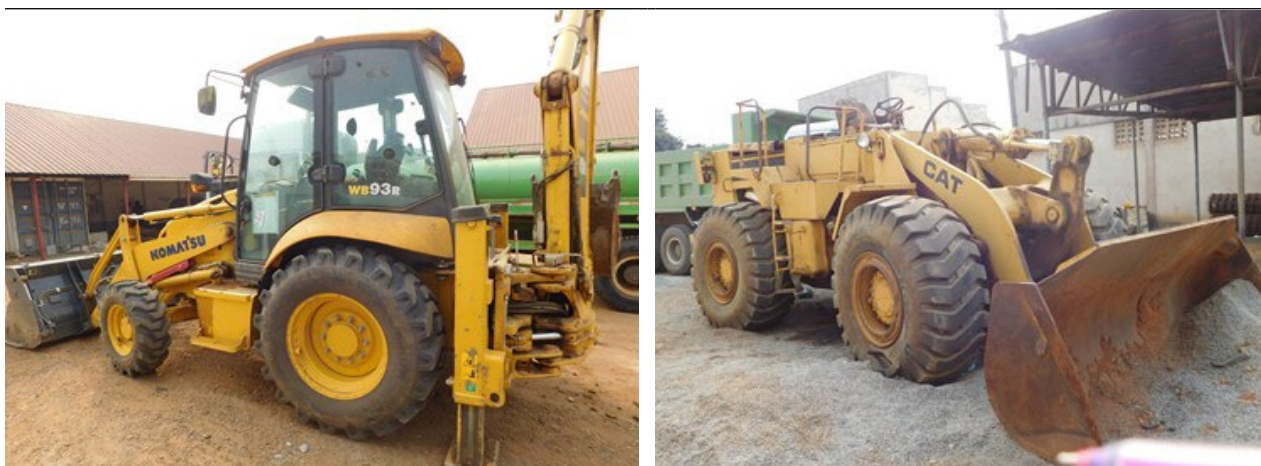
Some of the station's equipment in sound mechanical condition include the loaders above

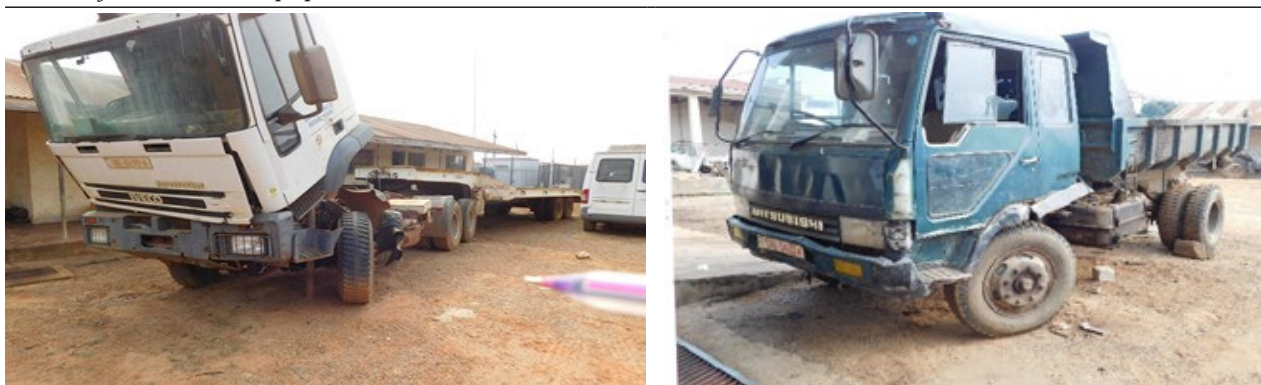
Some of the station's equipment that were broken down include the flatbed truck and tipper above. The lowbed(UG 1362W) which requires repair of its broken cabin, leaking compressor, coolant reservoir and modification of the ramp can go a long way in improving mobility of other road equipment if repaired and therefore should be prioritized.

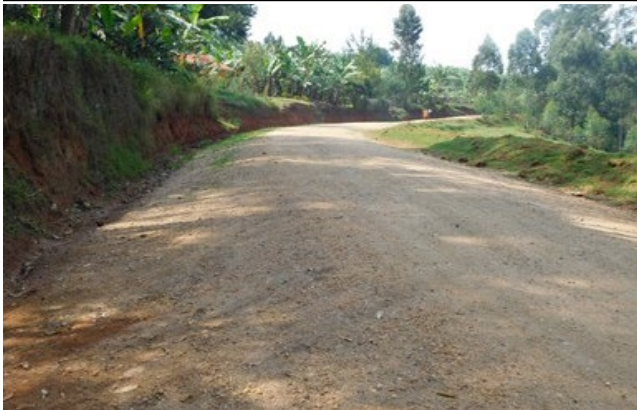
Kagashe-Rwakanyegero received mechanised maintenance i.e. grading, spot gravel and opening of side drains in Q3 FY2018/19

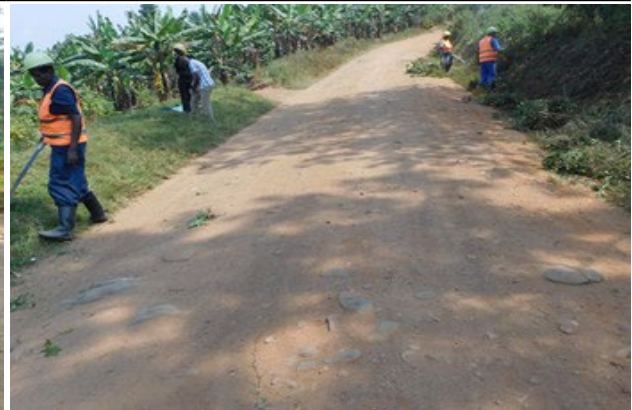
Road gang slashing along Kebisoni-Mubanga-Kihanga road. The road received mechanised maintenance in Q1 FY2018/19

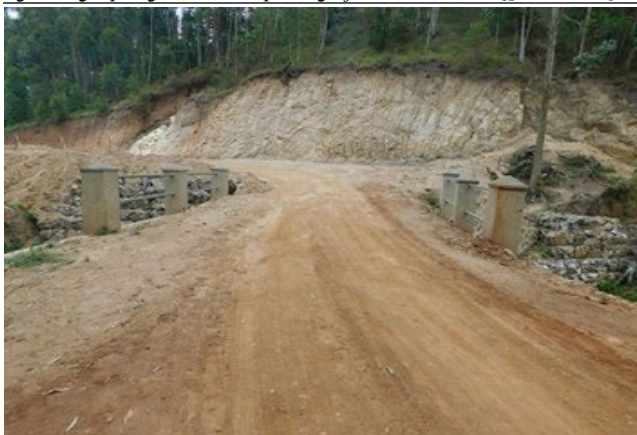
Kisinamururu ARMCO steel culvert bridge constructed at CH2+400 along Kisiizi-Nyarurambi-Kamaga rd using Force Account after the road was washed out.

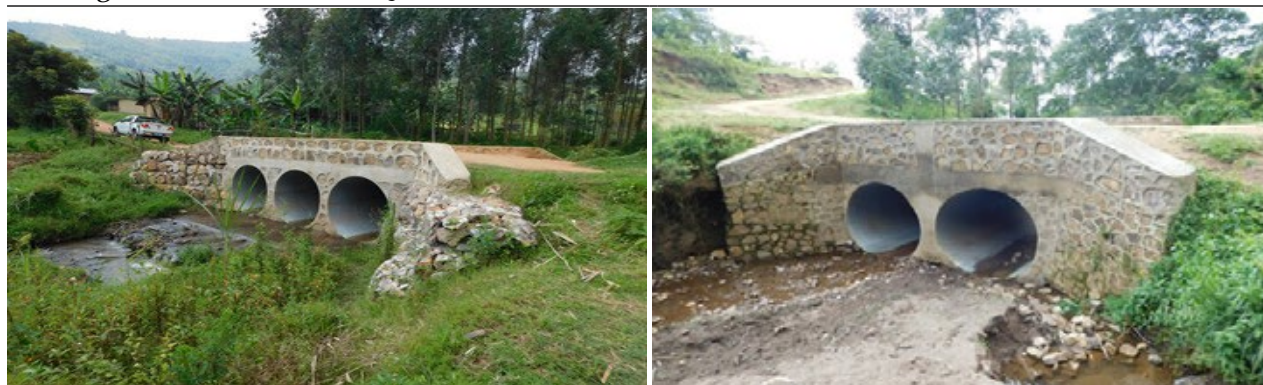
Other emergency works included installation of 3 lines of 1.8 metre diameter Armco culverts at Kigoye water crossing along Nyakishenyi-Marashaniro-Kyabamba road after the old 4 lines of 900mm diameter concrete culvert were washed out and 2 lines of 1.5metre diameter culverts at Rusharira crossing on the same road in Q2.

Kigoye (Left) and Rusharira (Right) water crossings on Nyakishenyi-Marashaniro-Kyabamba road were constructed in Q2 using emergency funding.

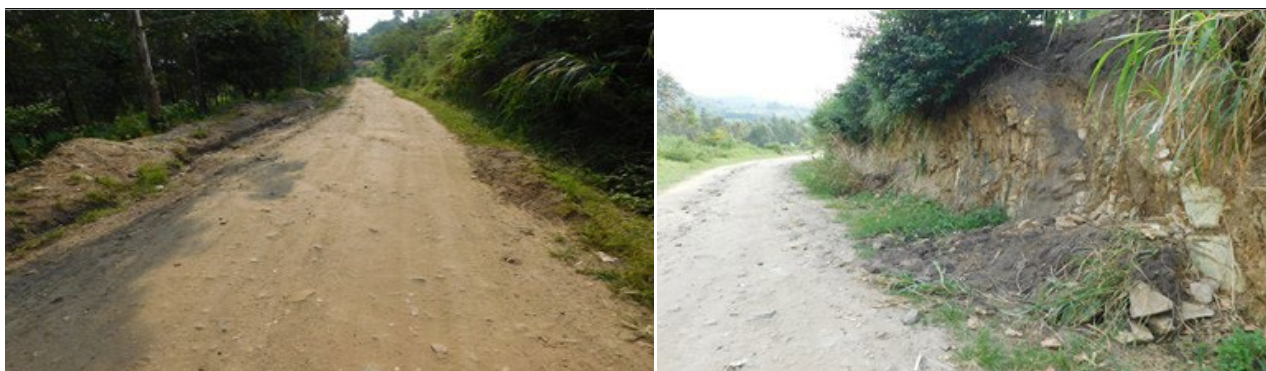
Ruhinda – Rwengeri road after UNRA's intervention (Grading/shaping and widening). The road was impassable and due for emergency works using URF funding in FY2018/19.

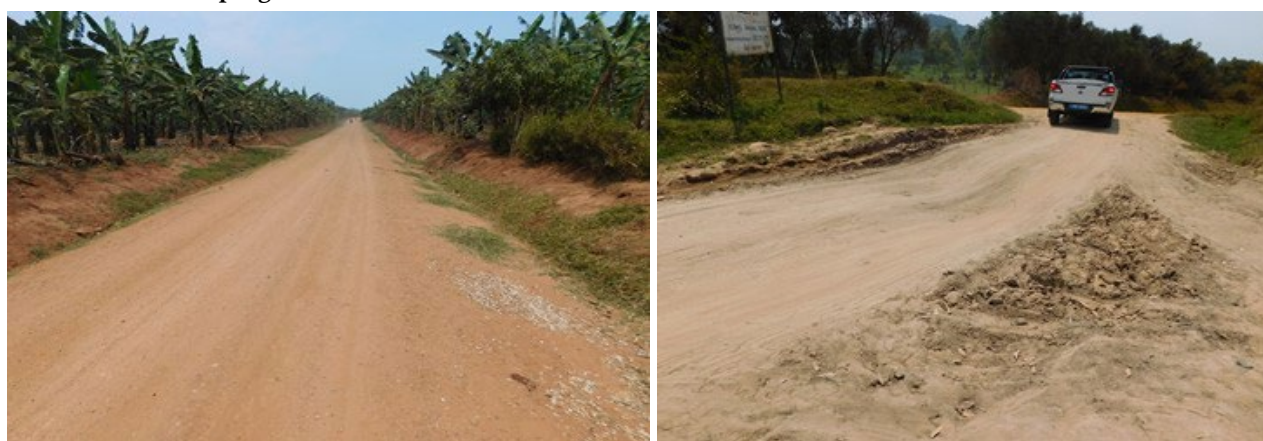
Kashaka-Karuyenje Rd (21.5km) received shaping, spot gravelling and bush clearing in Quarters 3 and 4 under the district roads programme.

Kashaka-Karuyenje Rd (21.5km) received grading and drainage improvement (disilting and opening of side drains) in Q4 FY2018/19. However, gravelling and installation of cross culverts is needed on some spots which have started failing such as CH21+500 as seen in the photo above on the RHS.

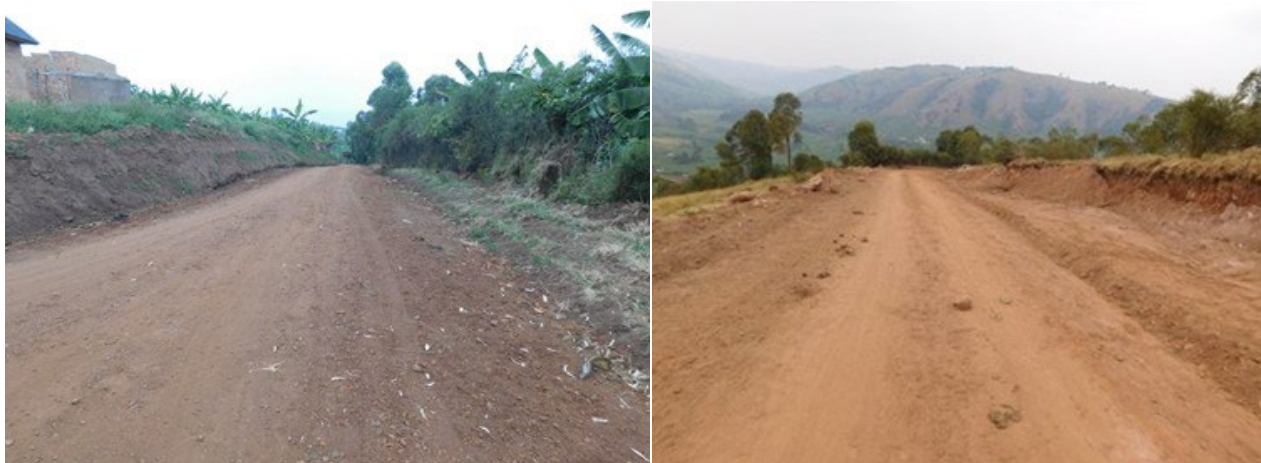
Nyamukana-Kashuro-Kitojo-Bugamba (22Km) received grading and spot gravelling up to 3.2km in Q4. On the LHS is a gravel borrow pit which is yet to be reinstated

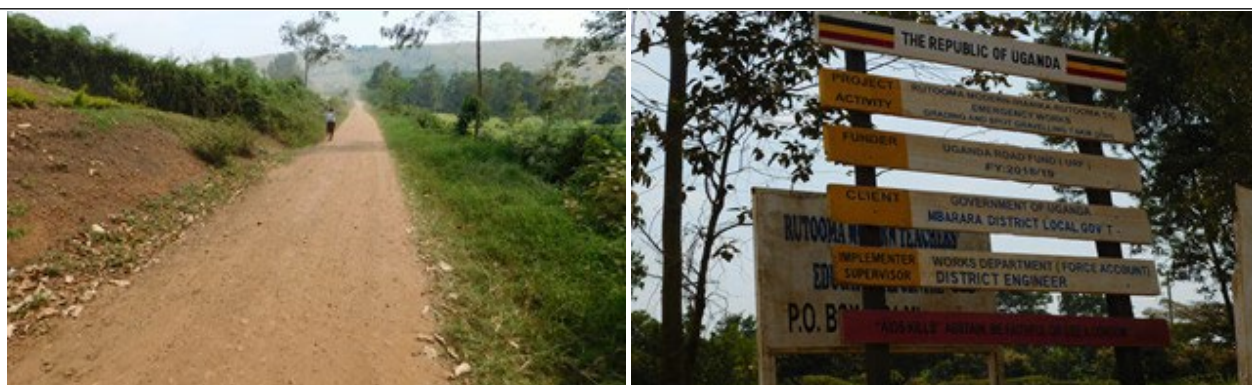
A section of Rutooma Modern-Ihanika-Rutooma rd after emergency repairs as per project billboard.

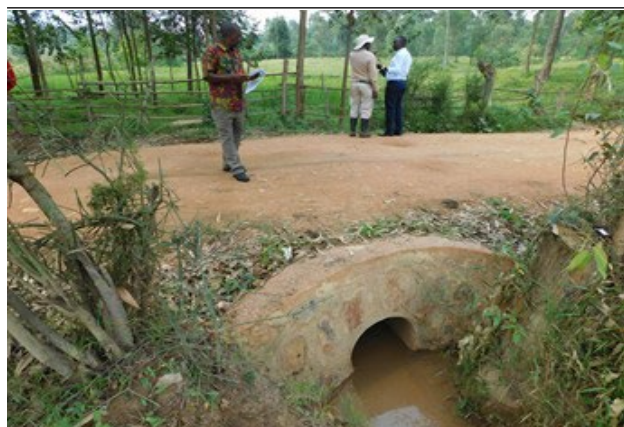
One of two 600mm diameter cross culvert lines installed on Katunju-Nyamuko Rd in Q4 FY2018/19

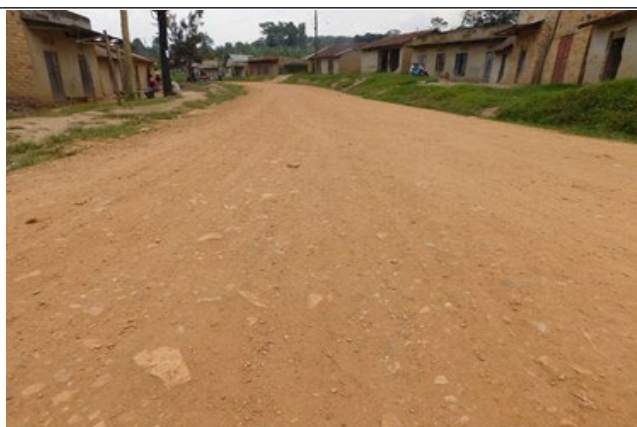
The entire length of Nyamuko-Rwenjeru T/C road (3.0km) was graded and graveled during FY2018/19.

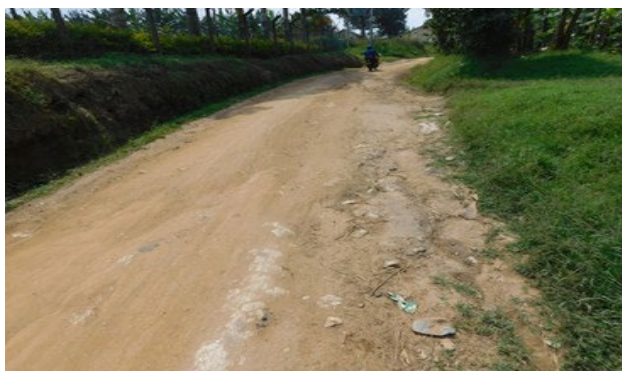
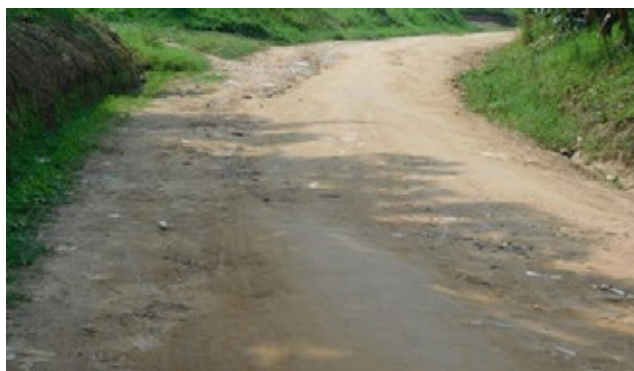
Keirere- Ruhendagazi rd (1.8km) was planned for grading but works were deferred to FY 2019/20 due to lack of a grader. Materials, allowances and fuel for the planned works had already been secured before close of FY2018/19.

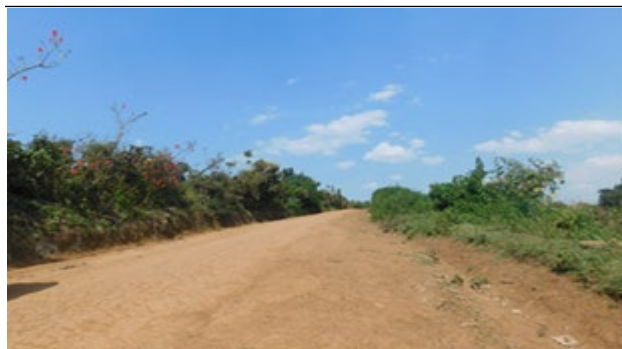
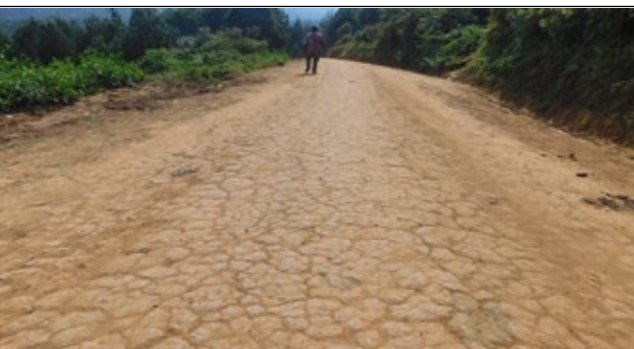
Kilwa-Hornby-Rugarama was graded but did not undergo gravelling due to breakdown of equipment.

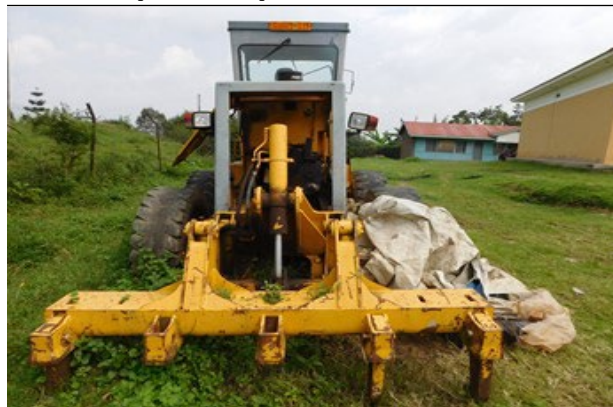
Grader LG0001-113 which has been grounded for 3 years.

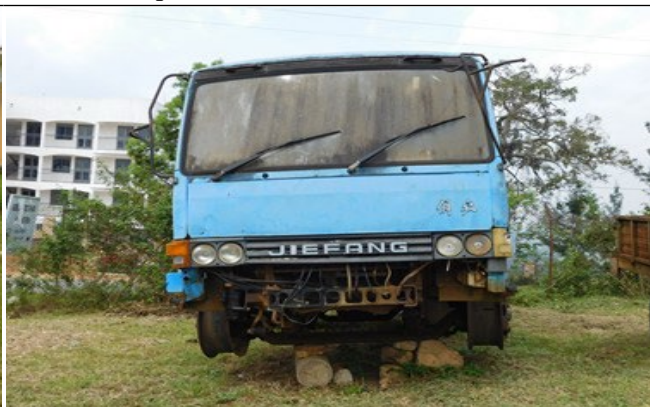
Like this Jiefang Tipper, many of the equipment are grounded due to serious state of disrepair.

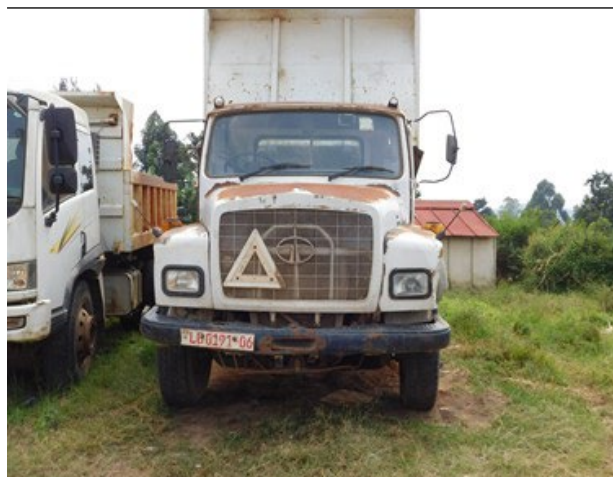
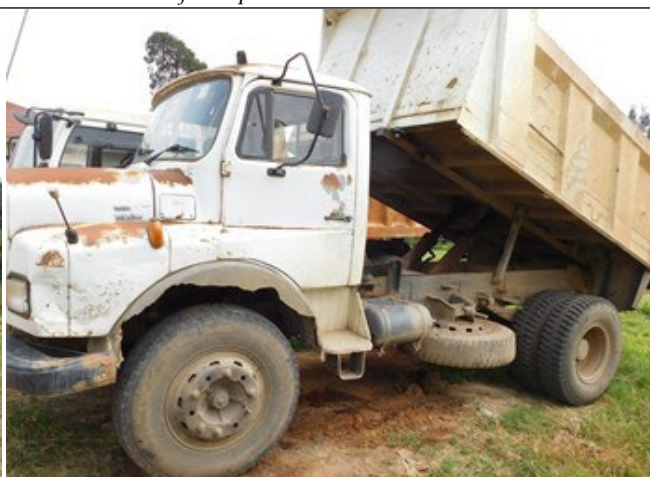
Tata Lorry LG0191-06 that received repairs to brakes, engine, battery replacement and 2 pairs of rear tyres among others

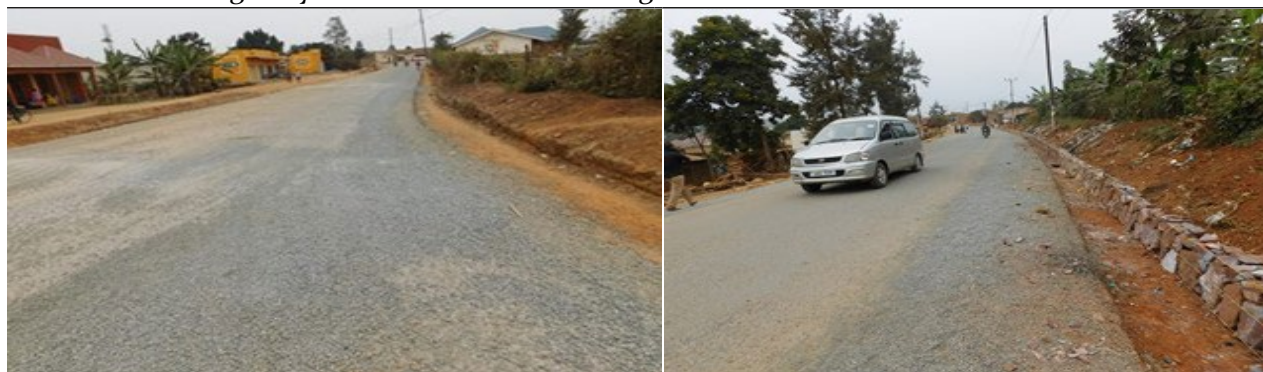
Resealing of Rwizi Road (phase III). Works included paving, resealing of 750 meters, and drainage improvement

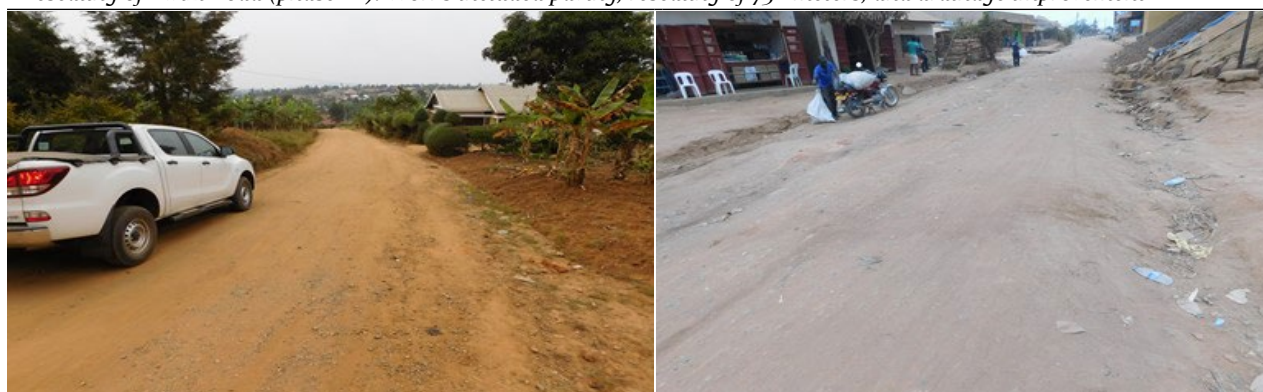
Joseph Kamanzi rd(2km) was graded in Q3 Fy2018/19

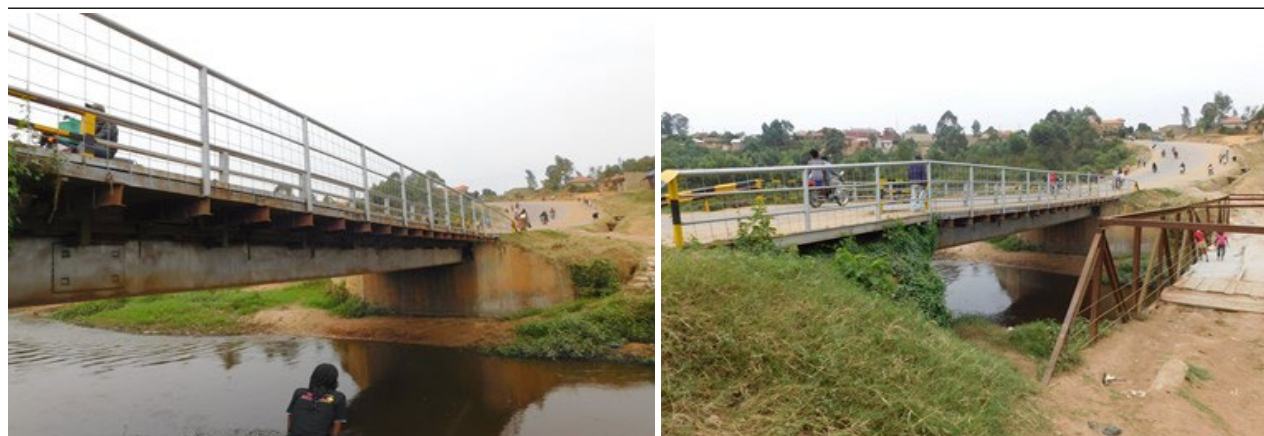
Work involved installation of an additional metal plates below the bridge to support the timber

The DA requested for UGX 101.237 million as emergency funding in FY2018/19 to install a chequered plate on Katetete Timber Bridge. URF released UGX 100 million for the project. The plate was installed at a total cost of UGX 105.3 million, which is 5.3 million in excess of the funds disbursed. Photos of the bridge after works were completed are shown below

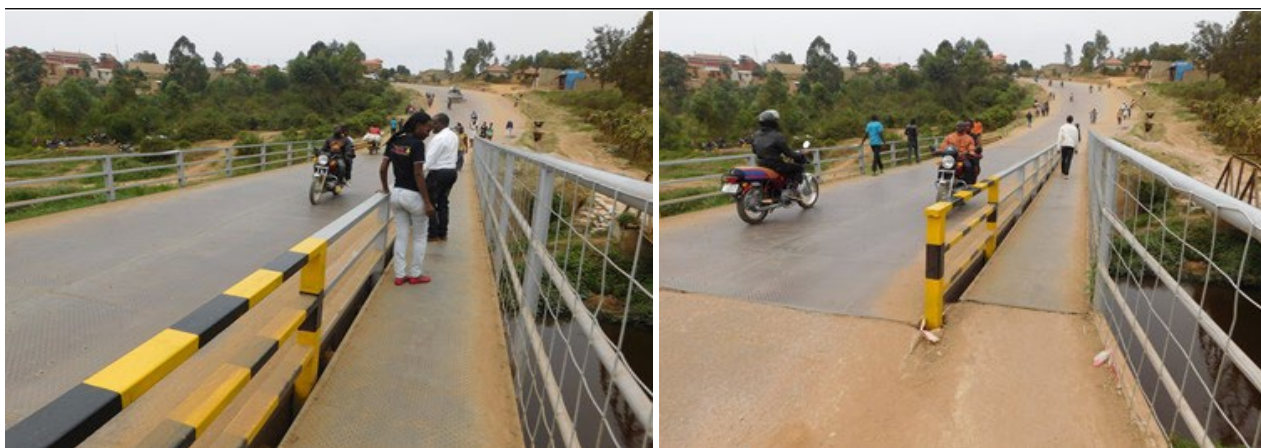
Additional works involved construction of pedestrian walkway and guard rails along the bridge.
